# **Rebuttal of NYC MTA Platform Screen Door Feasibility study**

Author: Joe Wu, PhD

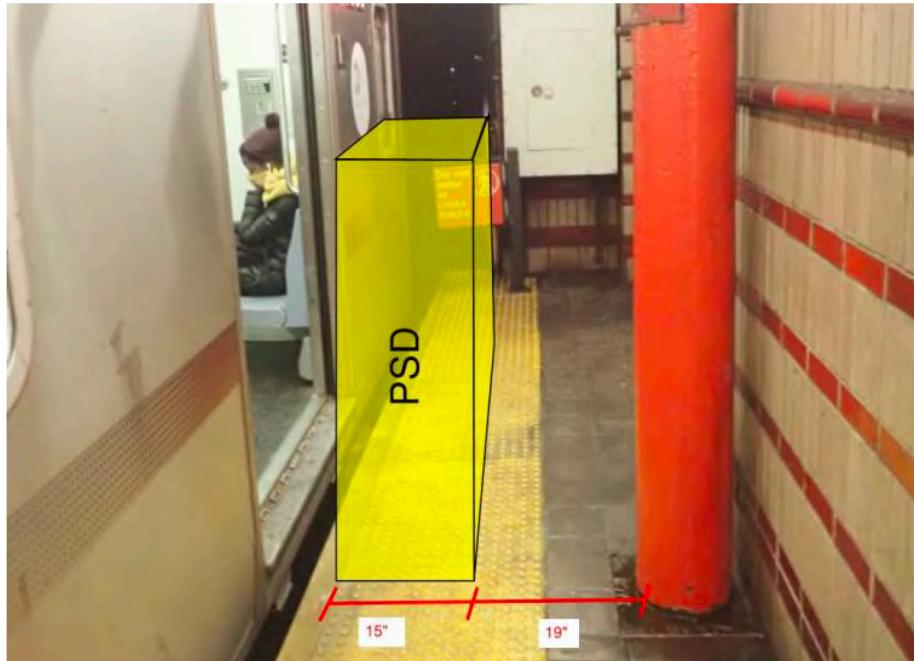
- That section of the platform without the PSD is too narrow for normal passengers to stand or walk on, let alone someone in a wheel chair.
- The pipe is a big obstruction and safety concern as someone may walk on that section of the platform and around the pipe to wait for train effectively walking close to the platform edge.

**Figure 1 – Non-compliant ADA condition**  
Hoyt Street Station
