Rebuttal of NYC MTA Platform Screen Door Feasibility study

Author: Joe Wu, PhD

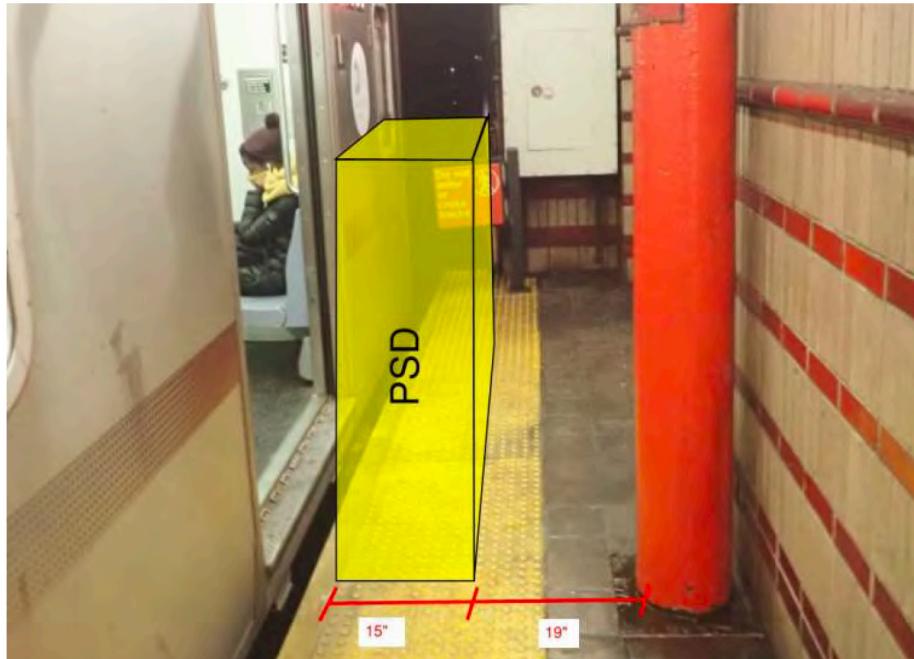
Hoyt street: ADA non-compliance (page 210)

- That section of the platform without the PSD is too narrow for normal passengers to stand or walk on, let alone someone in a wheel chair.
- The pipe is a big obstruction and safety concern as someone may walk on that section of the platform and around the pipe to wait for train effectively walking close to the platform edge.

Figure 1 – Non-compliant ADA condition
Hoyt Street Station

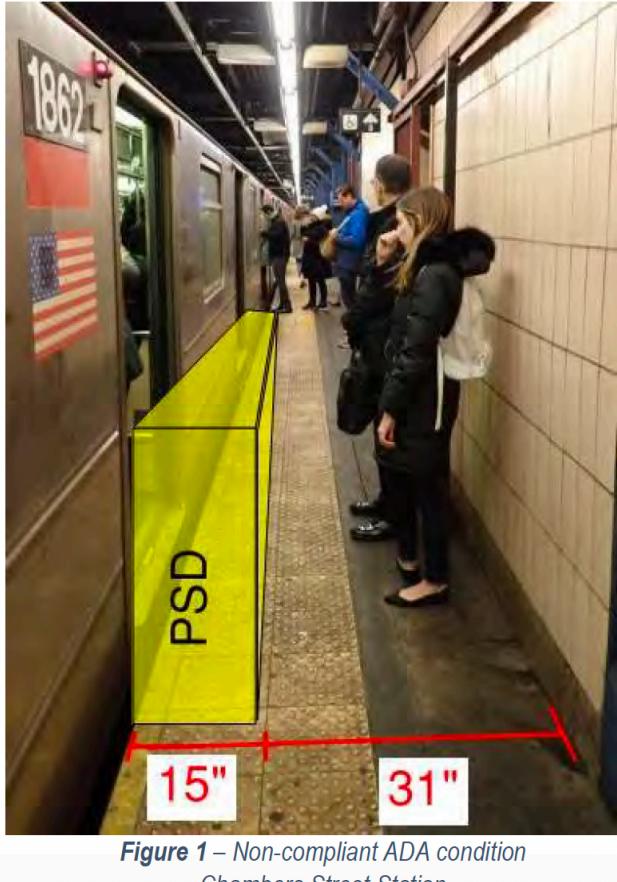
Chamber street: ADA non-compliance (page 68)

- Platform too narrow for passenger traffic.

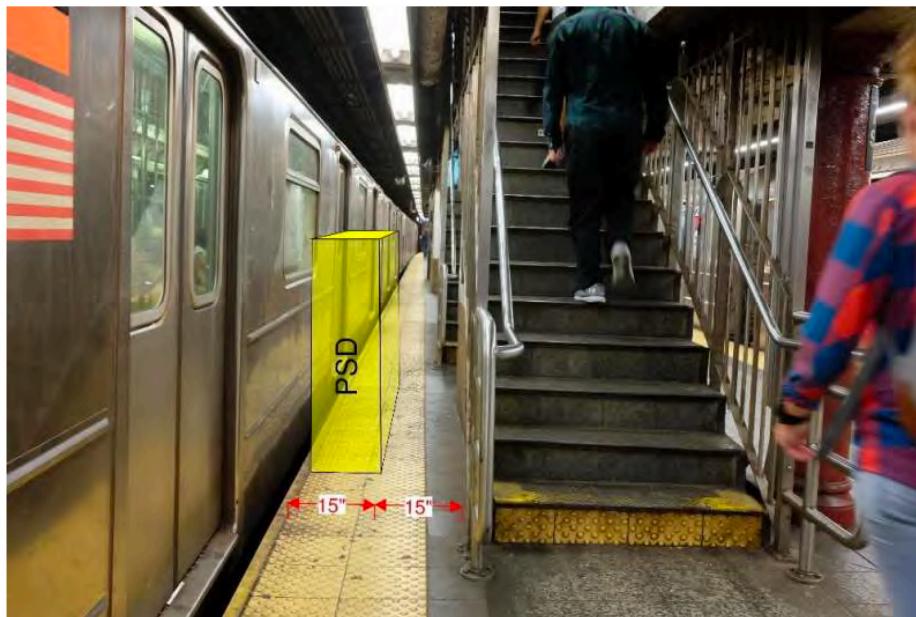
72nd street: ADA non-compliance (page 350)

- They cite 36 inches the minimum ADA requirement.
- At 30 inches (15+15) this section of the platform was not compliant with ADA in the first place and is too narrow for passenger traffic regardless of disability status. One foot will touch the yellow no-step line if someone were to walk through that strip of the platform, which goes against MTA's public safety announcement.
- A person in a wheel chair will not be descending to the platform using the stairs.

Figure 1 – Non-compliant ADA condition
72nd Street Station

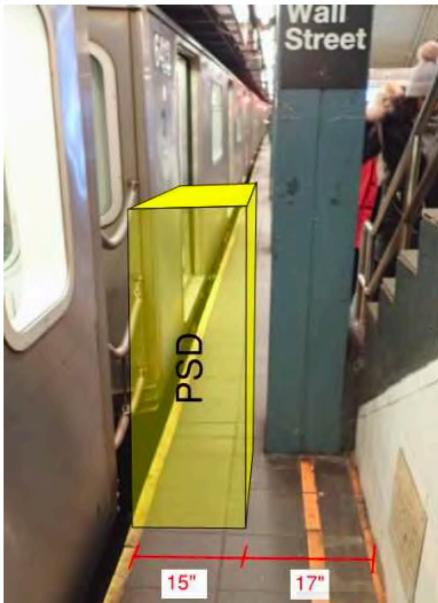
Wall street: ADA non-compliance (page 357)

- They cite 36 inches the minimum ADA requirement.
- At 32 inches (15+17), this section of the platform was not ADA compliant in the first place. In addition, the column would have gotten in the way of a wheel chair.
- A wheel chair bound person will not descend to the platform using the stairs.
- This section the platform is too narrow for any passenger to stand or walk through. Trying to walk around the column will lead to a disastrous accident.

Figure 1 – Non-compliant ADA condition
Wall Street Station

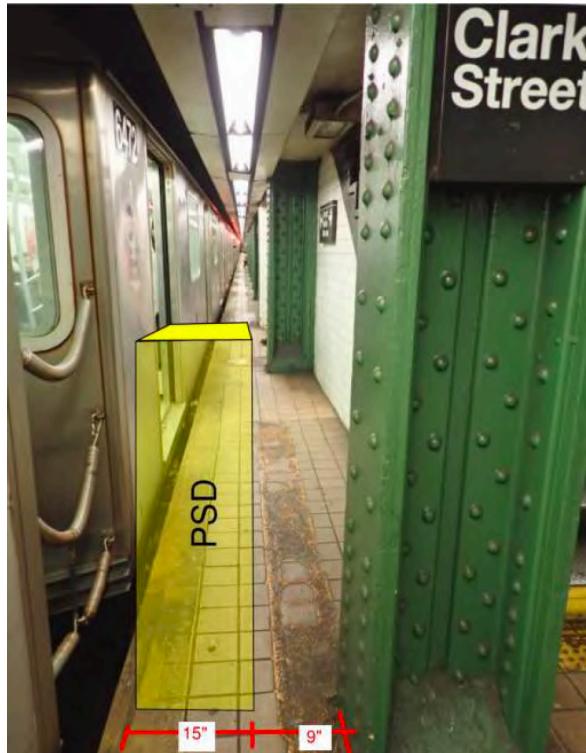
Clark street: ADA non-compliance (page 358)

- A minimum of 32 inches was cited for ADA compliance.
- At 24 inches, along with the columns, this area of the platform is not ADA compliant even in the absence of PSD. It is too narrow and dangerous for anyone to wait or walk through this area.

Figure 1 – Non-compliant ADA condition
Clark Street Station

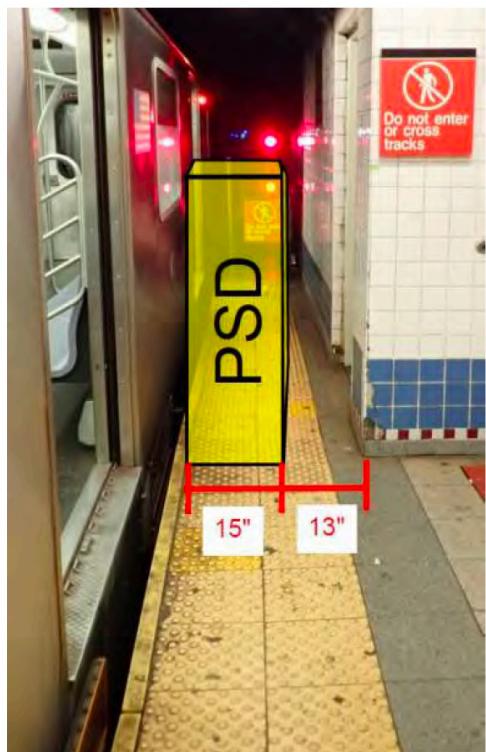
Flatbush: ADA non-compliance (page 231)

- ADA minimum requirement cited as 36 inches.
- Section is 28 inches (15+13) without the PSD, so it is not ADA compliant in the first place. I think they are expecting people roll through that section in a wheel chair.
- Note the "Do not enter or cross track sign on the wall". Too dangerous to be waiting or walking through that strip of the platform.

Figure 1 – Area of ADA non-compliance

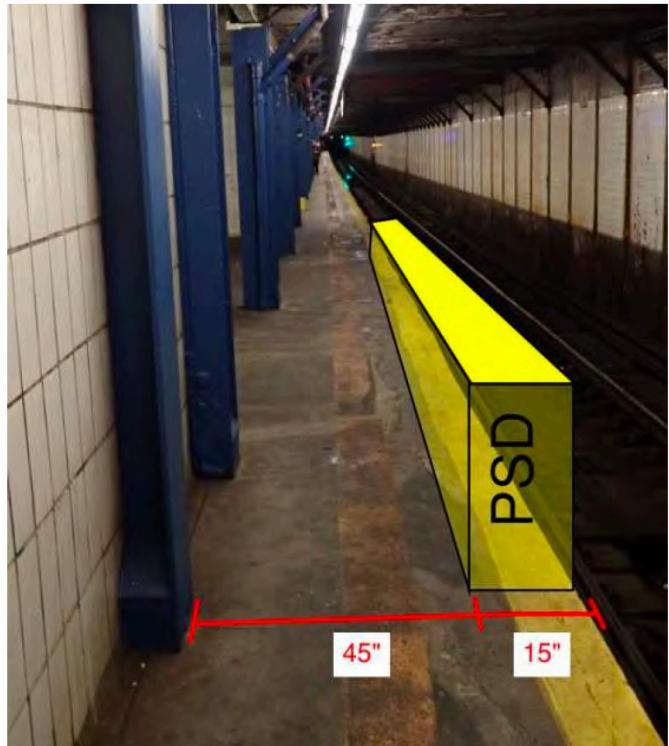
14th street: Egress non-compliance (page 51)

- Cited narrow and dangerous section of the platform (passengers do not have much space, maybe 2.5 feet at best before the recommended yellow no step line).
- Cited minimum of 5 feet 11 inches evacuation but the existing width of that section of the platform is already non-compliant, even without the PSD.

Figure 1 – Non-Compliant egress condition
14th Street Station

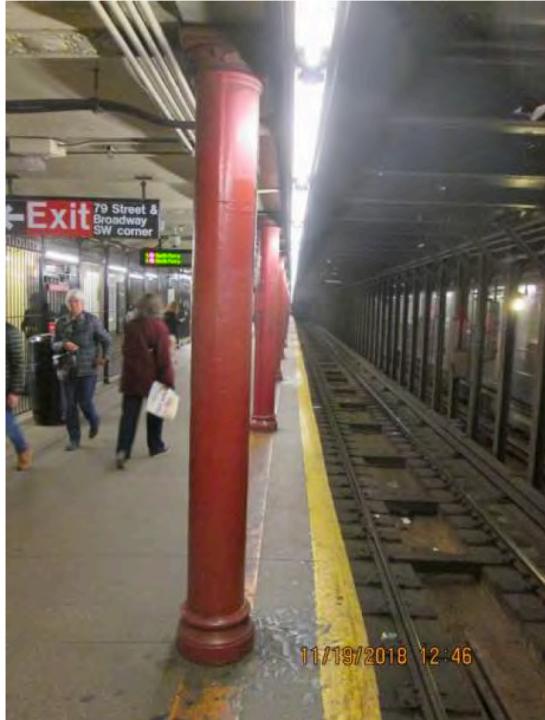
Columns close to the edge (page 177)

Figure 1 – Column 15" from the edge
79th Street Station

- Consider placing placing rope type platform barrier adjacent to the columns in between the column and the wall. You can potentially customize the length of the rope so that motors that raise these barriers do not need to be placed at every column.
