Rebuttal of NYC MTA Platform Screen Door Feasibility study

Author: Joe Wu, PhD

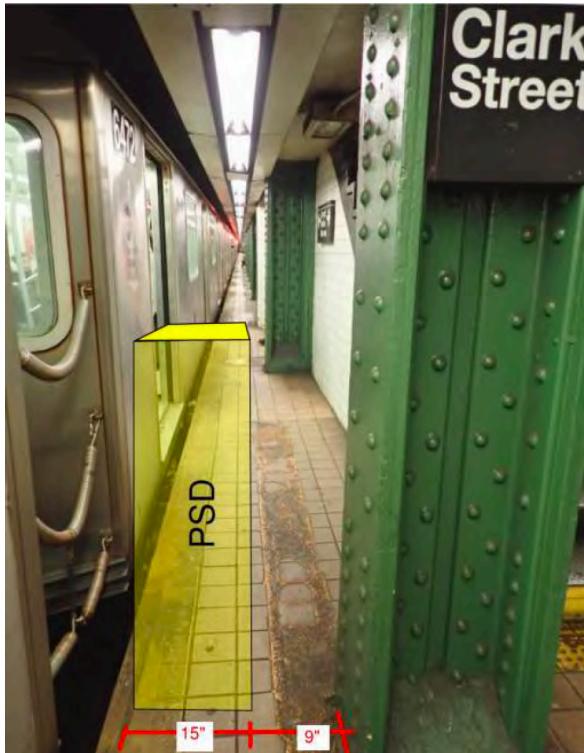
Clark street: ADA non-compliance (page 358)

- A minimum of 32 inches was cited for ADA compliance.
- At 24 inches, along with the columns, this area of the platform is not ADA compliant even in the absence of PSD. It is too narrow and dangerous for anyone to wait or walk through this area.

Figure 1 – Non-compliant ADA condition
Clark Street Station

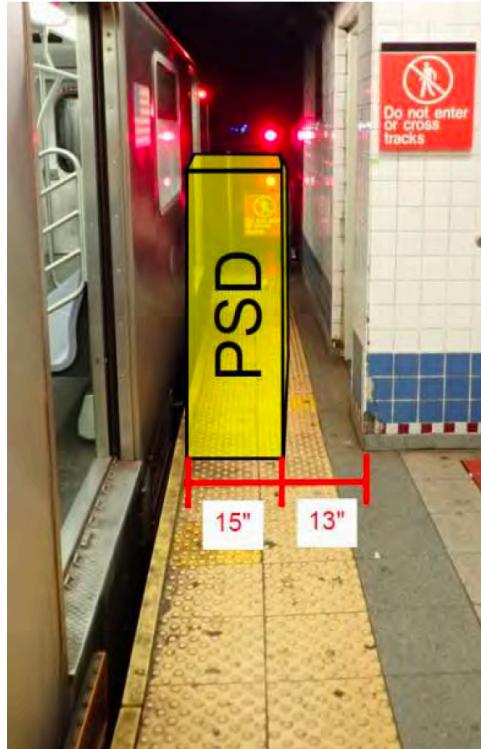
Flatbush: ADA non-compliance (page 231)

- ADA minimum requirement cited as 36 inches.
- Section is 28 inches (15+13) without the PSD, so it is not ADA compliant in the first place. It is dangerous to be waiting or walking through that strip of the platform regardless of disability status.

Figure 1 – Area of ADA non-compliance
Flatbush Avenue Brooklyn College Station
