Tile Week: YETS Maintenance Update

February 8, 2023

Peter Camporeale, Jacky Li
On behalf of TileCal maintenance team

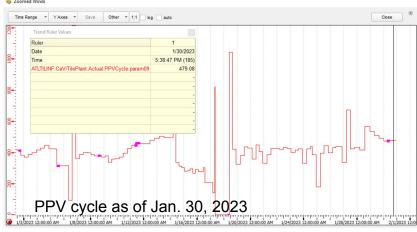
Before January 1st, PPV Cycle was approximately 700 minutes with 6 modules locked, having been identified in December as having possible major leaks (EBA07, EBA30, LBA30, LBA45, LBA58, LBC38)

Suddenly, on January 1st we lost ~200 minutes in the cooling cycle due to a major leak (middle connectors in LBC33 mostly)

After subsequent cooling interventions, the PPV cycle was recovered to ~500 minutes. The difference is due to small leaks in many modules (we simply cannot target every one)

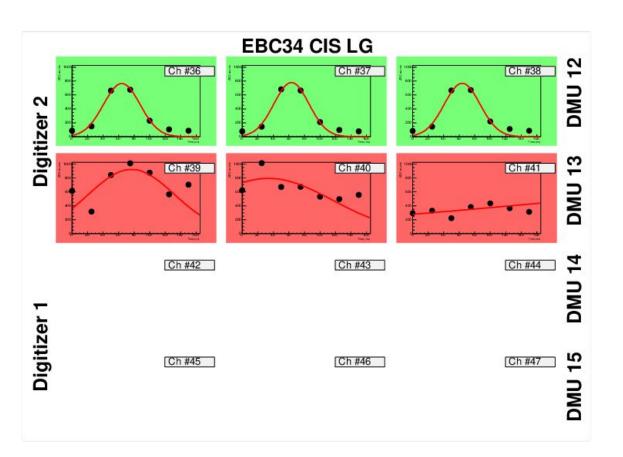
Status: Digitizer #2 failed DVS test with bad CIS pedestal in LG→ Maintenance list

EBC 34: Digitizer #2 bad (affecting channels 39-41)

Intervention: Digitizer was replaced (New address:4872 [decimal] or

1308[hexadecimal])
