Past and Present Coiled Tubing String Failures: History and Recent New Failures Mechanisms

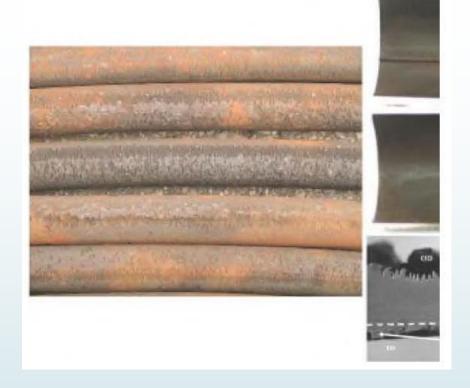
Corrosion-Operation By Exposure To Acid

- The corrosion damage is caused by the action of fluids pumped through the string and/or the action of corrosive environment in the well during operations.
- Includes the CT failures associated with the exposure of the pipe to the fluids pumped through the string and/or the well environment.

- The change from predominantly operational to predominantly Storage-Corrosion during this period significantly influenced by:
- 1. The reduction in Acidizing operations in North America
- 2. The increase in North America unit count
- 3. Change in job distribution to mostly support for shale fracturing (Perforation runs, plug Milling, or annular fracturing)

Actions that must be taken to avoid this kind of failure are focus on at least the following aspects:

- 1. Appropriate Acid mix design (fluids and inhibitors)
- 2. Neutralizing after Acid jobs using sodium carbonate $(Na(CO_3)_2)$
- 3. Displacement of remaining fluids with fresh "water + Inhibitor"
- 4. N₂ Purging

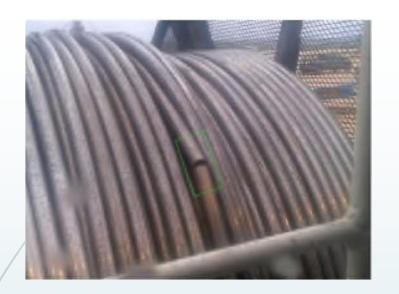
Severity of the Pitting Caused by MIC

- MIC failures associated with the use/accumulation of water contaminated with bacteria had occurred in the past, mainly in the form of very severe, localized, and aggressive pitting corrosion.
- MIC associated CT failures basically started to be a significant problem within the Coiled Tubing industry, as the fluid used for plug milling operations was changed to recirculated water.

- Very Severe
- Localized
- Aggressive

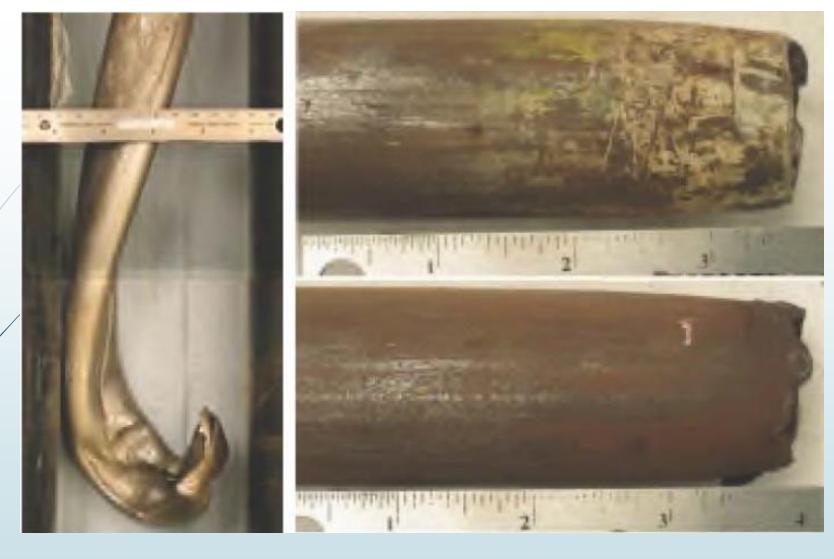
Human Error Examples

- In general, failures associated with human error caused an overload failure or buckling of the pipe.
- In general, the number of failures associated with human error has been low (1 to 5 cases per year).
- Whilst the frequency of string failures arising from human error has been relatively low, the resulting incidents are typically very high in profile.

Pipe Buckling

Overload Failure

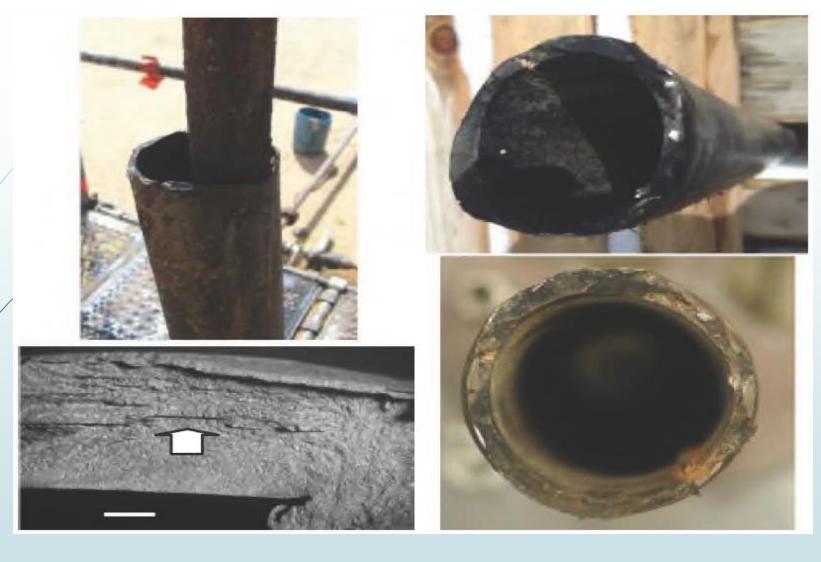
Hydrogen Induced Cracking (HIC)
Failure In Concentric Coiled Tubing
