SITE VISIT

The Rockwood 10 project is a new construction project located in NE Portland, Oregon. The requested site observations on June 11th, 2021 were related to the building enclosure components currently being installed. Areas of specific review included hollow metal doors, storefront, and integration of HVAC components. Observations were made of the condition of the roof on Building C.

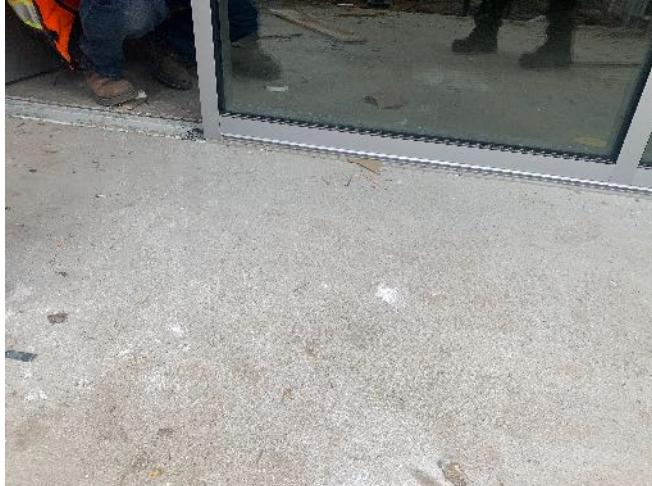
3 .01 Building B, 1st floor. Weeps have not been drilled in the sub sill of the storefront sill. Verify that weeps are installed per manufacturer's spacing recommendations.

Corrections made - complete.

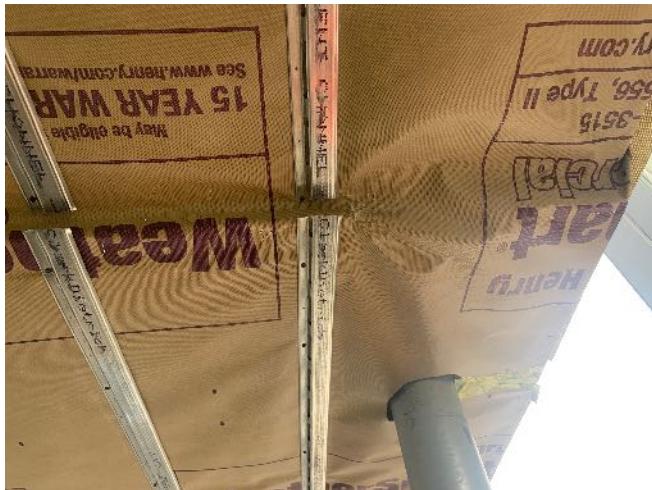
3 .03 Building A, West soffit. WRB/AB component detailing is incomplete in some areas and exhibits damage in other areas throughout both soffits. Complete detailing where needed and repair or replace damaged WRB/AB components.

Detailing occurring in sequence and being inspected prior to siding installation at each elevation.

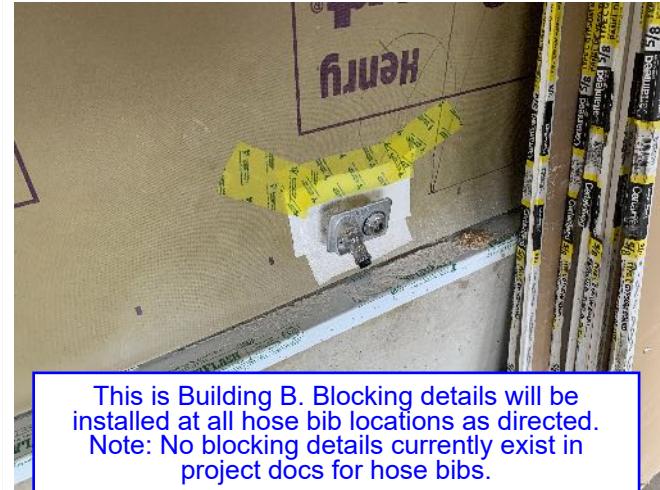
This is Building B. Blocking details will be installed at all hose bib locations as directed. Note: No blocking details currently exist in project docs for hose bibs.

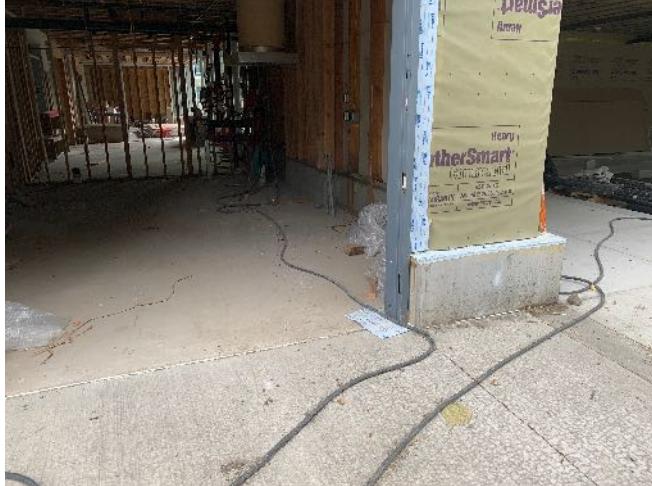
3 .09 Building A, South elevation. Hollow metal doors at exposed locations that have not been correctly detailed at the sill must be removed to allow for correct application of the sill detail.

Corrections 90% complete. Doors removed and sills detailed in accordance with project documents.

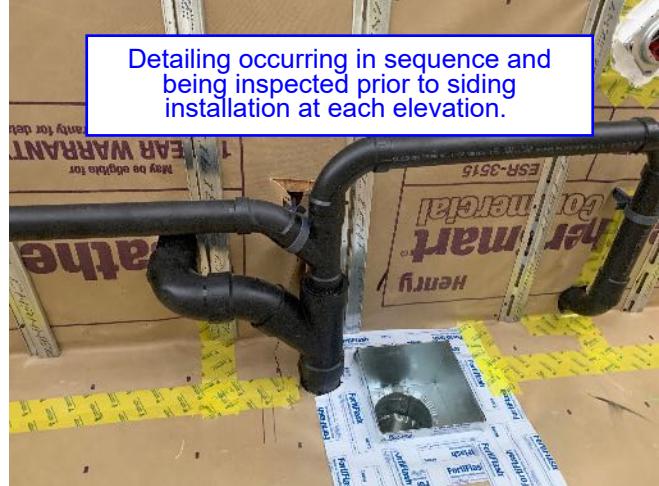
3 .10 Building A, South soffit. WRB/AB component detailing is incomplete in some areas and exhibits damage in other areas throughout both soffits. Complete detailing where needed and repair or replace damaged WRB/AB components. This condition was evident while the drywall subcontractor was installing the gypsum soffit at this area. Verify that all WRB/AB detailing is complete prior to cover.

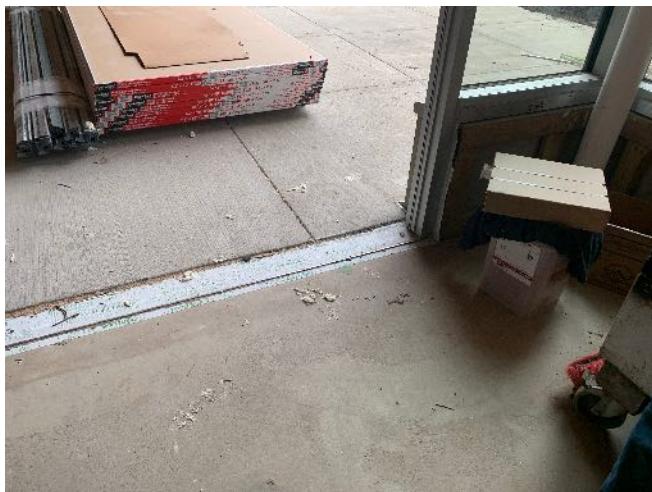
3 .11 Building A, North storefront entrance. The elevation of the storefront sill has been poured below the elevation of the adjacent exterior slab. The storefront framing will need to be removed to allow for a solid shim to be placed in the sill to provide a 1/4" drop from the sill to the adjacent exterior concrete. The solid shim will be stripped in with SAM per the original detail.

Corrections in progress at all WOM areas as discussed by LMC/QEC. HDPE being used for solid shim material as recommended by QEC.

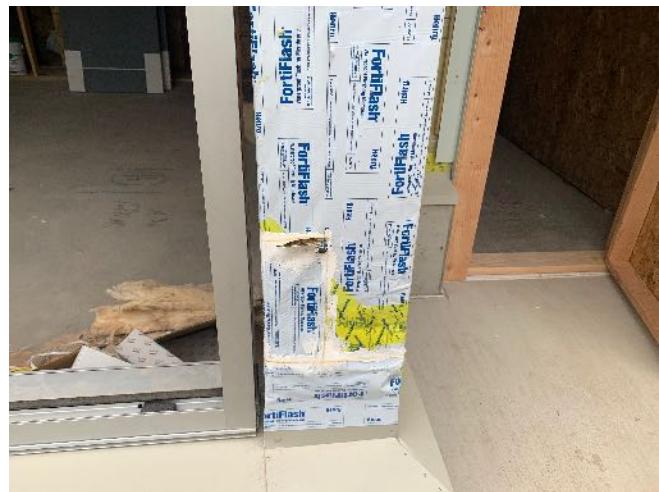
3 .12 Building A, East elevation. Repair damaged SAM at storefront corner.

All damage to SAM and WRB being corrected prior to siding install.

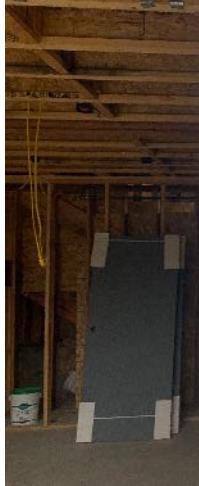
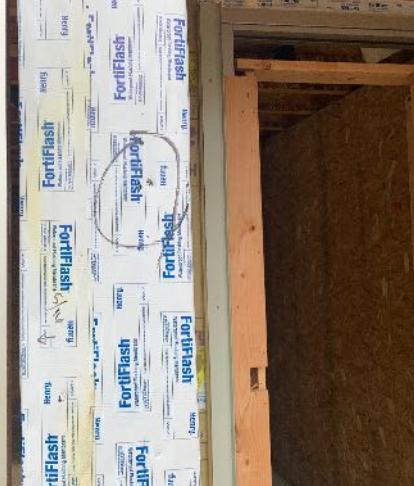
- 3 .13** Building A, East elevation. Repair damaged SAM at storefront corner.

All damage to SAM and WRB being corrected prior to siding install.

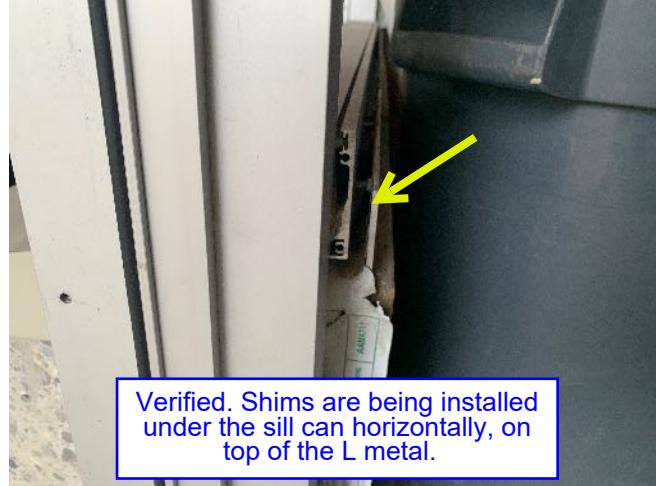
Verified. Shims are being installed under the sill can horizontally, on top of the L metal.

- 3 .14** Building A, East elevation. Storefronts have been installed with a shim between the structural back angle and storefront subsill. This is in accordance with Waechter's mark up of the shop drawings but not what was installed on the mock up. Verify that shim drainage below sill flashing was installed per our mock up discussions.

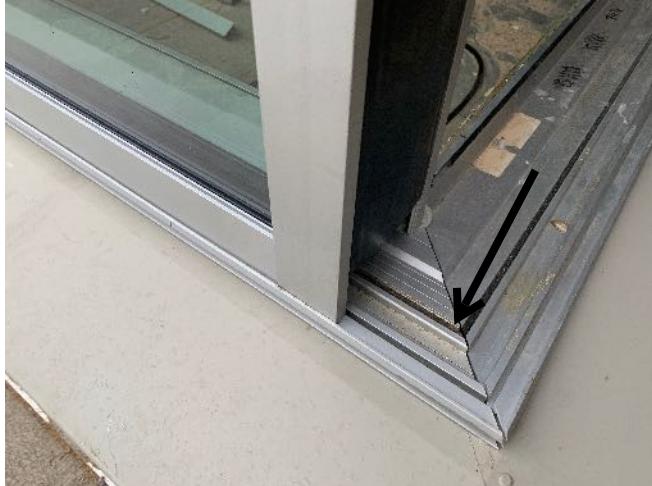
- 3 .15** Building A, East elevation. Storefront subsill. Complete sealant detailing at mitered corner of subsill prior to installing storefront sill can components.

See SVR 05 - 5.03 for response.

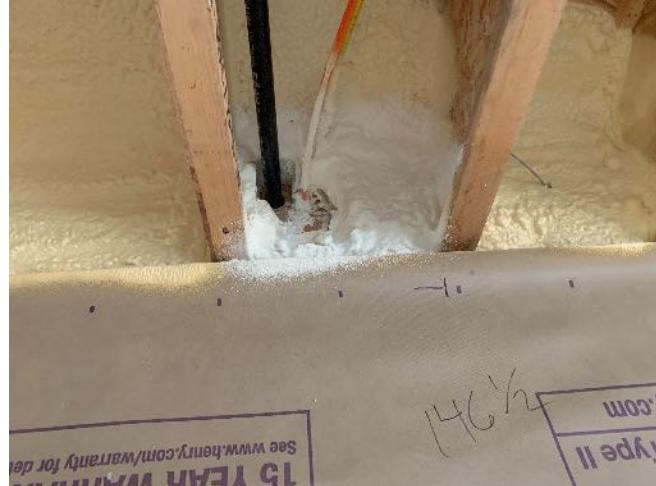
- 3 .16** Building A, East elevation. Repair areas of SPF damaged by installation of out of sequence work.

All SPF areas corrected and inspected by LMC and COG prior to cover.

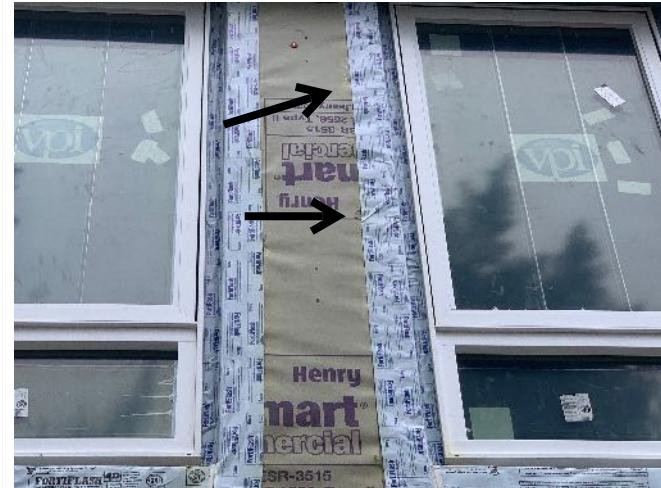
3 .17 Building B, South elevation. Repairs damaged areas of WRB prior to covering with furring and cladding.

All damage to SAM and WRB being corrected prior to siding install.

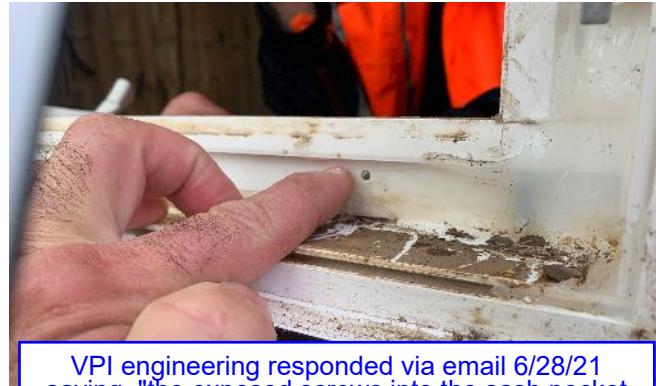
VPI engineering responded via email 6/28/21 saying, "the exposed screws into the sash pocket are typical and should not affect any water testing performance." LMC will require this to be noted by VPI in their warranty of all RW10 windows.

3 .18 Typical condition. Fasteners are seen protruding through the wall of the vinyl window frame. LMC to discuss with VPI if this condition is acceptable or if remedial work to the window will be required.

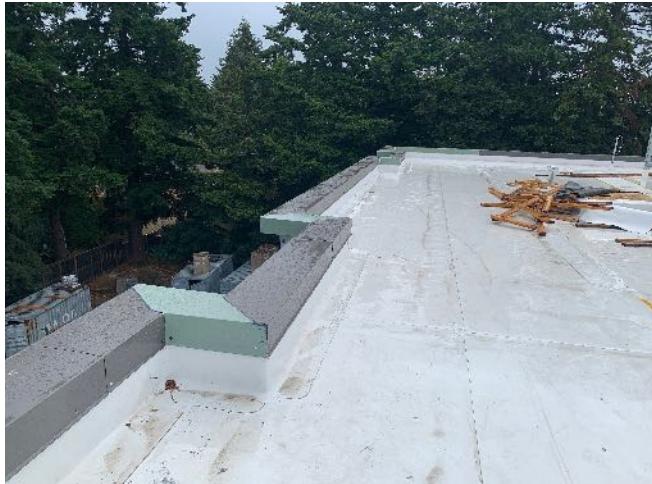
3 .19 Building C, Roof. The roof installation is largely complete. These observations will focus on issues with the current installation.

All parapet cap metals scheduled to be replaced in their entirety pending acceptance of revised mockup utilizing standing seam detail.

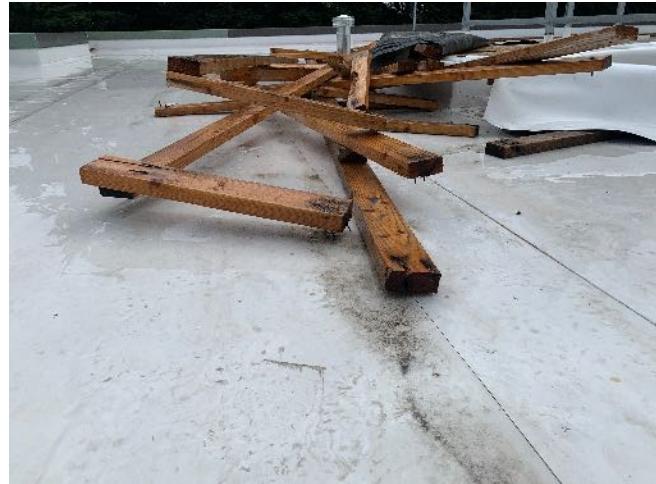
3 .20 Building C, Roof. Wood debris with fasteners protruding from the wood (likely from temporary guardrails) has been left on the roof without protecting the membrane. This debris should be removed in the presence of the roofer so they can accurately locate and identify areas of damage.

Debris removed and all TPO inspected and repaired.

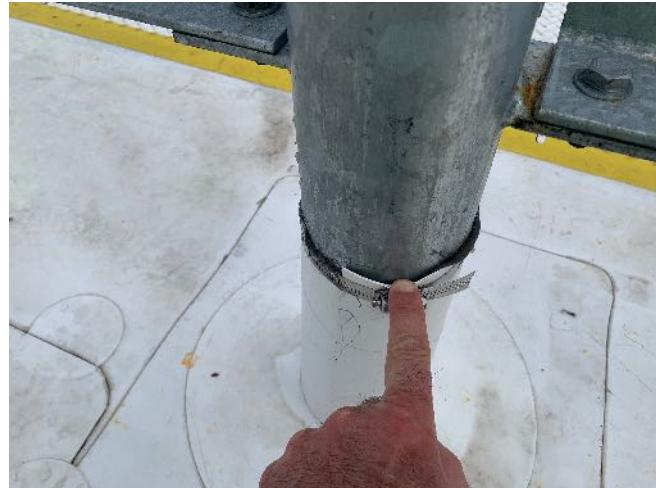
3 .21 Building C, Roof. Verify that water cut off mastic has been applied behind the top of the TPO membrane continuously around the pipe.

Corrections completed by roofing installer .

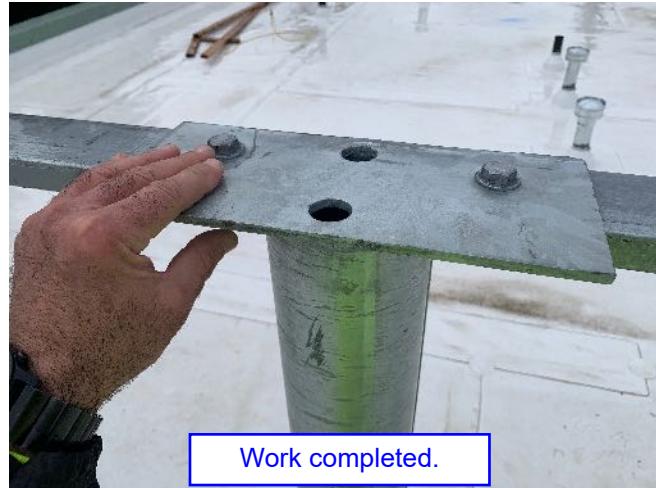
3 .22 Building C, Roof. These round pipes are the structural support for the mechanical screen. There are two holes in the plate on top of the pipe that provide a clear path for water into the roof assembly. These need to be plugged to prevent water ingress into the roof assembly. This needs to be remediated on all buildings in the project.

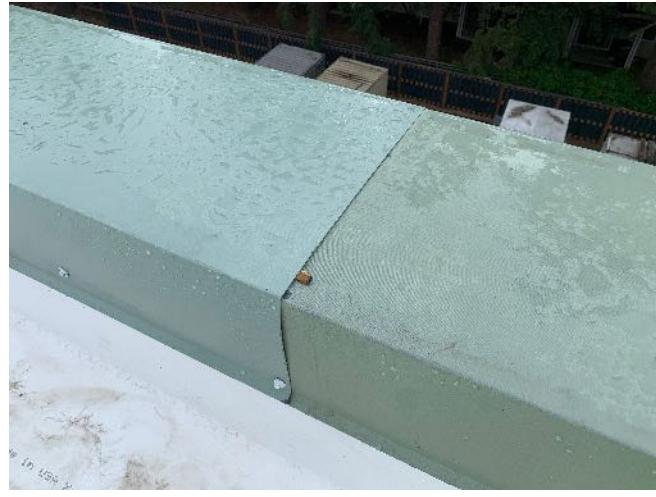
3 .23 Building C, Roof. Specifications section 076000 2.4.G.1 calls for standing seam metal at roofs. The parapet metal submittal does not indicate that seams would not be fabricated using standing seams. Please verify that the proper seam detail has been used and that the two pieces of metal have been properly sealed.

See response 3.19

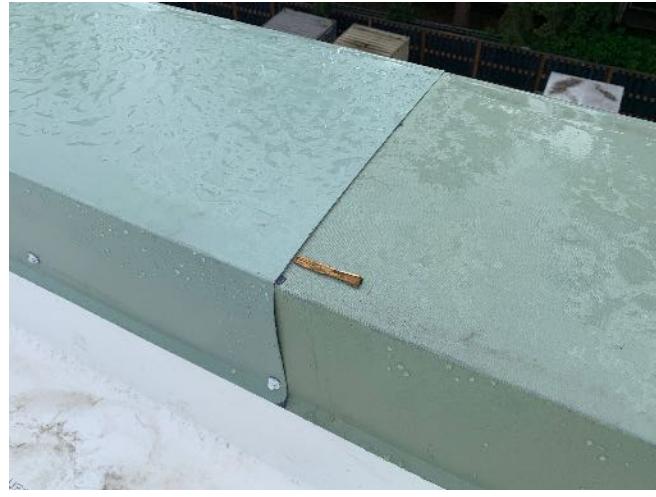
3 .24 Building C, Roof. Please verify that the proper seam detail has been used and that the two pieces of metal have been properly sealed.

See response 3.19

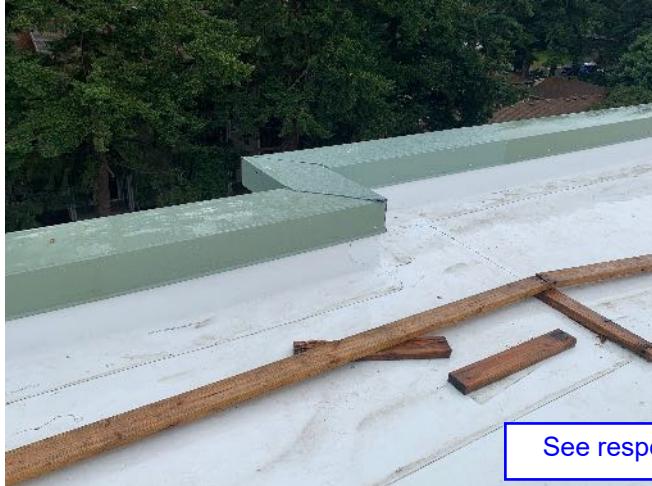
3 .25 Building C, Roof. The parapet metal in the right side of this image has been fastened approximately 12" O.C. The parapet metal in the left side of the image has a total of 2 fasteners holding it in place. Verify uplift requirements for fastener spacing and install consistently around all roof parapets.

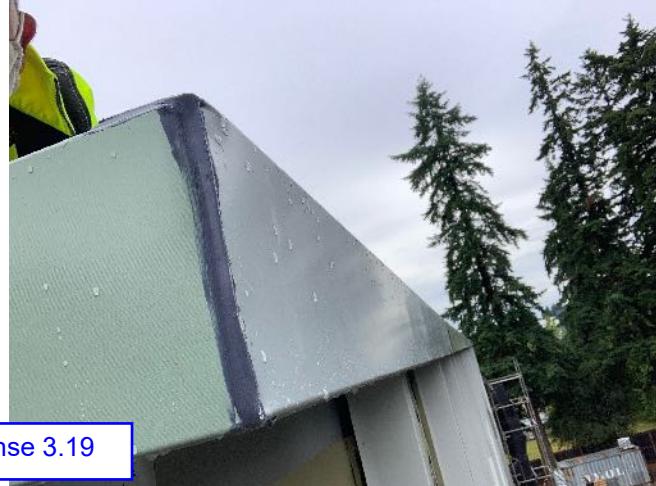
3 .26 Building C, Roof. This outside corner detail is completely sealant dependent. There are not mechanical fasteners holding the corner together. When the metal expands and contracts, this corner will open up. Fabricate corners with 18" legs per 076000 2.4 H.

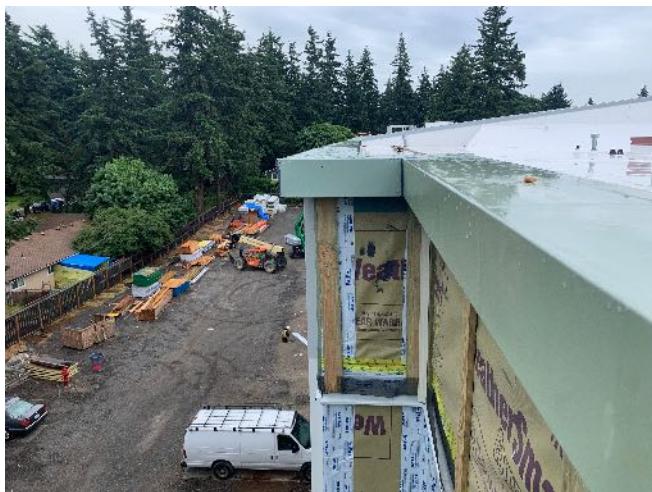
3 .27 Building C, Roof. This parapet metal has no slope as currently installed. Parapet metal must be sloped per SMACNA standards, the specification and submittal documents. The flatness combined with flat seams provides a risk for water intrusion at the seams.

See response 3.19

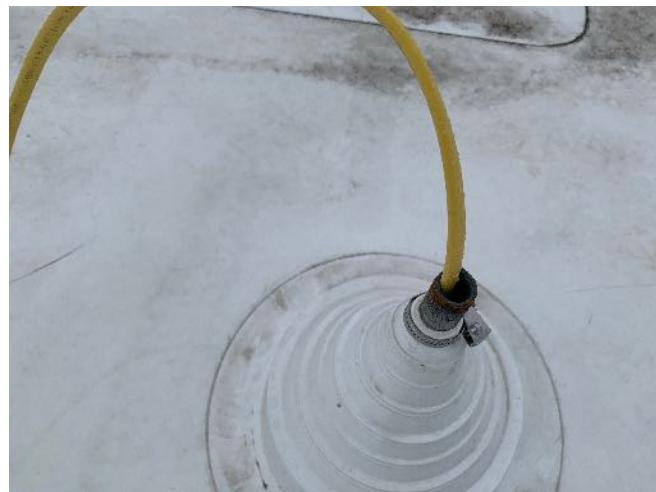
3 .28 Building C, Roof. Pre fabricated pipe boots have been installed for electrical penetrations. The annular space between the conduit and the Romex is unsealed, providing a clear path fro water into the roofing system. Correct this at all locations at all roofs.

Work complete. Sealants, J-Box, outlet and bubble cover installed.

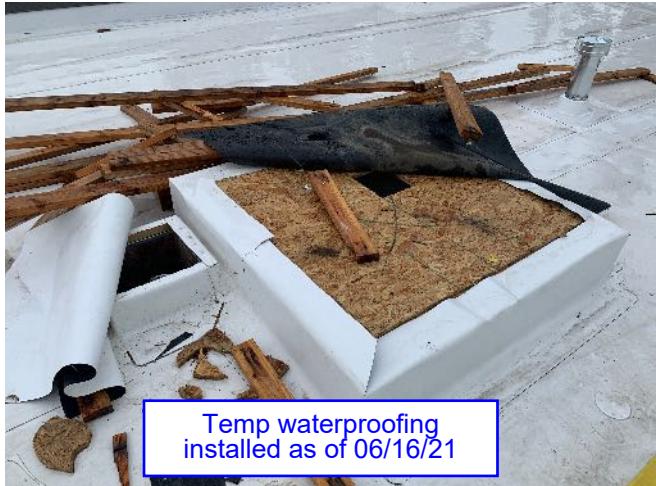
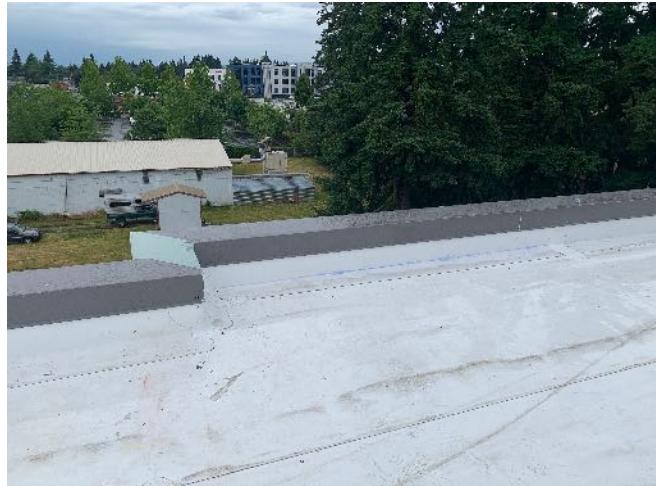
<p>3 .29 Building C, Roof. Two curbs have been left without weather protection, allowing water ingress into the building. Provide temporary waterproof coverings (a piece of TPO properly fastened over the curb and draping down the sides would suffice) over these curbs until the equipment is permanently installed.</p>	<p>3 .30 Building C, Roof. These lengths of parapet metal are fastened only by 2 fasteners in each 10' piece of metal. Verify uplift requirements for fastener spacing and install consistently around all roof parapets.</p> <p style="text-align: right;">See response 3.19</p>
--	--

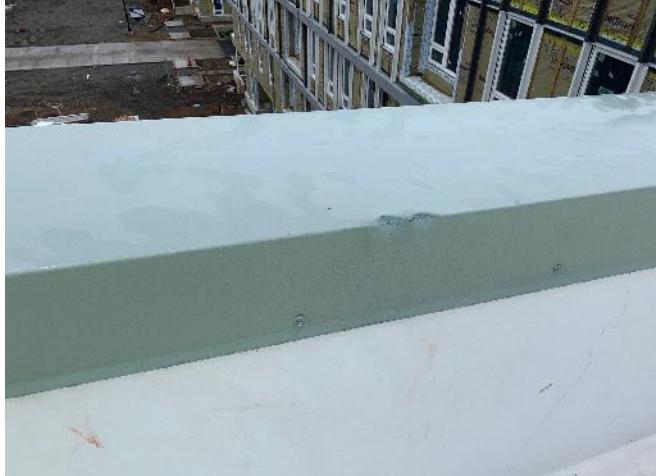
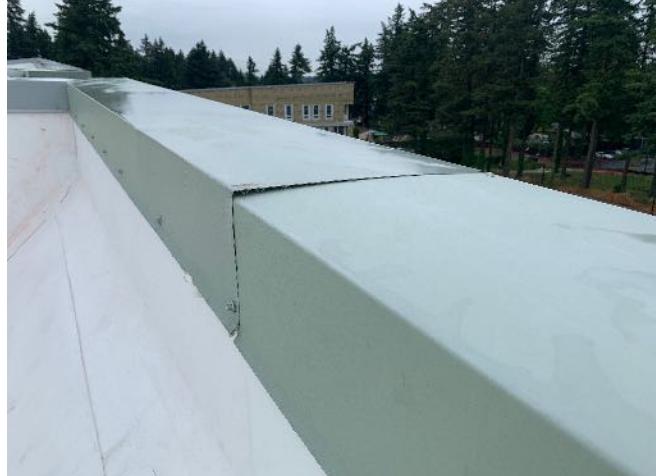
<p>3 .31 Building C, Roof. Parapet metal has been damaged prior to or during installation. Replace as directed by Waechter.</p>	<p>3 .32 Building C, Roof. Please verify that the proper seam detail has been used and that the two pieces of metal have been properly sealed.</p> <p style="text-align: center;">See response 3.19</p>
--	--

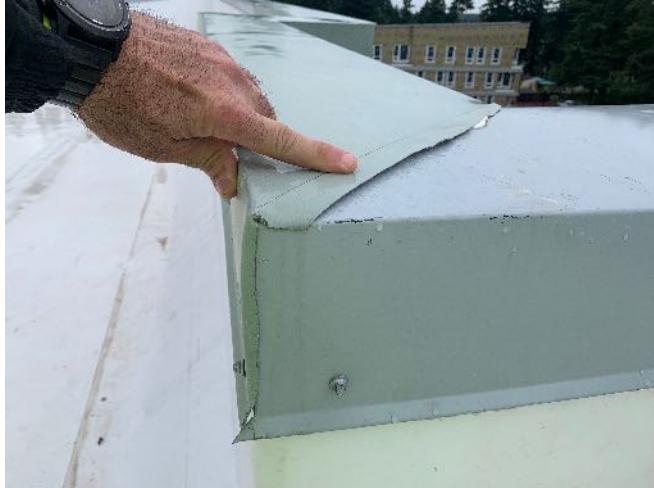
3 .33 Building C, Roof. This work is unacceptable and must be removed and replaced.

[See response 3.19](#)

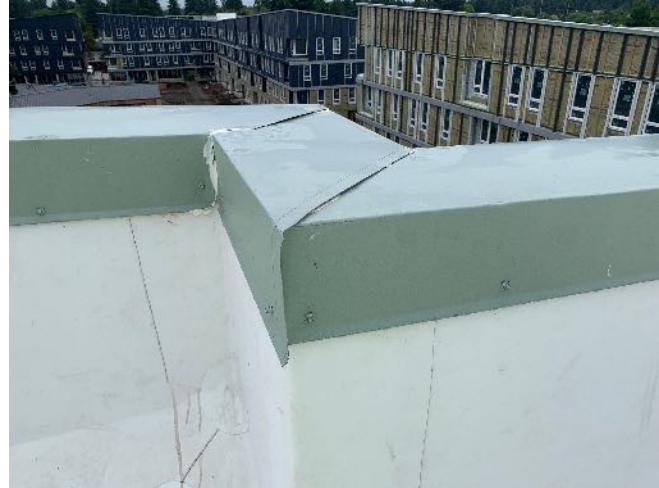
3 .34 Building C, Roof. This work is unacceptable and must be removed and replaced.

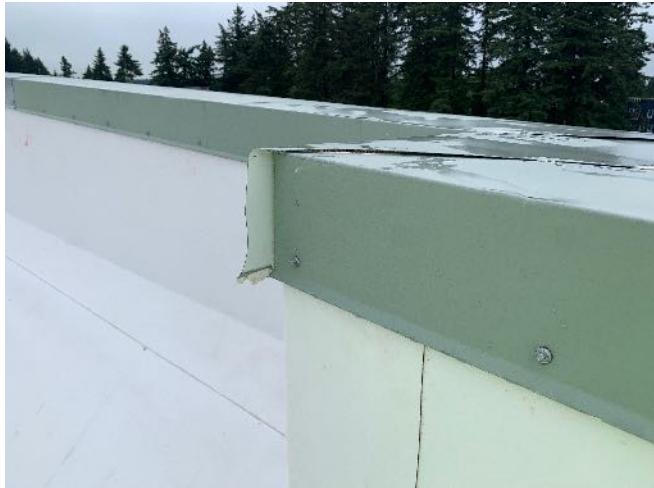
3 .35 Building C, Roof. This work is unacceptable and must be removed and replaced.

[See response 3.19](#)

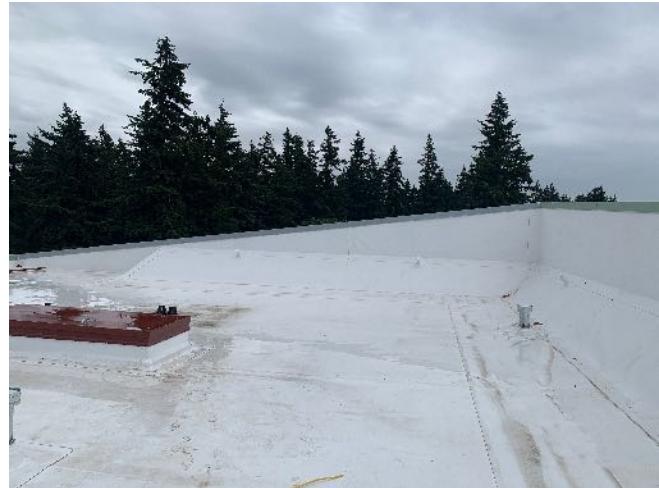
3 .36 Building C, Roof. These lengths of parapet metal are fastened only by 2 fasteners in each 10' piece of metal. Verify uplift requirements for fastener spacing and install consistently around all roof parapets.

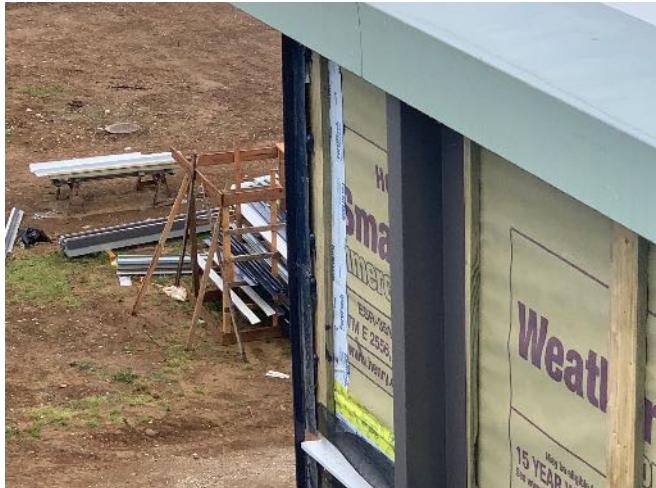
3 .37 Building C, inset on South elevation. Sealant is apparently being used behind the metal cladding components. Verify that metal cladding components are adequately structurally attached to the furring.

Sealant not being used for attachment of metal. This is excess caulk installers wiping off on rain screen/wrb. All metals nailed as detailed prior to panel installation.

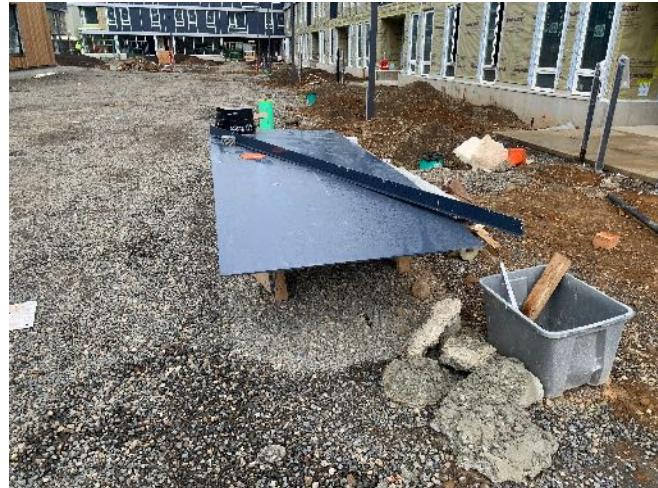
3 .38 Building B, South elevation. Hardie Panel products should not be stored in the rain or allowed to become saturated prior to installing on the building. If Panels become saturated, place them inside to completely dry out before installing on the building.

This was damaged material being used for cut station work bench only. Discarded after use.

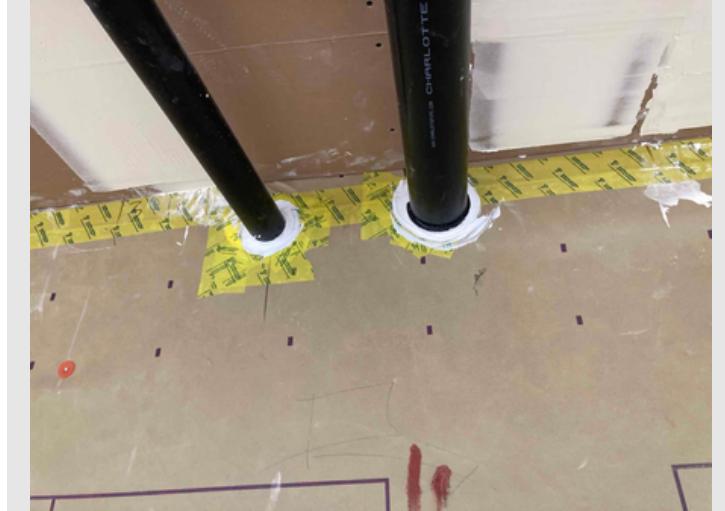
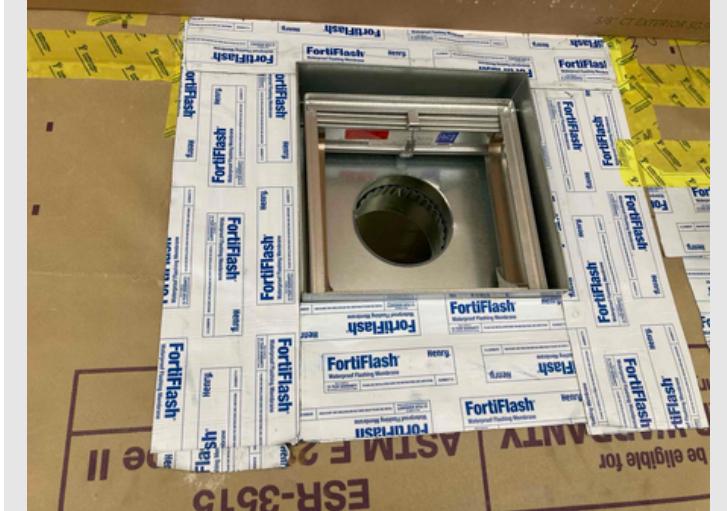
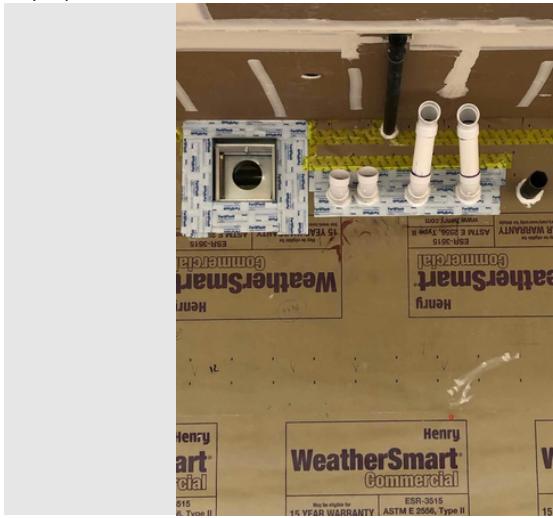
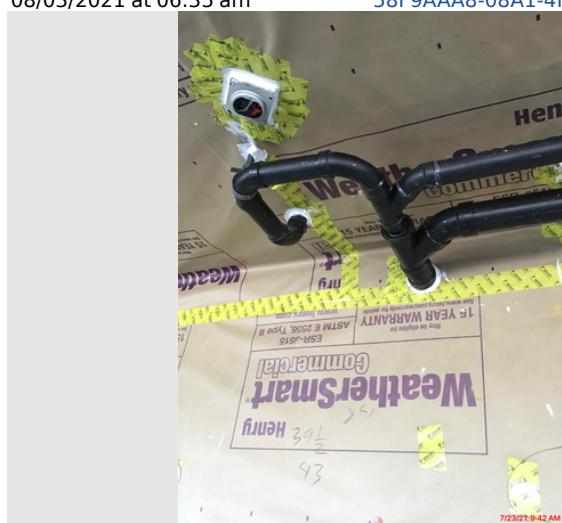
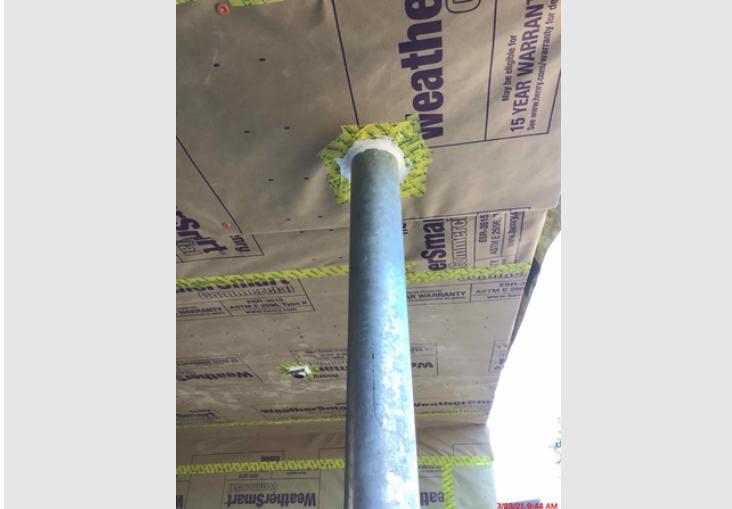
SVR 03: 3.02, 3.03, 3.04, 3.07, 3.10

3 .02 Building A, West soffit. WRB/AB component detailing is incomplete in some areas and exhibits damage in other areas throughout both soffits. Complete detailing where needed and repair or replace damaged WRB/AB components.

There is a good amount of detailing to be completed on the building A and B soffit WRB/AB prior to the application of the gypsum soffit.
