# FIELD NOTES

DATE: 5/20/2021

PROJECT: Rockwood 10

SUBJECT: West/ROW Planting and Associated Coordination

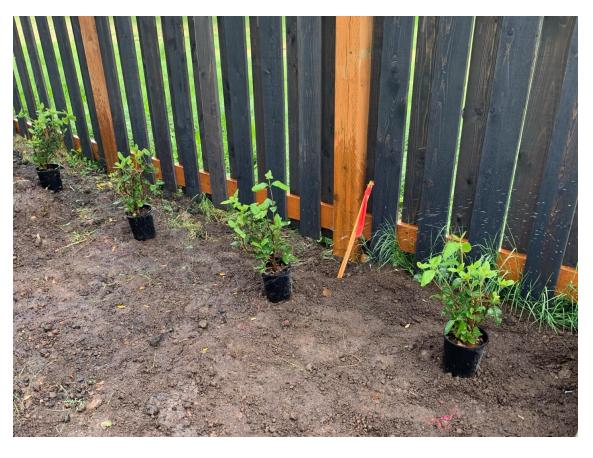
a. Many materials are not yet available on site. In west parking perimeter Viburnum Tinus was reviewed. Material is undersized and may be an issue when reviewed by city. Spec calls for 24" height. Code requires 30" height within 12 months of planting.

(VT)	VITI	VIBURNUM TINUS 'ROBUSTUM'	ROUNDLEAF LAURUSTINUS	CG #1, 24" HEIGHT	42" O.C.	PARKING LOT; 3'-4' TALL AT MATURITY	YES	
------	------	---------------------------	-----------------------	-------------------	----------	--	-----	--

Adjust spacing from fence to 30" typical (Teufel).

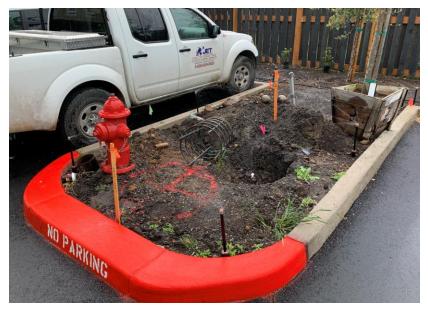
KPFF Utility Coordination Mark-up

b. Next Island north with hydrant has a survey mark for central light pole location. KPFF had requested that this pole be offset to north corner of island. Please confirm that pole can be installed per KPFF request to avoid potential tree conflict (LMC).

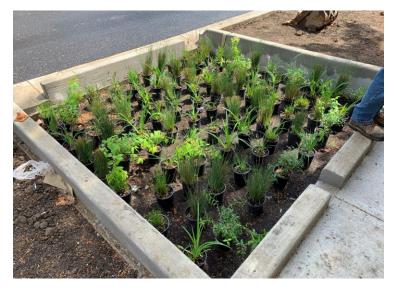
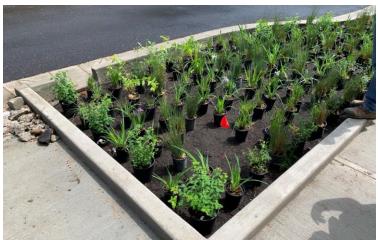
# 3. 185<sup>th</sup> Stormwater Planters (SW locations)

a. Reviewed, no comments.

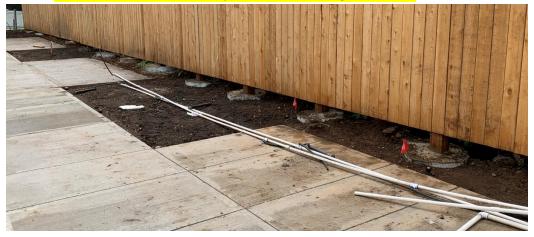
a. Footings are installed above grade and will be visible from street and sidewalk. Please confirm that these can be adjusted to be below grade (LMC).

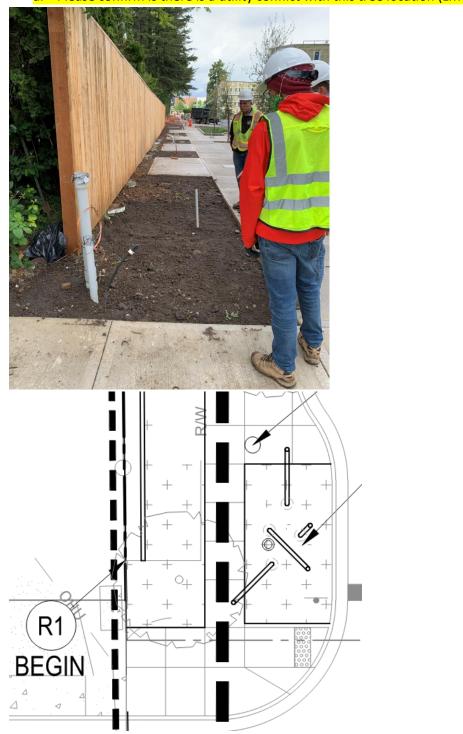
a. Please confirm is there is a utility conflict with this tree location (LMC).
