# New Drawings of the Alhambra: Deformations of Muqarnas in the Pendentives of the Sala de la Barca

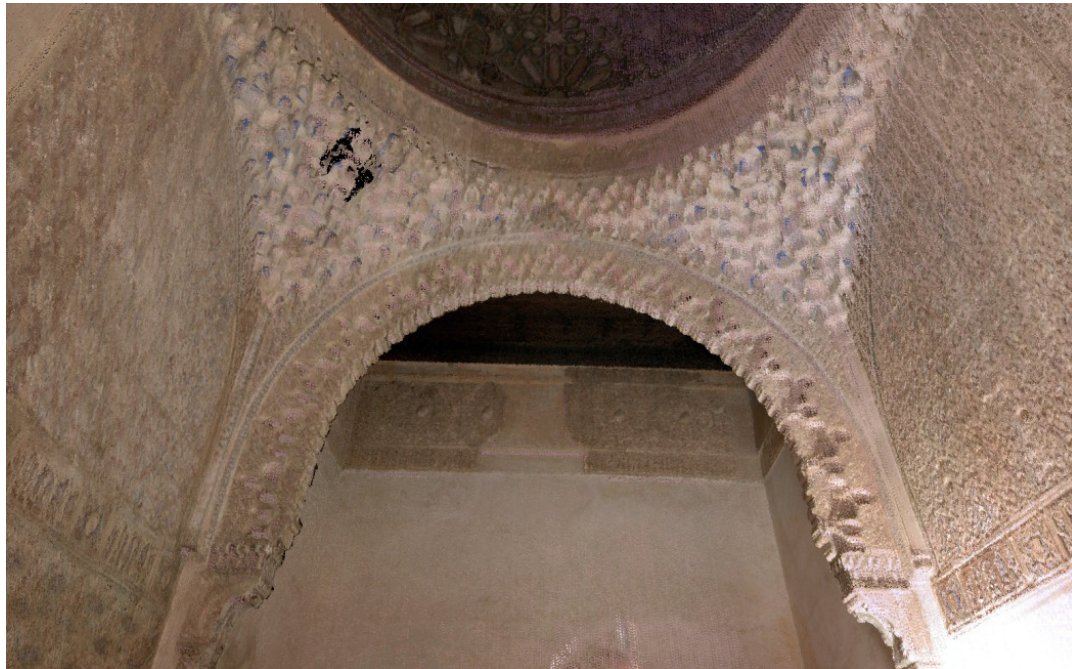
**Figure 16.** Pendentives in the *Sala de la Barca* (point cloud).

We used a laser scanner to capture the muqarnas (Figure 16) and derived our drawings: accurate plans and elevations that unveiled significant deformations and differences between the real construction and the theoretical schemes of geometrical grouping of muqarnas defined by Jones and Goury and the rest of scientific bibliography. Our study is the first one that unveil those deformations.
