# REPORT ON AN IN-SITU INTEGRITY TEST (NON-DESTRUCTIVE) OF COMPRESSIVE STRENGTH OF STRUCTURAL ELEMENTS ON AN ONGOING BUILDING LOCATED AT 62, COLLEGE ROAD, OFF IJU ROAD IFAKO IJAIYE, LAGOS STATE.

### CONSOLATE ENGINEERING SERVICES NIG.LTD.

**DECEMBER 2024**

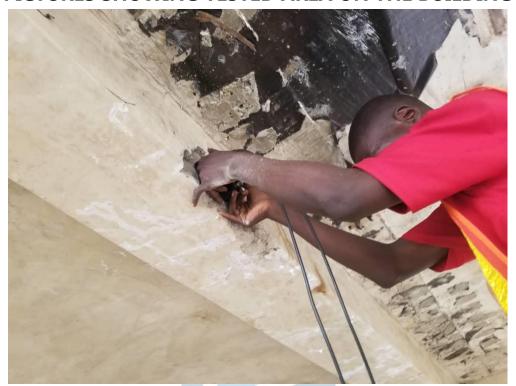
FIG 4: Pundit on Beam

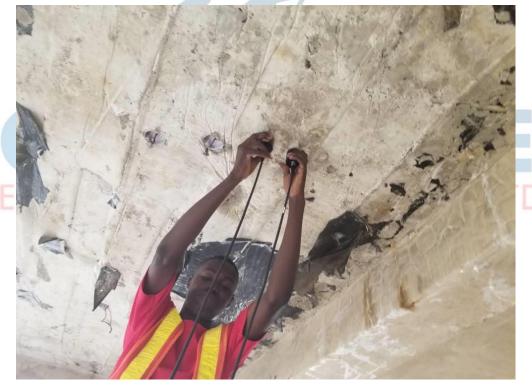
FIG 5: Pundit on Slab

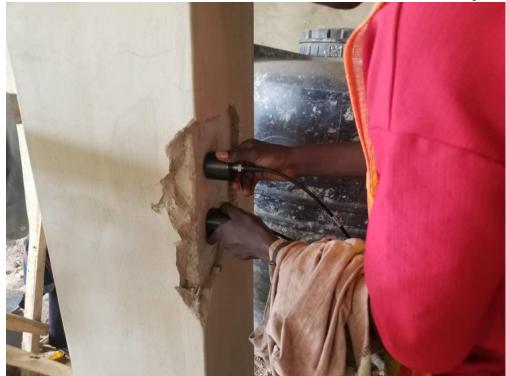
FIG 6: Pundit on Column

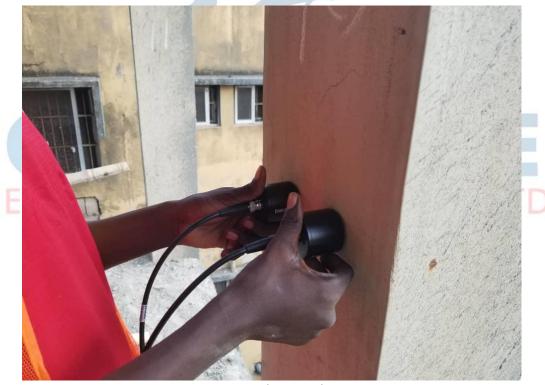
FIG 7: Pundit on Column
