# IT ON AN IN-SITU INTEGRITY TEST (NON-**UCTIVE) OF COMPRESSIVE STRENGTH OF RAL ELEMENTS ON AN ONGOING BUILDING** LUCATED AT 62, COLLEGE ROAD, OFF IJU ROAD IFAKO IJAIYE, LAGOS STATE.

# **FOR** SAMUEL AKINNUSI

**DECEMBER 2024**

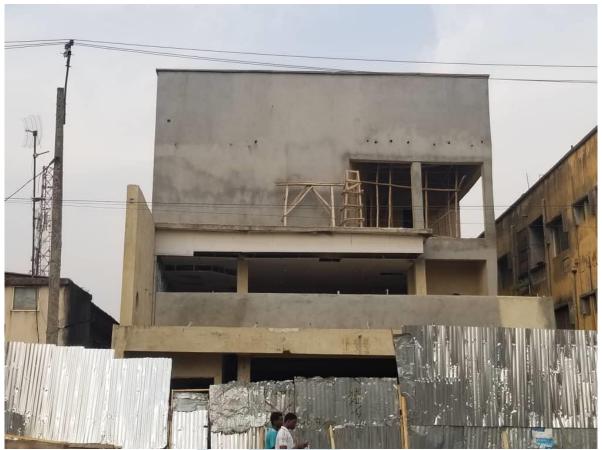
- The structure is an ongoing three floor building (see fig 1).
- Construction stage: finishing (see fig 1).
- It is built for commercial purpose (see fig 1).
- No drawing was provided as at the time of test.
- All structural members are over 28 days as at the time of test.

FIG. 1: Front View

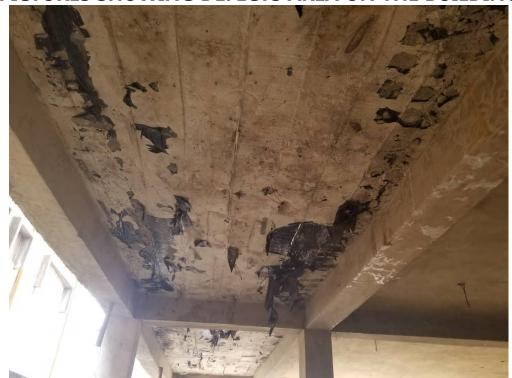
- Exposure of reinforcement was observed on slab (see fig 2&3).
- No dampness was observed on the building.
- No spalling was observed on reinforced concrete slab.
- No cracks were observed on the building.

FIG. 2: Exposure of reinforcement on Slab

- 3. Structural members where exposure of reinforcement was observed should be properly grouted.
- 4. New beams and columns should be introduced at sagging area as specified by a structural engineer.

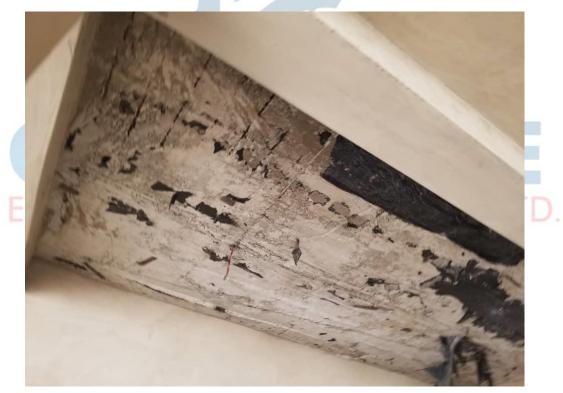
FIG. 3: Exposure of reinforcement on Slab
