### M/V “*BLACK JACK*”

**REPORT OF MARINE SURVEY**

**2002 Sea Ray  
340 Amberjack**

34SeaRay02  
July 27, 2020

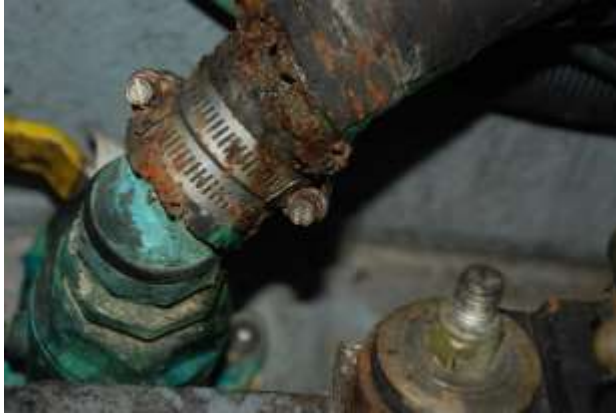
NOTE: The neoprene hose from the macerator pump to the below waterline discharge valve, is aged, cracked throughout, and leaks when the discharge valve is opened. Properly replace the head system discharge neoprene hose as necessary. The neoprene hose from the vacuum tank to the holding tank is aged and cracking. Replace the holding tank inlet neoprene hose as needed.

Head system discharge neoprene hose/leaks

- A. **The neoprene hose from the macerator pump to the below waterline discharge valve is aged, cracked throughout, and leaks when the discharge valve is opened**
  - Properly replace the head system discharge neoprene hose as necessary
- C. The neoprene hose from the vacuum tank to the holding tank is aged and cracking
  - Replace the holding tank inlet neoprene hose from the vacuum tank as needed

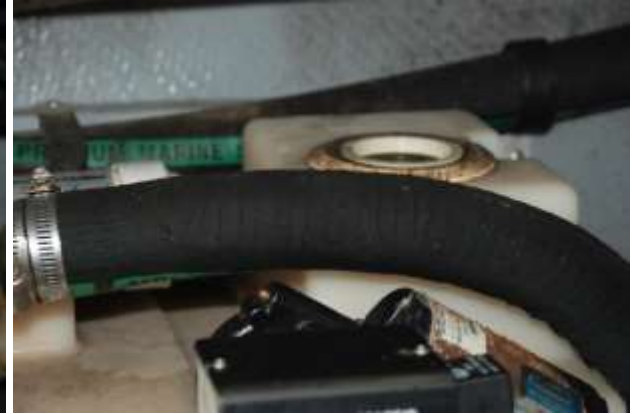
Holding tank inlet neoprene hose aged

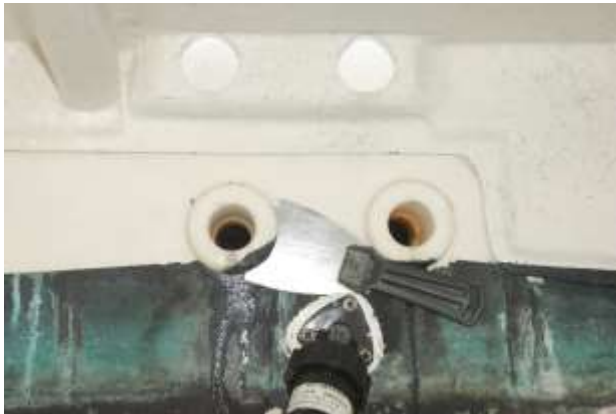
Port aft outboard through-hull fitting not secure

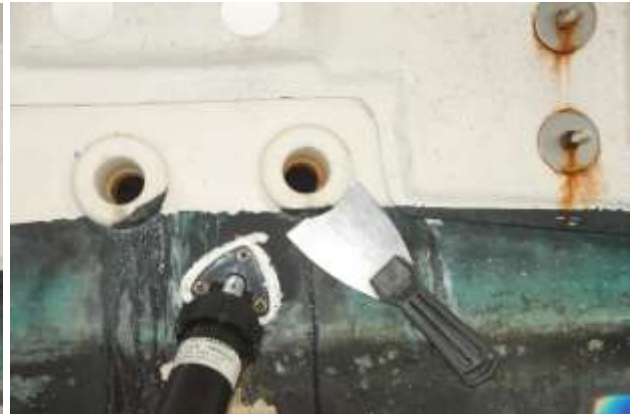
Port aft inboard through-hull fitting not sealed

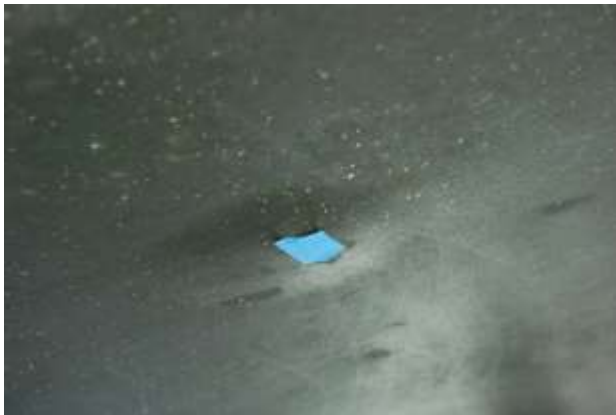
| Hull: | Molded FRP laminate, deep-Vee , hard chines; partial inner/mid/outer strakes; molded sheer-line spray-rails, drive tunnels – GC overall; <b>no</b> delamination; * <b>two osmotic blisters noted</b> |

Osmotic hull blister starboard forward

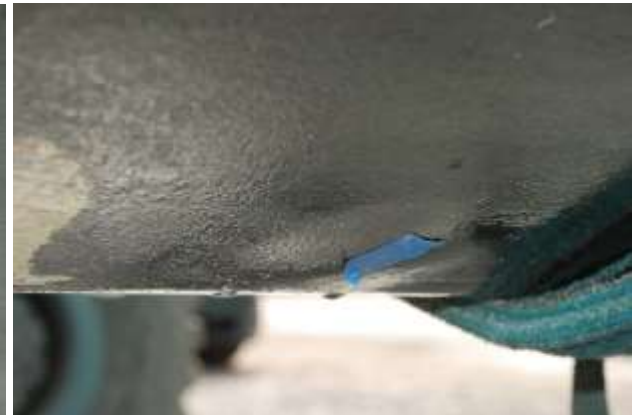
Osmotic hull blister port forward

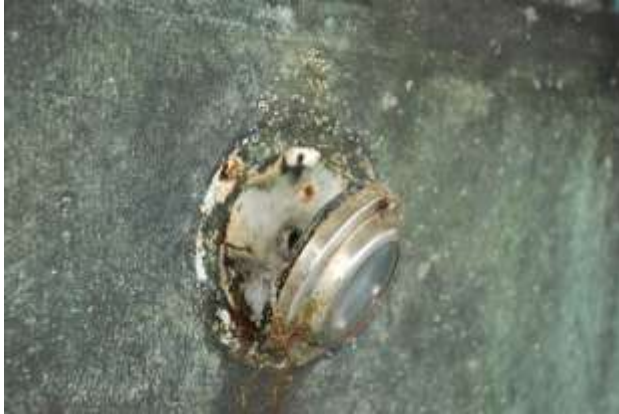
NOTE: The port transom underwater light functions, but the light fixture is not secured in place, allowing water to trickle into the vessel through the wiring conduit. Properly re-secure the port underwater light fixture in place as necessary. At the time of inspection, the two-part anchor and steaming navigation light spar insert does not function. Service and prove the anchor/steaming light as necessary. At the time of inspection, the port side 110V outlets do not function, and no GFCI outlet was found tripped. Service and/or prove the port side 110V outlets as needed. The remote searchlight system appears sound, but does not function. Service the searchlight control system, and prove the searchlight as needed. The port gunwale courtesy, and live well lights do not function. Service these two lights as needed.

Port transom underwater light fixture not secure

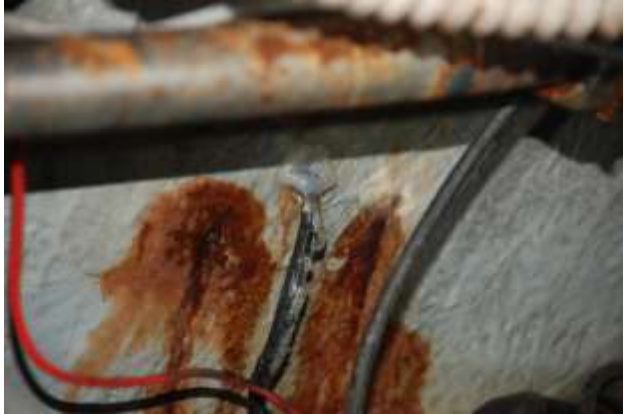
Port underwater light in transom, leaks water in

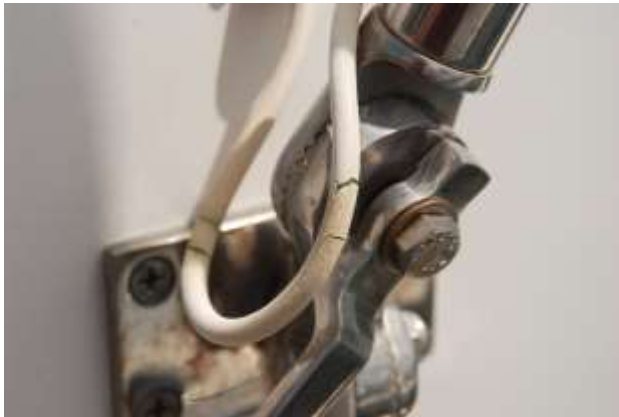
| Antennas:* | <b>One</b> Shakespeare 8’ VHF, stainless ratchet mount – AS/GC; <b>cable cracks</b><br><b>one</b> Raymarine Raystar120 remote GPS, short spar at arch – AS/GC |

VHF antenna cable insulation cracks

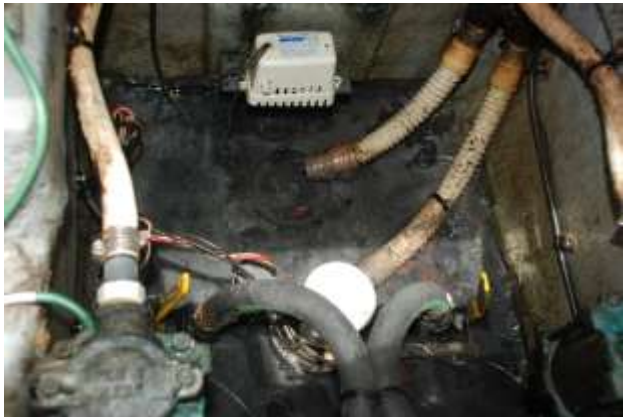
Aft bilge debris; foul water build-up

Recommend the trapped water be removed from the engine space where needed, and determine how to prevent water intrusion into these areas in the future. **Cosmetic findings** include: the topside gel coat is oxidized and in need of compounding and wax; the external cockpit and bridge seating upholstery is oxidized, with some stitching separation and tearing in some areas; there are two 4-5" osmotic blisters (see **Images**). Service these cosmetic findings where needed.

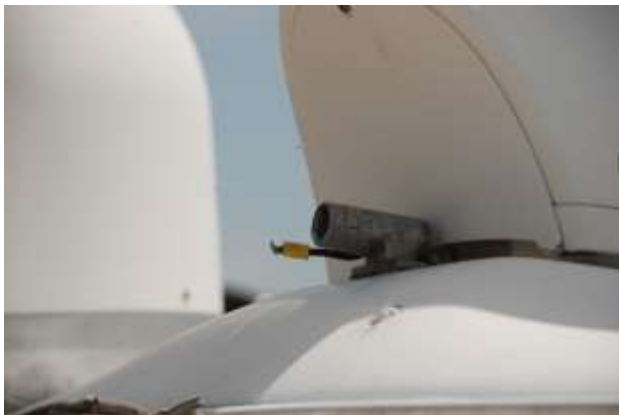
Anchor/steaming light spar insert outlet at arch

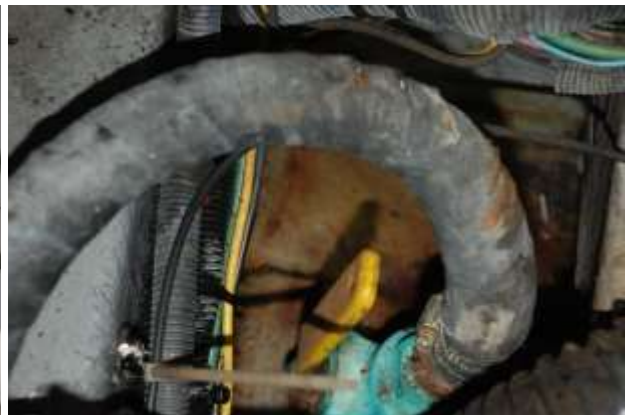
NOTE: The generator cooling inlet seacock handle does not move with moderate force, and was not proved, and the neoprene hose, from the seacock to the strainer, is in poor condition, aged and cracked throughout. Exercise and prove the generator cooling inlet valve, and the replace the cooling inlet neoprene hose as necessary.

Genset cooling inlet neoprene hose aged/cracks

- A. **The generator cooling inlet seacock handle does not move with moderate force, was not proved, and the neoprene hose, from the seacock to the strainer is in poor condition, aged and cracked throughout** – Exercise and prove the generator cooling inlet valve, and the replace the cooling inlet neoprene hose as necessary
