Dealer Quality Assessment - Detailed Report

Dealer name	Location
RENAULT ENFIELD	9 CROWN ROAD EN1 1TX ENFIELD United Kingdom
Dealer code	RRG
82612500	YES
NV Renault Sales / year	NV Dacia Sales / Year
387	143
Workshop Customers / Day	Principal Audited Brand
25	RENAULT
Auditor	Audit Date
LYONS STEPHEN	09/07/2024

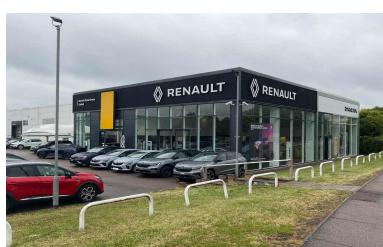
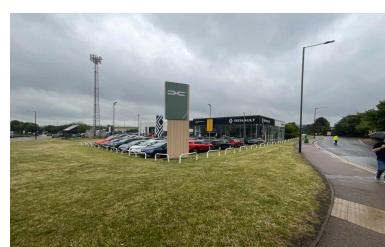
10 - The dealership exterior is in impeccable condition, is clean and is well maintained ✓

OK - The exterior appearance of the dealership is in impeccable condition

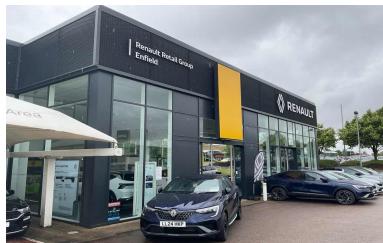
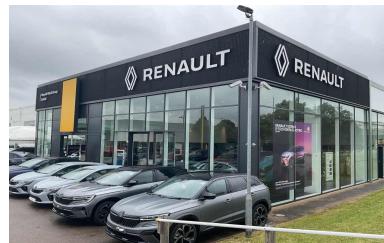
10b - The exterior area respects the visual charter of the Renault brand

OK - The exterior area respects the visual charter of the Renault brand

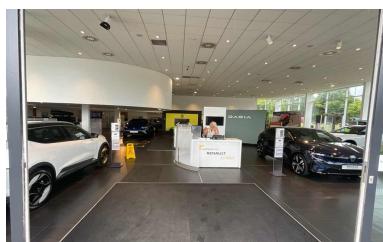
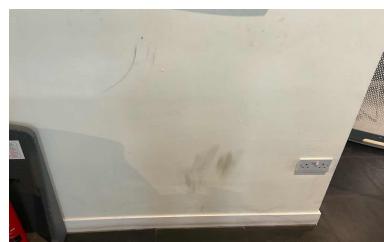
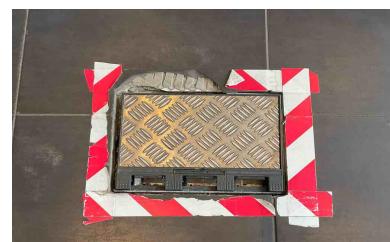
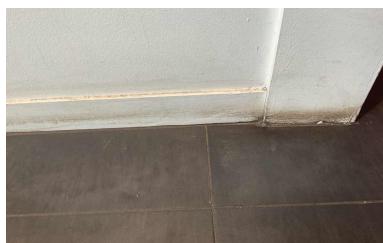
11 - The Renault Showroom Interior is in perfect condition

Dirty walls and skirting boards. Tiling broken around electrical floor box.

KO - The interior appearance of the dealership is not perfect condition

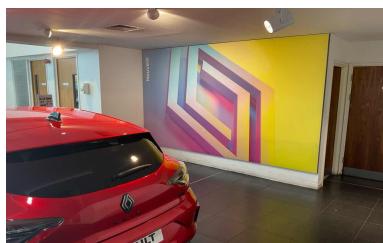
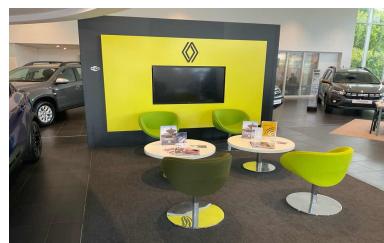
11b - The Showroom respects the visual charter of the Renault brand

OK - The showroom respects the visual charter of the Renault brand

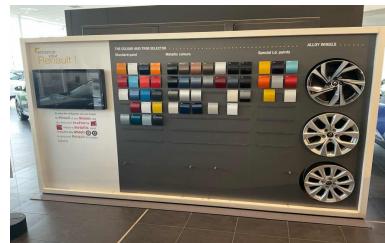
12 - The Renault showroom furniture is clean and well maintained

OK - The showroom furniture is in good condition and properly maintained

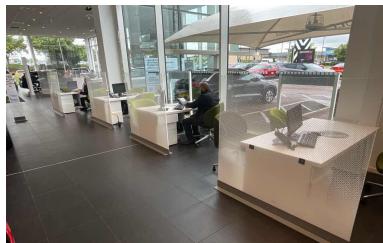
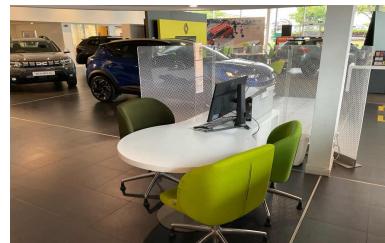
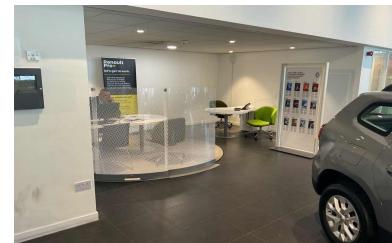
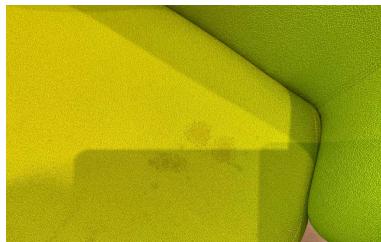
13 - The Renault sales desks are correctly positioned (away from the windows) and in perfect condition

4 out 8 desks in windows. Some chairs dirty.

KO - The sales desk are not positioned correctly or in a non-compliant state

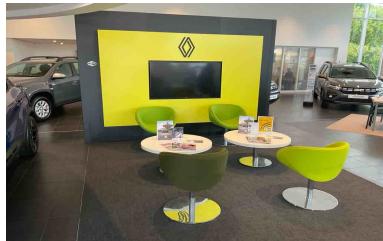
15 - The customer waiting area is suitable for waiting & up to standard

Waiting area screen not working. Advised that it had been checked a part has blown for the screen.

KO - The furniture in the customer area is not properly maintained and / or non-compliant as a waiting area

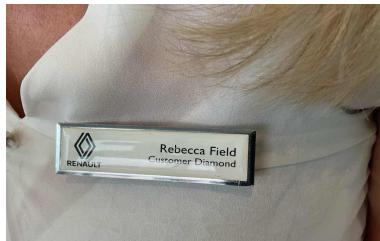
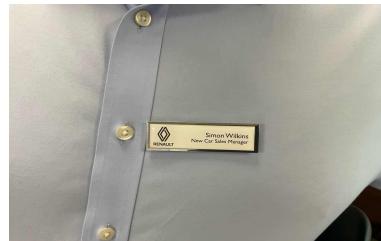
17 - Sales staff wear appropriate and identifiable business attire

OK - Sales staff are identifiable

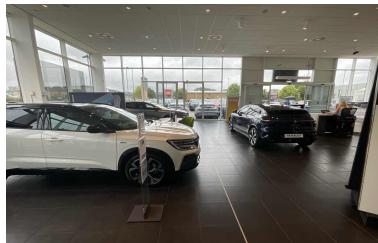
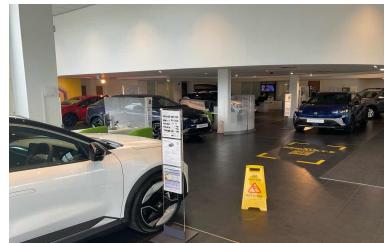
22 - New vehicles are presented according to the Renault brand's standards

Orthogonal rule followed.

OK - New vehicles are displayed according to the brand's standards

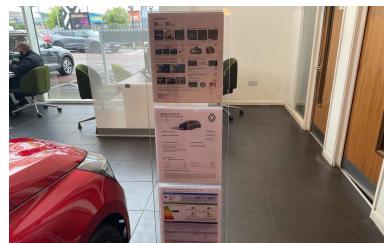
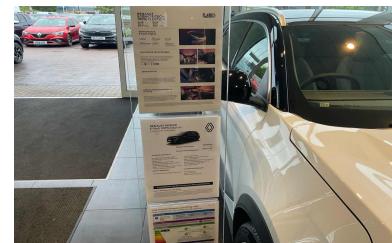
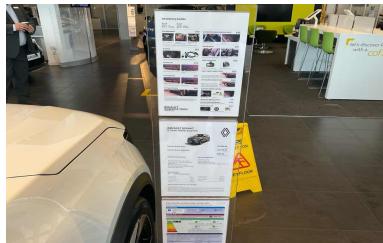
23 - The Renault price-product display stands are compliant

OK - Renault price displays are compliant and contain all the mandatory up-to-date information

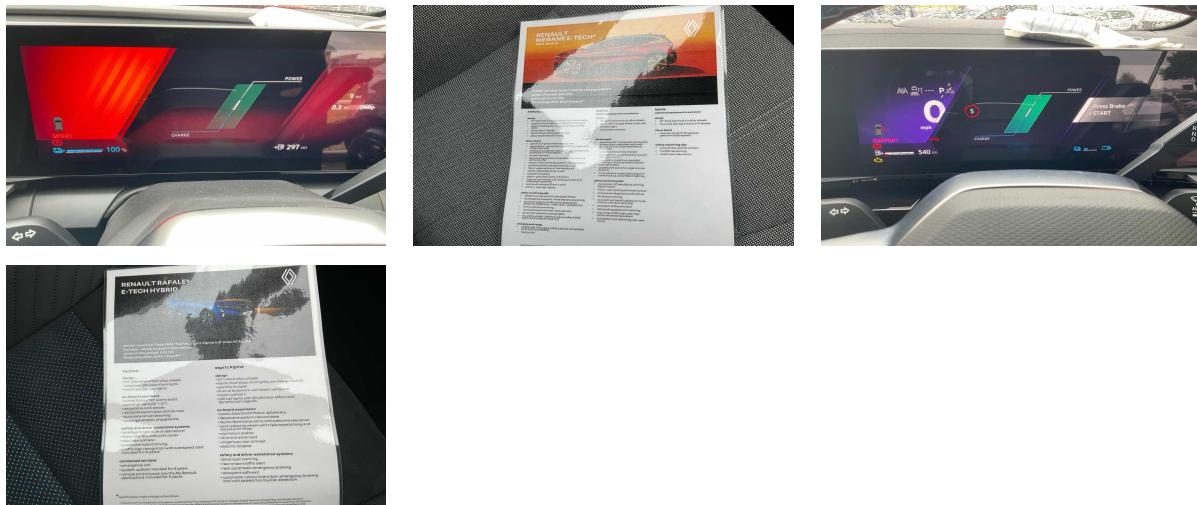
29 - Demonstrator vehicles are present in the Test Drive area and ready to be driven

OK - The vehicles of the demonstrator fleet are present in the dedicated area, ready to be driven according to the manufacturer's standards

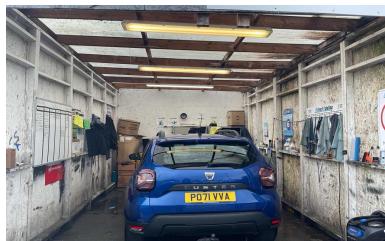
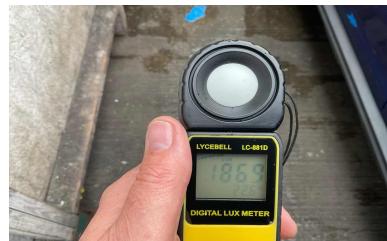
51 - The preparation area meets the manufacturer's standards

OK - The preparation area complies with the recommendations and is clean and tidy

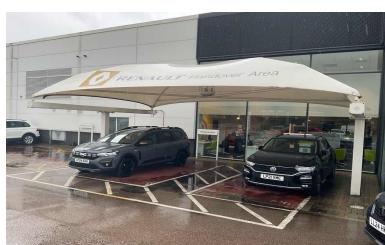
53 - The handover area meets the manufacturer's standards

Inspection completed outside and does not meet the current standard.

KO - The handover area does not comply with manufacturer's standards or there is no handover area present

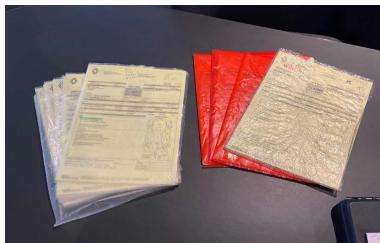
107 - All files are complete & are prepared the day before

16 bookings with 16 job packs prepared. Service check list completed digitally.

OK - all prepared files are ready the day before, and all files are complete

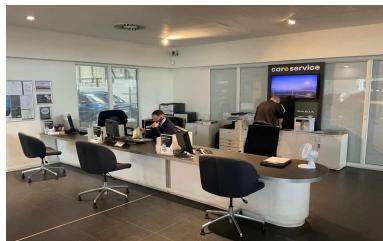
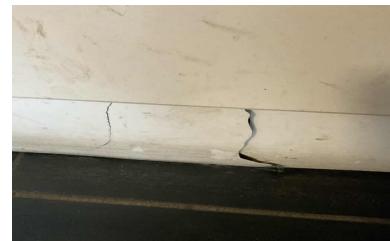
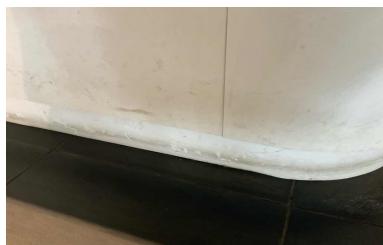
114 - The reception area complies with the brand's recommendations and is in impeccable condition

Desk base board damaged and dirty.

KO - The reception area does not comply with the standards and/or not maintained

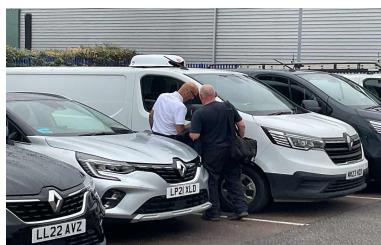
118 - The vehicle inspection area is present and complies with the recommendations

Inspection completed outside and does not meet the current standard.

KO - The vehicle inspection area is not clean and / or does not comply with the recommendations

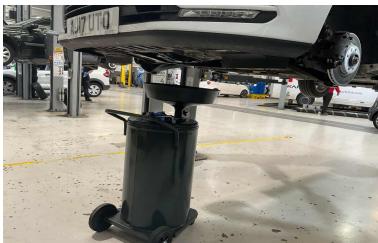
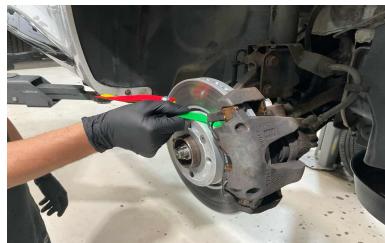
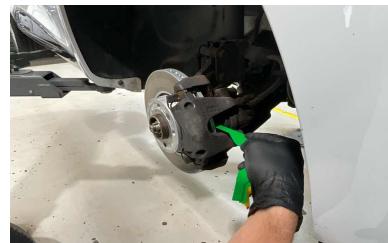
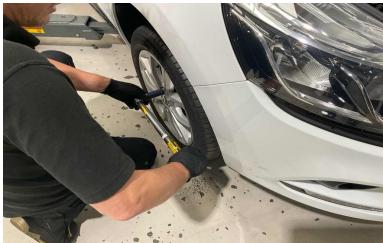
139 - The front brakes of the vehicle are checked

OK - The brakes check complies with that of the repair methods

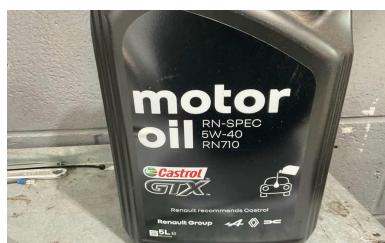
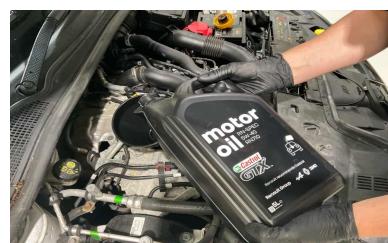
140 - The oil used conforms to the manufacturer's recommendations

RN0710 5w40 oil required. RN0710 5w40 oil used.

OK - The standard of oil used is in accordance with the ICM sheet

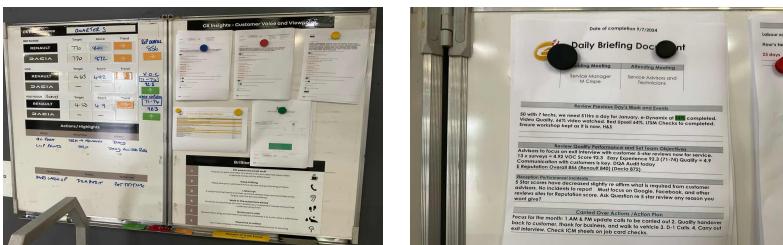
149 - A daily after-sales briefing takes place

OK - A daily briefing is carried out

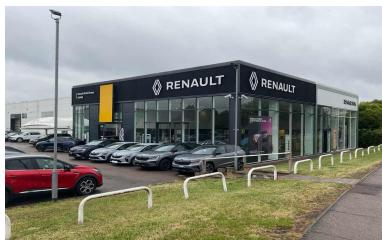
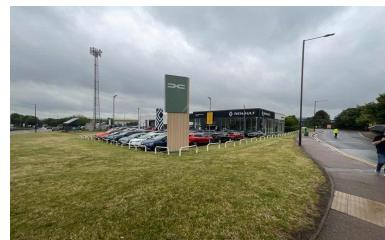
10 - The dealership exterior is in impeccable condition, is clean and is well maintained

OK - The exterior appearance of the dealership is in impeccable condition

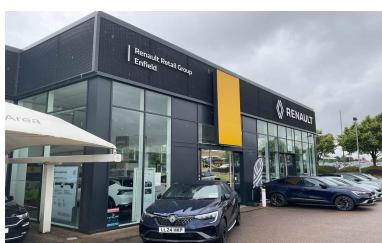
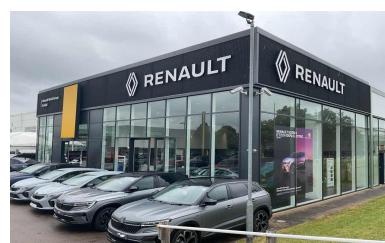
10b - The exterior area respects the visual charter of the Renault brand

OK - The exterior area respects the visual charter of the Renault brand

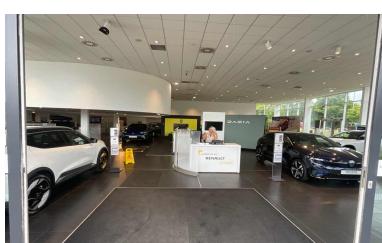
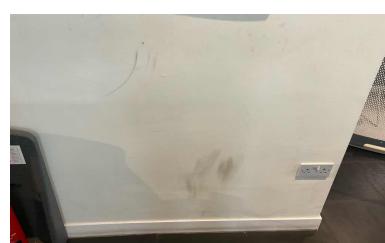
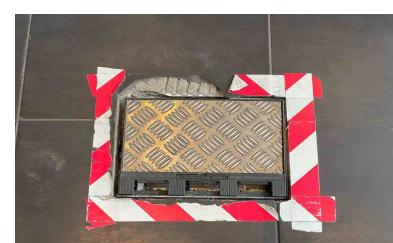
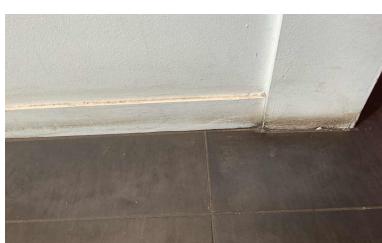
11 - The Renault Showroom Interior is in perfect condition

Dirty walls and skirting boards. Tiling broken around electrical floor box.

KO - The interior appearance of the dealership is not perfect condition

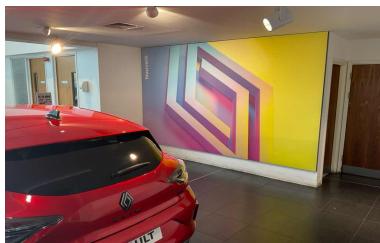
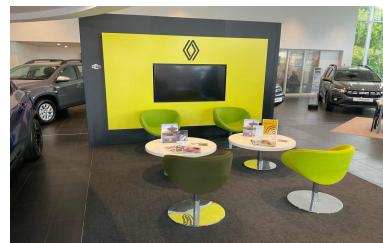
11b - The Showroom respects the visual charter of the Renault brand

OK - The showroom respects the visual charter of the Renault brand

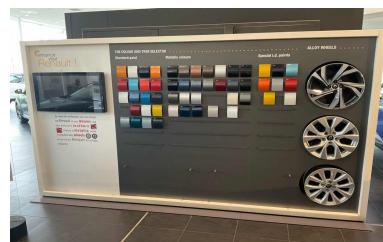
12 - The Renault showroom furniture is clean and well maintained

OK - The showroom furniture is in good condition and properly maintained

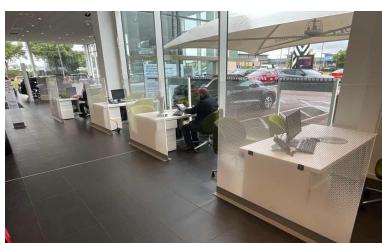
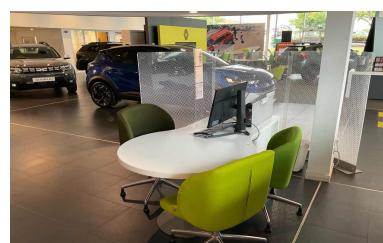
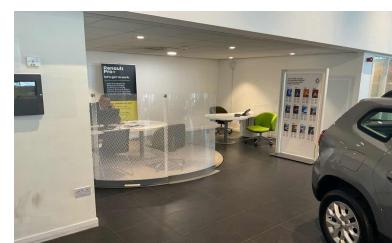
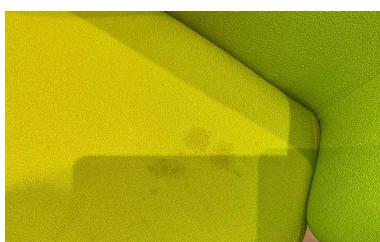
13 - The Renault sales desks are correctly positioned (away from the windows) and in perfect condition

4 out 8 desks in windows. Some chairs dirty.

KO - The sales desk are not positioned correctly or in a non-compliant state

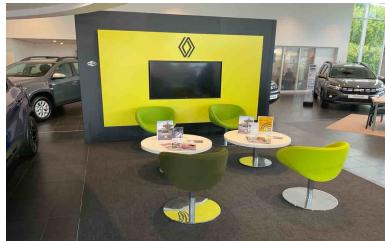
Waiting area screen not working. Advised that it had been checked a part has blown for the screen.

KO - The furniture in the customer area is not properly maintained and / or non-compliant as a waiting area

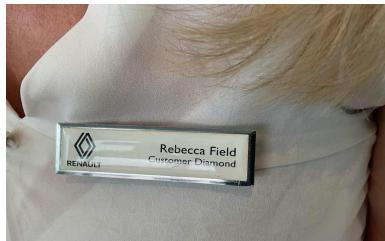
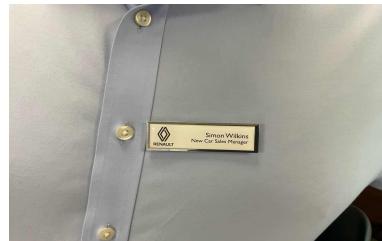
17 - Sales staff wear appropriate and identifiable business attire

OK - Sales staff are identifiable

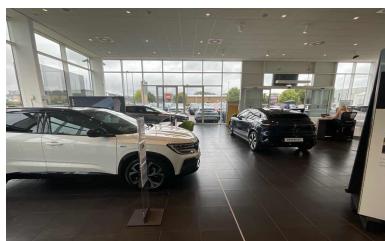
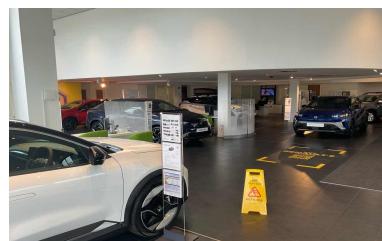
22 - New vehicles are presented according to the Renault brand's standards

Orthogonal rule followed.

OK - New vehicles are displayed according to the brand's standards

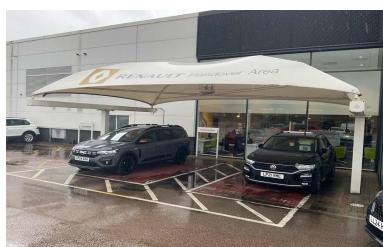
Inspection completed outside and does not meet the current standard.

KO - The handover area does not comply with manufacturer's standards or there is no handover area present

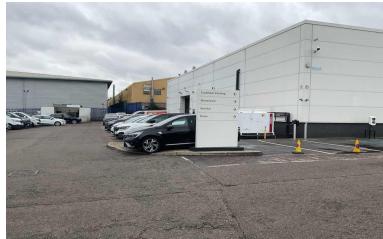
113 - Access to the after-sales services is identifiable upon arrival at the dealership

OK - Access to the after-sales services is identifiable upon arrival at the dealership

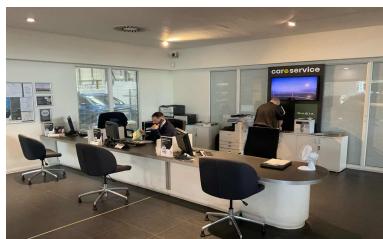
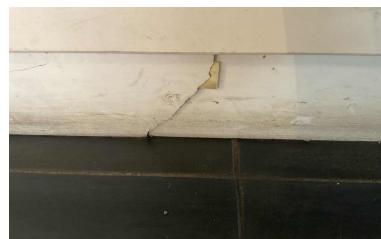
114 - The reception area complies with the brand's recommendations and is in impeccable condition

Desk base board damaged and dirty.

KO - The reception area does not comply with the standards and/or not maintained

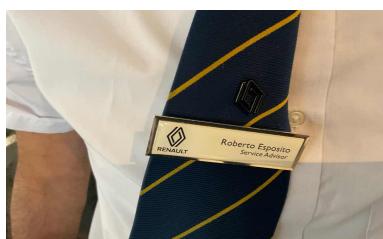
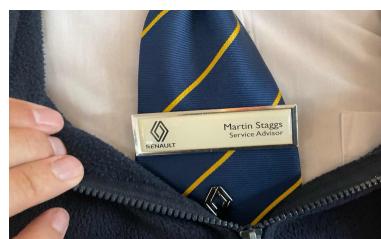
115 - Front-office staff wear appropriate business attire to allow customers to identify them

OK - All front-office staff wear standard badges and uniforms

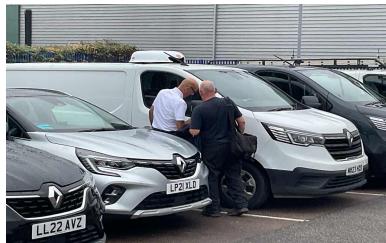
118 - The vehicle inspection area is present and complies with the recommendations X

Inspection completed outside and does not meet the current standard.

KO - The vehicle inspection area is not clean and / or does not comply with the recommendations

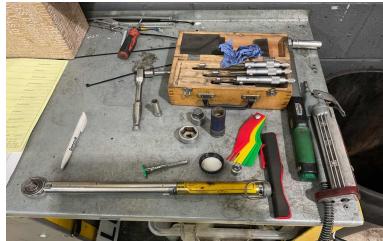
129 - The technician has the equipment and tools at their disposal to carry out vehicle maintenance ✓

OK - All the equipment and tooling is available to the technician

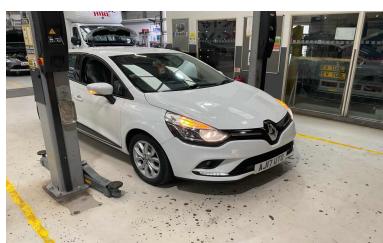
133 - An electronic assessment of the vehicle is carried out (only for RENAULT cars) ✓

OK - The assessment of the vehicle's electronic control units (ECU) was carried out during the observed service

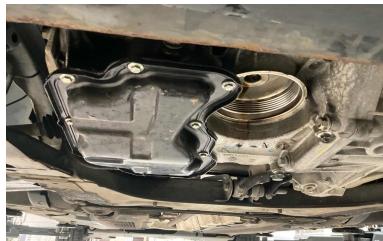
136 - Fluid replacement and top up is carried out according to the manufacturer's recommendations ✓

OK - The oil filter is changed in accordance with the manufacturer's recommendations

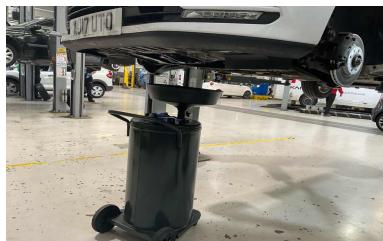
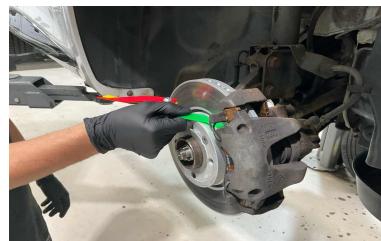
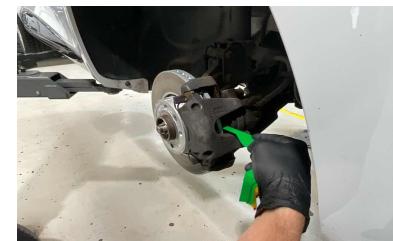
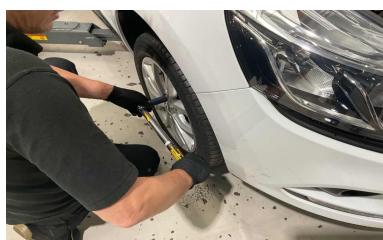
139 - The front brakes of the vehicle are checked ✓

OK - The brakes check complies with that of the repair methods

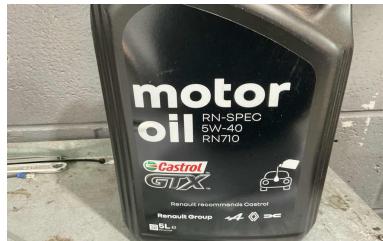
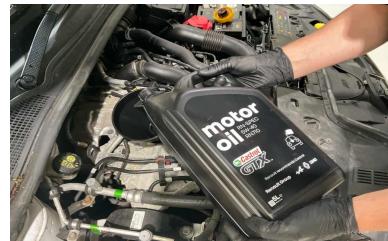
140 - The oil used conforms to the manufacturer's recommendations

RN0710 5w40 oil required. RN0710 5w40 oil used.

OK - The standard of oil used is in accordance with the ICM sheet

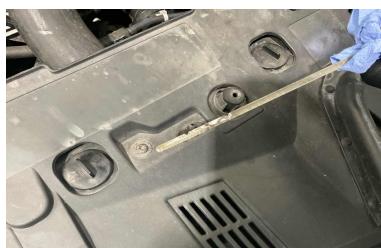
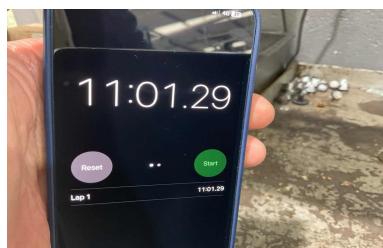
141 - Checking the oil level complies with the manufacturer's recommendations

OK - The oil level on the dipstick is correct

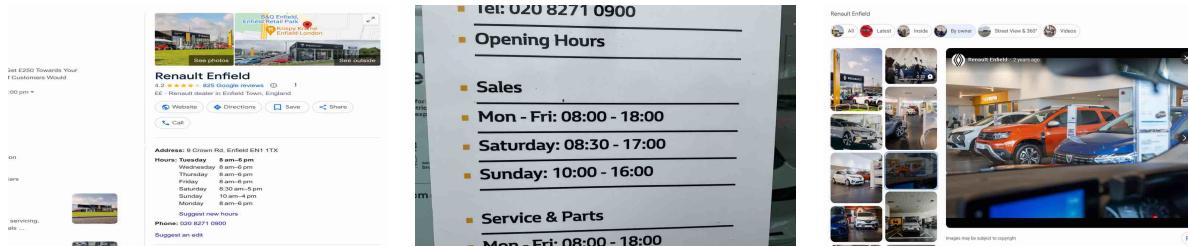
201 - The dealer is correctly represented by Google via his GMB profile X

- 1. No “Own this business” evident. 2. Dealer name correct. 3. Address correct. 4. Contact information available. 5. Opening hours correct. 6. Photo under “by owner” out of date.**

KO - GMB (Google My Business) is not correctly used

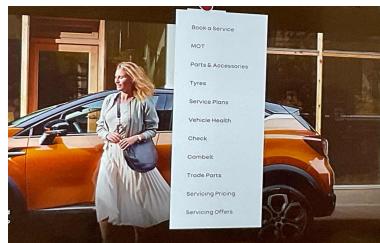
1. Not all the same service offerings appear under “offers” menu when clicking service offers, compared to the service drop down menu. 2. Available description/catchphrase okay, service opening hours available.

PA - all offers & services are presented, but there is some missing information
