# Dealer Quality Assessment - Detailed Report

Dealer name	Location
WILSONS EPSOM	NONSUCH BUSINESS PARK KILN LANE KT171DH EPSOM United Kingdom
Dealer code	RRG
82613400	NO
NV Renault Sales / year	NV Dacia Sales / Year
250	250
Workshop Customers / Day	Principal Audited Brand
48	RENAULT
Auditor	Audit Date
JOHN ROSTRON	15/11/2024

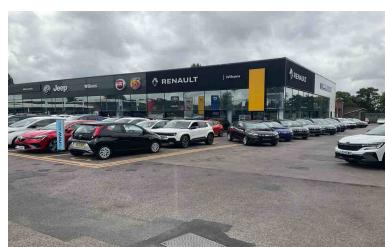
10 - The dealership exterior is in impeccable condition, is clean and is well maintained ✓

***OK - The exterior appearance of the dealership is in impeccable condition***

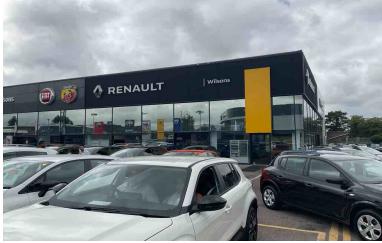
10b - The exterior area respects the visual charter of the Renault brand

***OK - The exterior area respects the visual charter of the Renault brand***

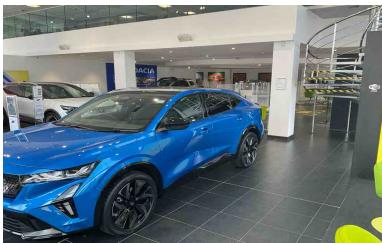
11 - The Renault Showroom Interior is in perfect condition

***OK - The interior appearance of the dealership is in perfect condition***

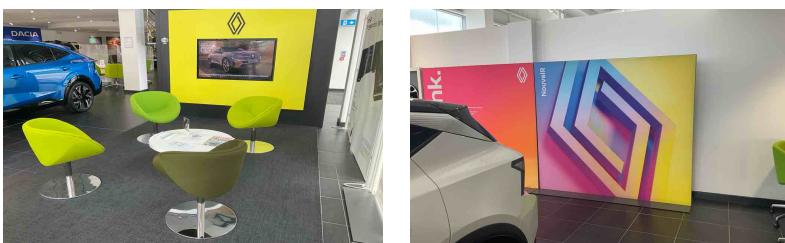
11b - The Showroom respects the visual charter of the Renault brand

***OK - The showroom respects the visual charter of the Renault brand***

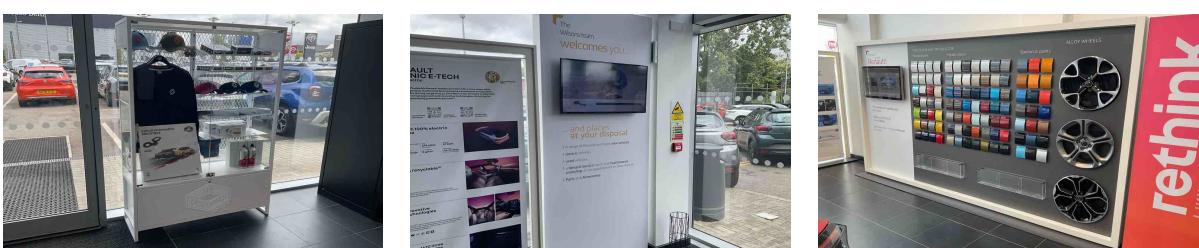
12 - The Renault showroom furniture is clean and well maintained

***OK - The showroom furniture is in good condition and properly maintained***

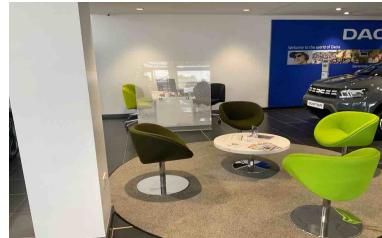
13 - The Renault sales desks are correctly positioned (away from the windows) and in perfect condition

***OK - The sales desk are correctly positioned and in perfect condition***

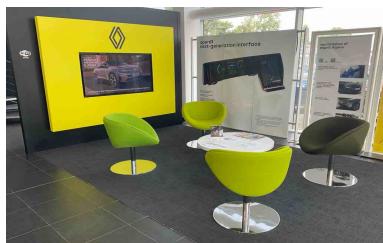
15 - The customer waiting area is suitable for waiting & up to standard

***OK - The furniture in the customer area is clean and compliant as a waiting area***

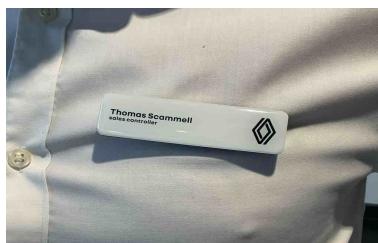
17 - Sales staff wear appropriate and identifiable business attire

***OK - Sales staff are identifiable***

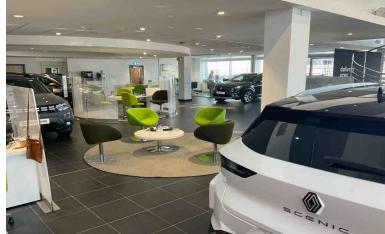
22 - New vehicles are presented according to the Renault brand's standards ✓

**OK - New vehicles are displayed according to the brand's standards**

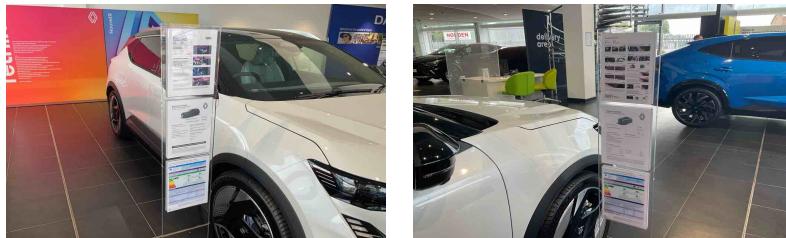
23 - The Renault price-product display stands are compliant ✓

**OK - Renault price displays are compliant and contain all the mandatory up-to-date information**

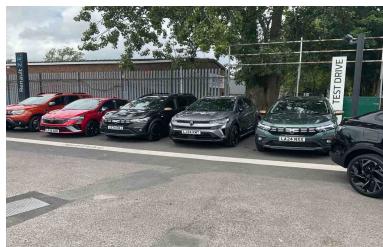
29 - Demonstrator vehicles are present in the Test Drive area and ready to be driven

**OK - The vehicles of the demonstrator fleet are present in the dedicated area, ready to be driven according to the manufacturer's standards**

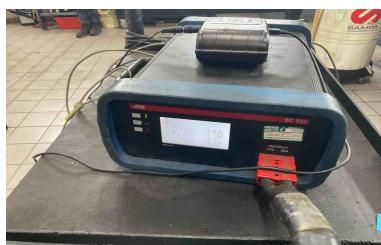
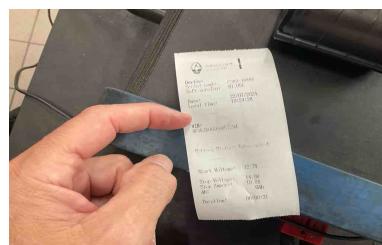
48 - The dealership has recommended chargers in sufficient number

**There are two full ATEQ BC-512 chargers and an additional one without printer. Expected NV sales will be 500 units requiring one charger. Tested and working OK.**

**OK - The dealership has the regulatory battery charger and it is fully functional**

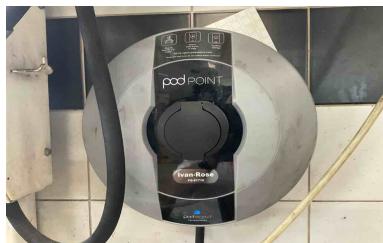
49 - There is an electric vehicle charging station for new vehicle preparation

**OK - There is a charging station for new electric vehicles and it is in good condition**

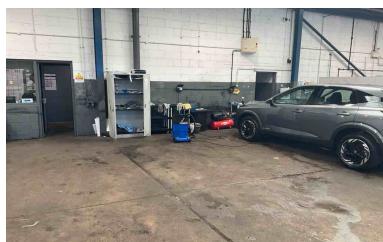
51 - The preparation area meets the manufacturer's standards

**OK - The preparation area complies with the recommendations and is clean and tidy**

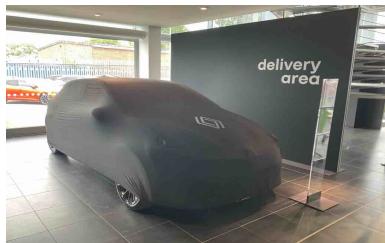
53 - The handover area meets the manufacturer's standards

***OK - The handover area complies with manufacturer standards***

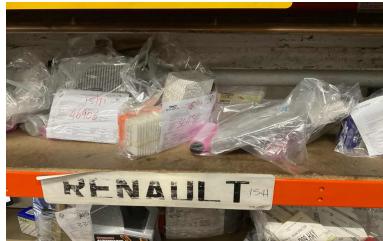
*The parts are pre picked (sealed in bags to prevent cross contamination) and include the picking slip*

*OK - Spare parts are always prepared in advance and are made available to the workshop in labelled boxes or lockers*

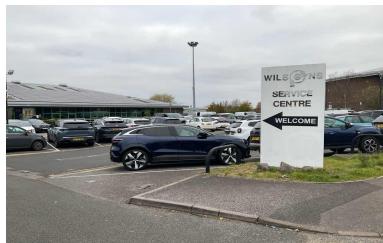
113 - Access to the after-sales services is identifiable upon arrival at the dealership

*OK - Access to the after-sales services is identifiable upon arrival at the dealership*

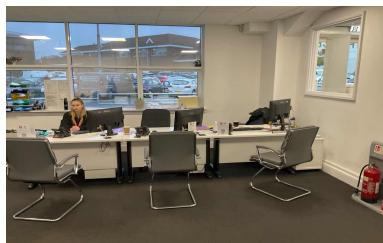
114 - The reception area complies with the brand's recommendations and is in impeccable condition

*The Service Department is multi-franchise (Renault/Dacia, Vauxhall, Fiat, Alfa Romeo, Jeep, and Hyundai). The area is brand neutral.*

*OK - The reception area complies with the standards and is perfectly maintained*

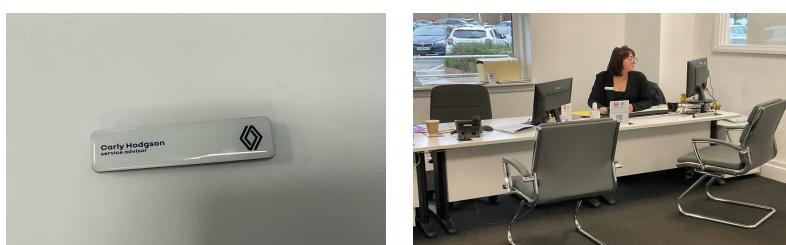
115 - Front-office staff wear appropriate business attire to allow customers to identify them

*OK - All front-office staff wear standard badges and uniforms*

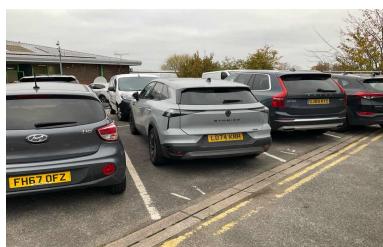
118 - The vehicle inspection area is present and complies with the recommendations

**Vehicles are inspected in the car park area**

**KO - The vehicle inspection area is not clean and / or does not comply with the recommendations**

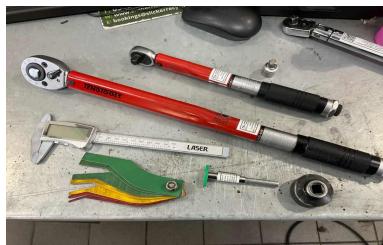
129 - The technician has the equipment and tools at their disposal to carry out vehicle maintenance ✓

**OK - All the equipment and tooling is available to the technician**

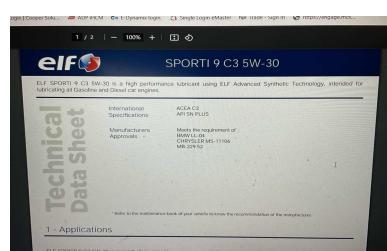
140 - The oil used conforms to the manufacturer's recommendations

**The ICM states RN17. The oil used is Elf Sport 9 C3 5W30 (bulk oil supplied via Nissan GB). The oil specification sheet does not explicitly state RN17 but it is specified as ACEA C3 5W30.**

**OK - The standard of oil used is in accordance with the ICM sheet**

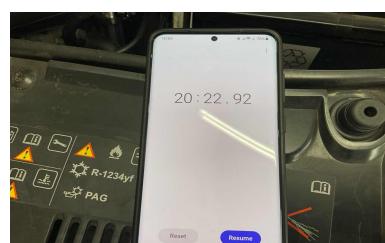
141 - Checking the oil level complies with the manufacturer's recommendations

**OK - The oil level on the dipstick is correct**

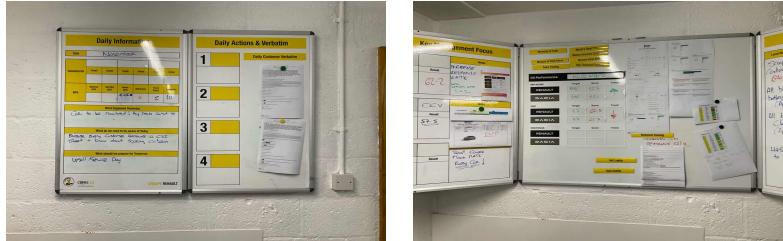
**OK - A daily briefing is carried out**

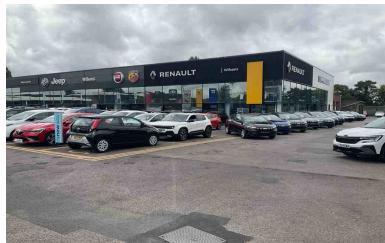
10 - The dealership exterior is in impeccable condition, is clean and is well maintained

*OK - The exterior appearance of the dealership is in impeccable condition*

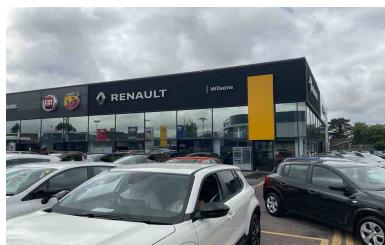
10b - The exterior area respects the visual charter of the Renault brand

*OK - The exterior area respects the visual charter of the Renault brand*

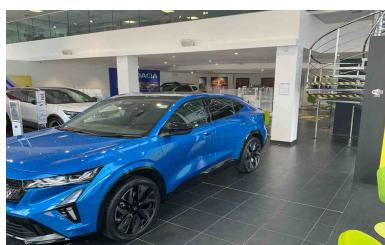
11 - The Renault Showroom Interior is in perfect condition

*OK - The interior appearance of the dealership is in perfect condition*

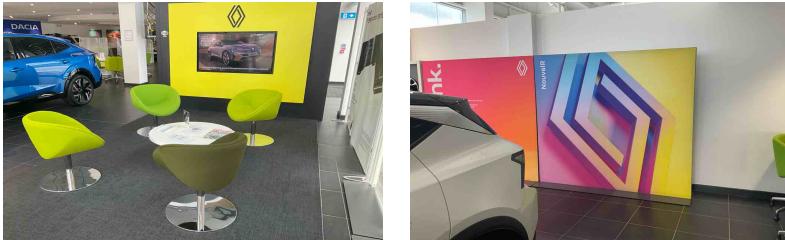
11b - The Showroom respects the visual charter of the Renault brand

***OK - The showroom respects the visual charter of the Renault brand***

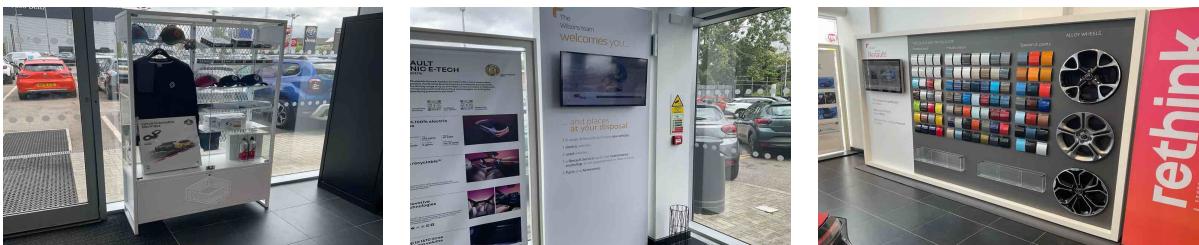
12 - The Renault showroom furniture is clean and well maintained

***OK - The showroom furniture is in good condition and properly maintained***

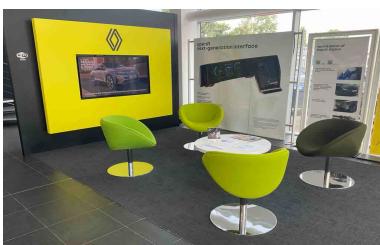
15 - The customer waiting area is suitable for waiting & up to standard

***OK - The furniture in the customer area is clean and compliant as a waiting area***

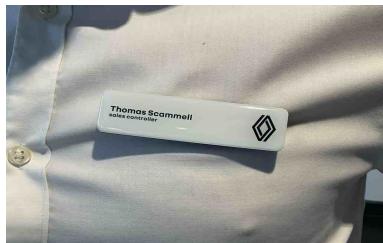
17 - Sales staff wear appropriate and identifiable business attire

***OK - Sales staff are identifiable***

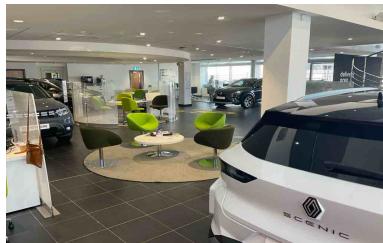
22 - New vehicles are presented according to the Renault brand's standards

***OK - New vehicles are displayed according to the brand's standards***

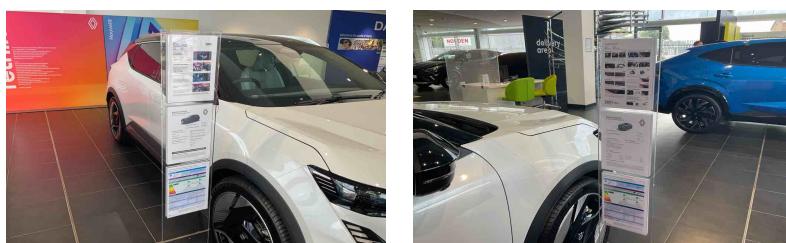
23 - The Renault price-product display stands are compliant

***OK - Renault price displays are compliant and contain all the mandatory up-to-date information***

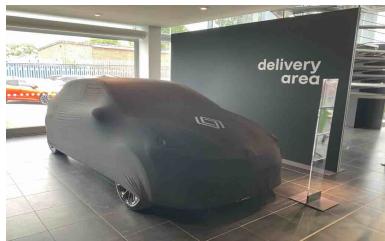
53 - The handover area meets the manufacturer's standards

***OK - The handover area complies with manufacturer standards***

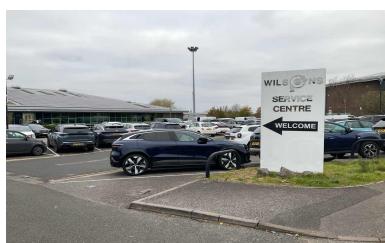
113 - Access to the after-sales services is identifiable upon arrival at the dealership

***OK - Access to the after-sales services is identifiable upon arrival at the dealership***

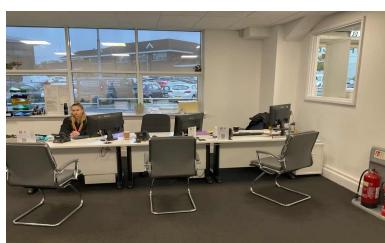
114 - The reception area complies with the brand's recommendations and is in impeccable condition

***The Service Department is multi-franchise (Renault/Dacia, Vauxhall, Fiat, Alfa Romeo, Jeep, and Hyundai). The area is brand neutral.***

***OK - The reception area complies with the standards and is perfectly maintained***

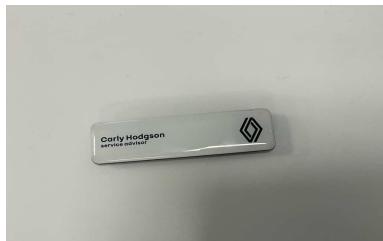
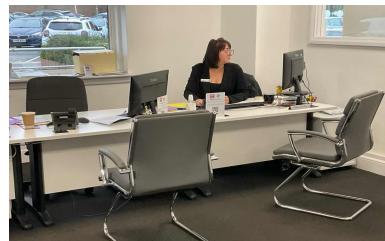
115 - Front-office staff wear appropriate business attire to allow customers to identify them

***OK - All front-office staff wear standard badges and uniforms***

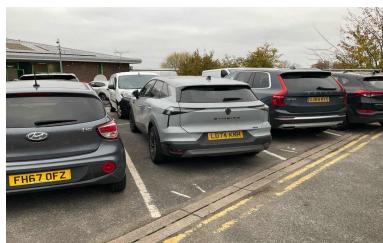
118 - The vehicle inspection area is present and complies with the recommendations

***Vehicles are inspected in the car park area***

***KO - The vehicle inspection area is not clean and / or does not comply with the recommendations***

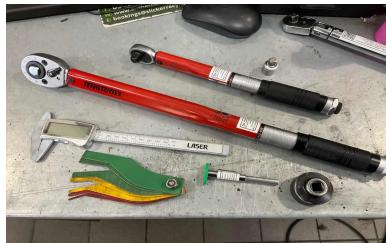
129 - The technician has the equipment and tools at their disposal to carry out vehicle maintenance ✓

*OK - All the equipment and tooling is available to the technician*

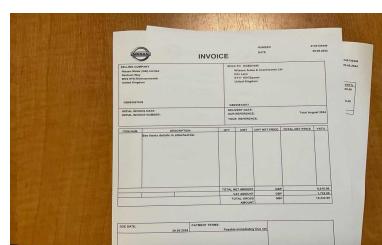
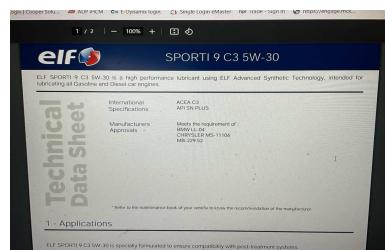
140 - The oil used conforms to the manufacturer's recommendations

**The ICM states RN17. The oil used is Elf Sport 9 C3 5W30 (bulk oil supplied via Nissan GB). The oil specification sheet does not explicitly state RN17 but it is specified as ACEA C3 5W30.**

**OK - The standard of oil used is in accordance with the ICM sheet**

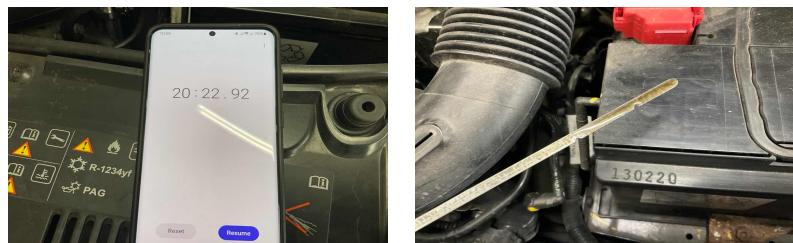
141 - Checking the oil level complies with the manufacturer's recommendations

***OK - The oil level on the dipstick is correct***

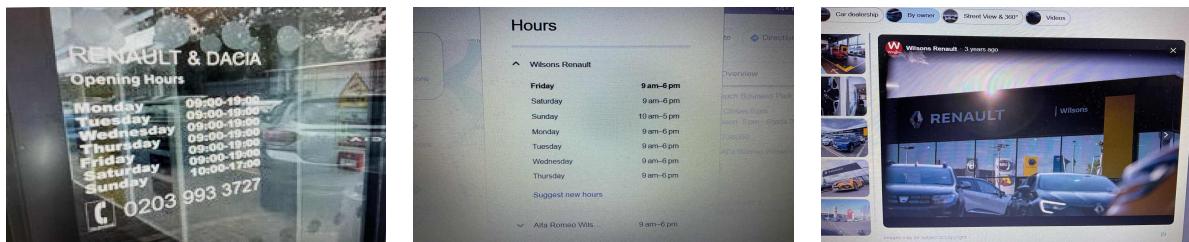
- 1. No “Own this business” evident. 2. Dealer name correct. 3. Address correct. 4. Contact information available. 5. Opening hours are not aligned between Google and those on the entrance door 6. Photo under “by owner” is 3 years old but and not current.**

**KO - GMB (Google My Business) is not correctly used**
