Dealer Quality Assessment - Detailed Report

| Dealer name | Location |
|---|---|
| GARAGE VALCKENIER KOBEGEM | BRUSSELSESTEENWEG 337 1730 ASSE-KOBEGEM Belgium |
| Auditor | Audit Date |
| JULIE WUYTS | 21/06/2024 |

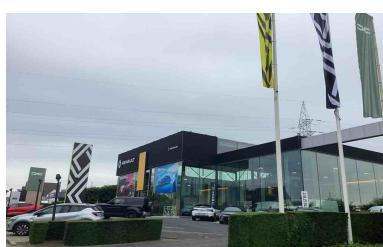
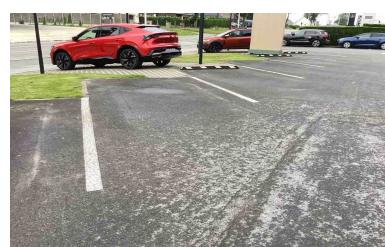
10 - The dealership exterior is in impeccable condition, is clean and is well maintained ✓

OK - The exterior appearance of the dealership is in impeccable condition

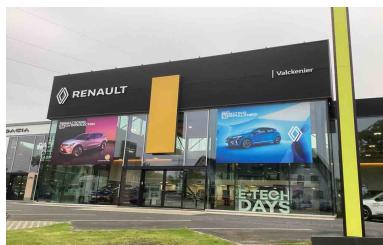
10b - The exterior area respects the visual charter of the Renault brand

OK - The exterior area respects the visual charter of the Renault brand

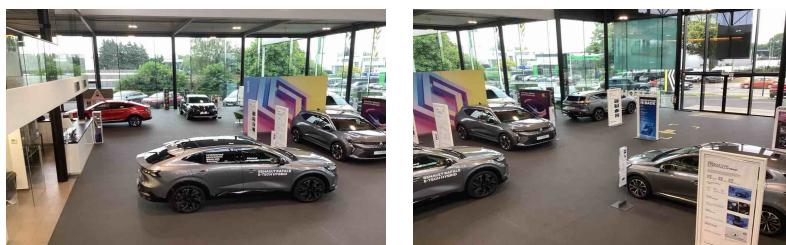
11 - The Renault Showroom Interior is in perfect condition

Vloer voldoet niet aan de normen

KO - The interior appearance of the dealership is not perfect condition

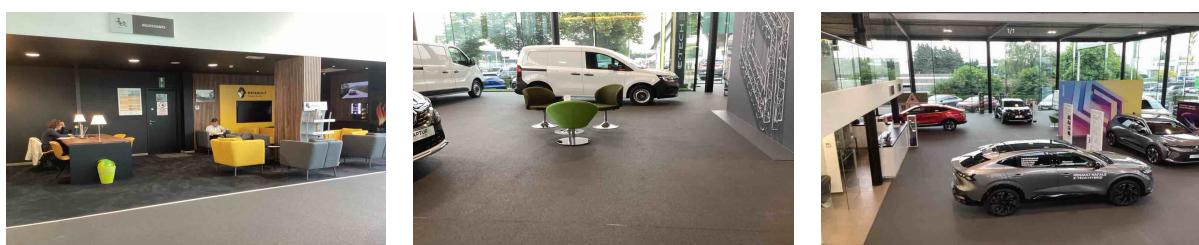
11b - The Showroom respects the visual charter of the Renault brand

Geen vloertegels

KO - The showroom does not respect the visual charter of the Renault brand

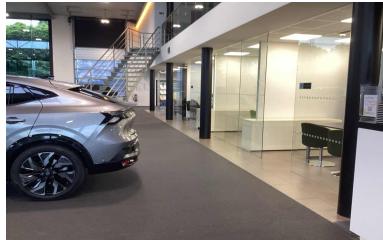
13 - The Renault sales desks are correctly positioned (away from the windows) and in perfect condition

OK - The sales desk are correctly positioned and in perfect condition

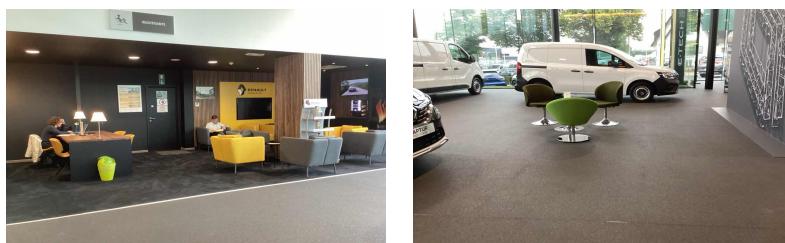
15 - The customer waiting area is suitable for waiting & up to standard

OK - The furniture in the customer area is clean and compliant as a waiting area

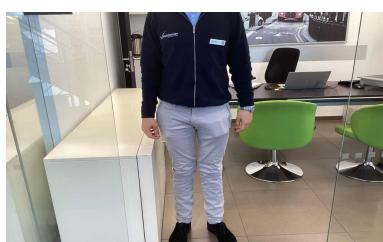
17 - Sales staff wear appropriate and identifiable business attire

OK - Sales staff are identifiable

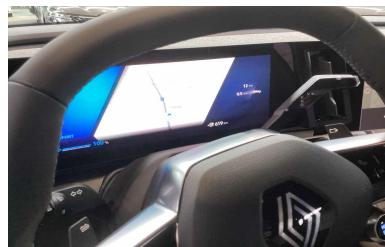
22 - New vehicles are presented according to the Renault brand's standards

OK - New vehicles are displayed according to the brand's standards

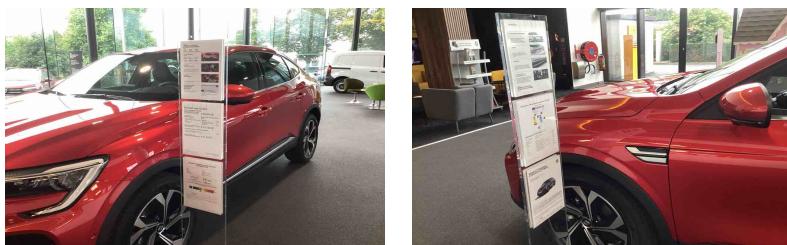
23 - The Renault price-product display stands are compliant

OK - Renault price displays are compliant and contain all the mandatory up-to-date information

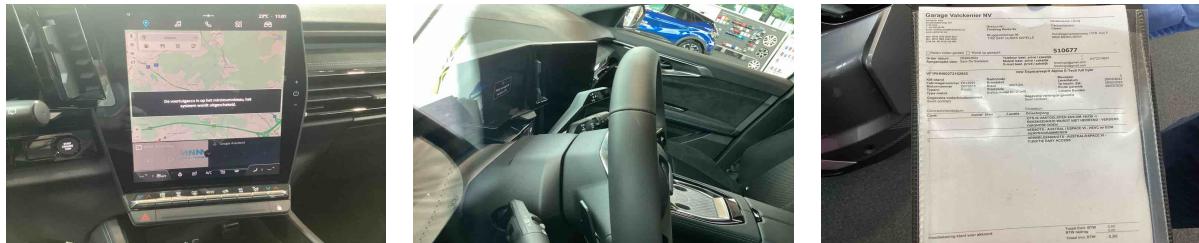
26 - The vehicles on display all have a charged battery

1 voertuig voldoet niet aan de normen: 12v accu is niet opgeladen, ze zijn bezig met de auto technisch inorde te brengen echter plaatst men de auto ondertussen in de showroom waar klanten deze meldingen kunnen zien.

KO - Not all vehicles on display are charged correctly

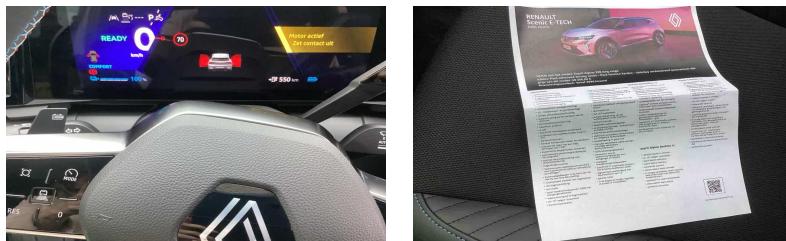
29 - Demonstrator vehicles are present in the Test Drive area and ready to be driven

OK - The vehicles of the demonstrator fleet are present in the dedicated area, ready to be driven according to the manufacturer's standards

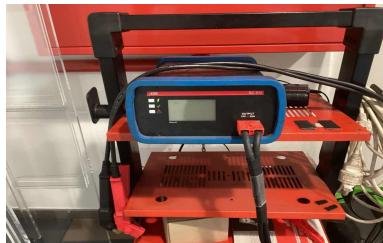
48 - The dealership has recommended chargers in sufficient number

1 lader ter beschikking

OK - The dealership has the regulatory battery charger and it is fully functional

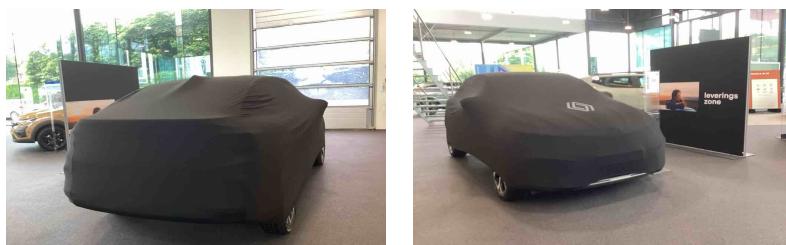
53 - The handover area meets the manufacturer's standards X

Ruimte voldoet niet aan de Renault voorwaarden , mag niet in de showroom zelf staan.

KO - The handover area does not comply with manufacturer's standards or there is no handover area present

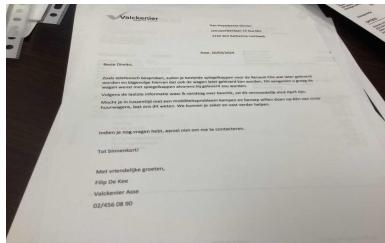
35 - The customer is informed of the late delivery of their vehicle

OK - Customers are informed of delays to their order in good time

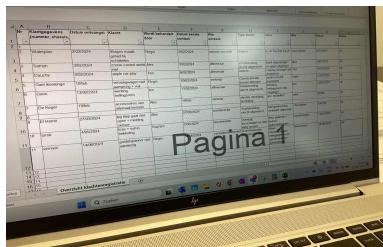
57 - There is an internal or company procedure for dealing with customer issues or complaints ✓

Klachten worden tijdig opgevolgd

OK - There is an up-to-date customer complaints log

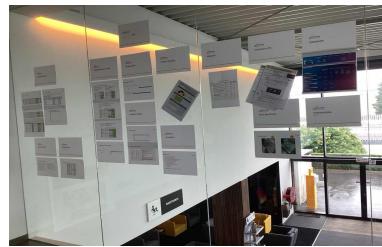
60 - There is a monthly meeting to review the latest quality data on NV activity & gives rise to the necessary measures to improve the situation B ✗

Er zijn nergens actieplannen te bespeuren voor de maand April en ook het eerste kwartaal van 2024 zijn er geen actieplannen. T1 opgevraagd die was er niet.

KO - A quality meeting is not carried out monthly or it is not formalized, or/and no measurable actions are followed

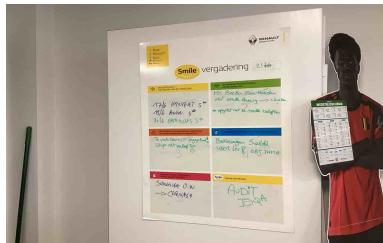
63 - There are brief daily meetings to drive sales and quality

OK - The Sales Manager leads a short daily meeting in front of a tracking board or digital support

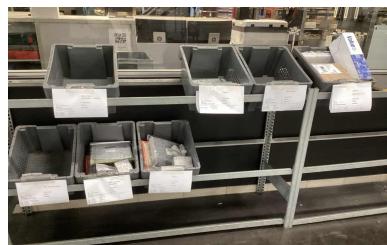
109 - Spare parts are prepared in advance & are made available to the workshop in a compliant manner

OK - Spare parts are always prepared in advance and are made available to the workshop in labelled boxes or lockers

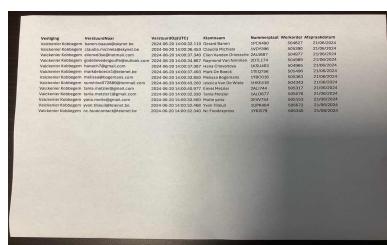
112 - The customer is contacted the day before as a reminder of their appointment

Klanten worden de dag voordien gecontacteerd via e-mail

OK - The customer is systematically contacted the day before the appointment and there is a trace of the confirmation

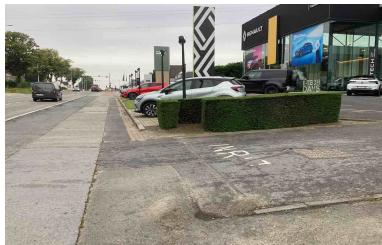
113 - Access to the after-sales services is identifiable upon arrival at the dealership

Geen richtingsborden

KO - Access to the after-sales services is not identifiable upon arrival at the dealership

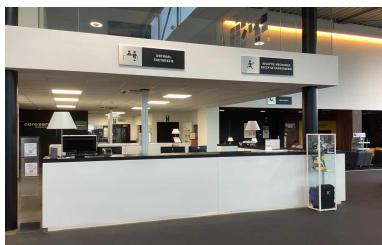
114 - The reception area complies with the brand's recommendations and is in impeccable condition

OK - The reception area complies with the standards and is perfectly maintained

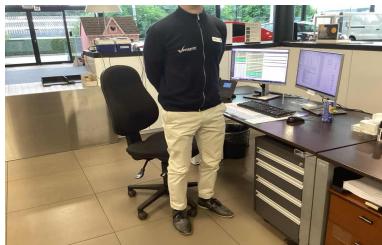
115 - Front-office staff wear appropriate business attire to allow customers to identify them

OK - All front-office staff wear standard badges and uniforms

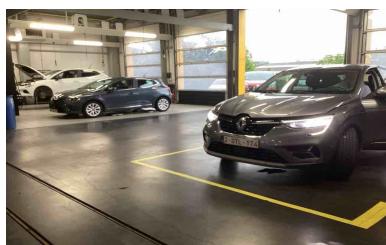
118 - The vehicle inspection area is present and complies with the recommendations ✗

Controle zone bevindt zich in de garage en bevat niet de juiste merknaam - welkom -

KO - The vehicle inspection area is not clean and / or does not comply with the recommendations

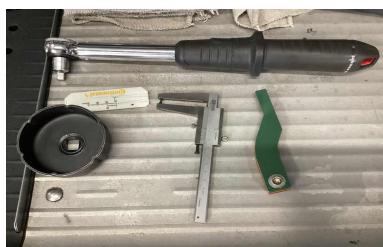
129 - The technician has the equipment and tools at their disposal to carry out vehicle maintenance

OK - All the equipment and tooling is available to the technician

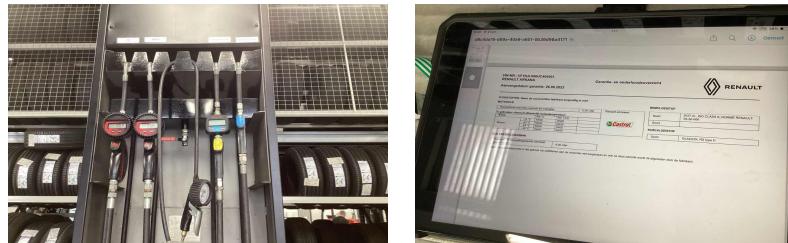
140 - The oil used conforms to the manufacturer's recommendations

RN17 5W30

OK - The standard of oil used is in accordance with the ICM sheet

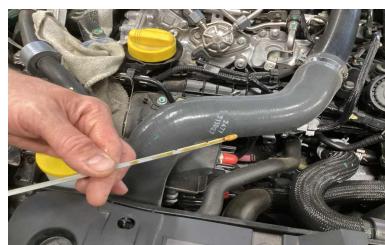
141 - Checking the oil level complies with the manufacturer's recommendations

OK - The oil level on the dipstick is correct

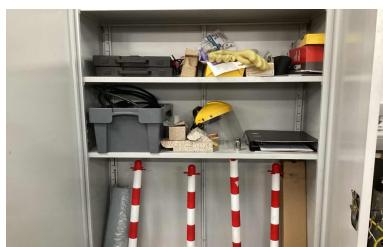
144 - There is a dedicated High Voltage Zone workstation for the maintenance of electric vehicles

OK - The workstation and the main safety elements are present

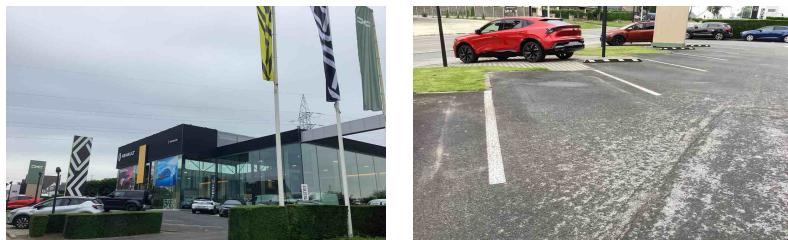
10 - The dealership exterior is in impeccable condition, is clean and is well maintained

OK - The exterior appearance of the dealership is in impeccable condition

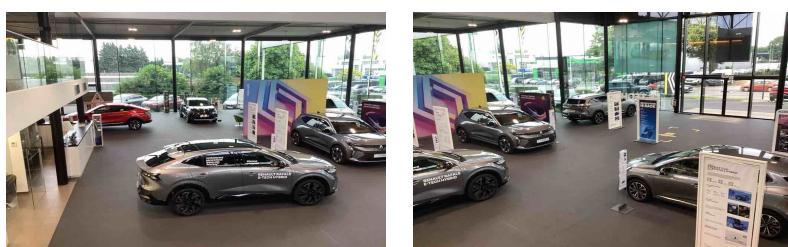
11 - The Renault Showroom Interior is in perfect condition

Vloer voldoet niet aan de normen

KO - The interior appearance of the dealership is not perfect condition

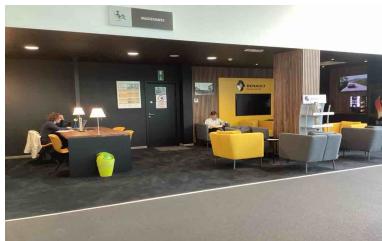
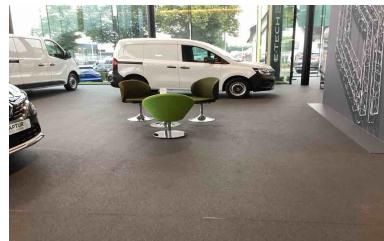
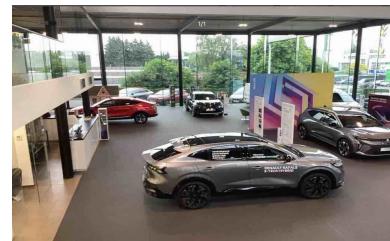
11b - The Showroom respects the visual charter of the Renault brand

Geen vloertegels

KO - The showroom does not respect the visual charter of the Renault brand

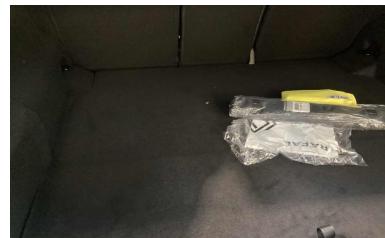
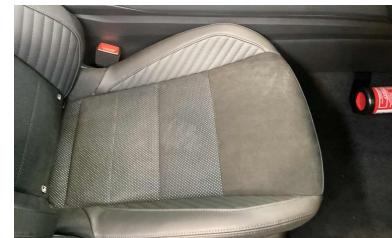
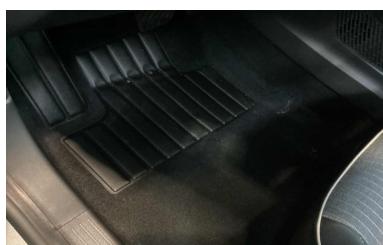
25 - The new vehicles exhibited in the Renault Showroom are in perfect condition

Sommige auto's bevatten een vuile koffer, vieze ondergrond aan de passagiers ruimte en hier en daar wat vegen exterieur

KO - The vehicles on display are not in perfect condition

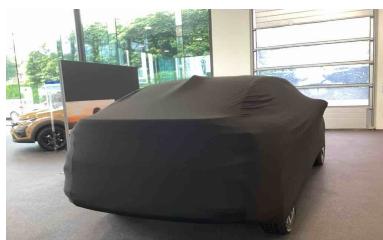
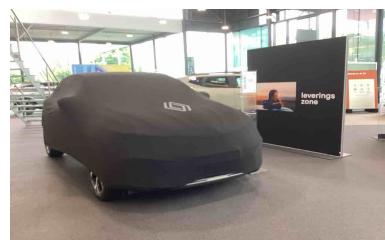
53 - The handover area meets the manufacturer's standards

Ruimte voldoet niet aan de Renault voorwaarden , mag niet in de showroom zelf staan.

KO - The handover area does not comply with manufacturer's standards or there is no handover area present

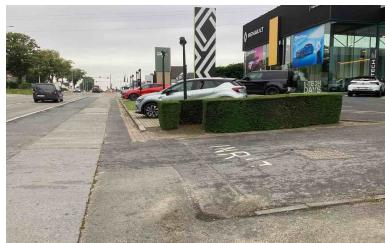
Geen richtingsborden

KO - Access to the after-sales services is not identifiable upon arrival at the dealership

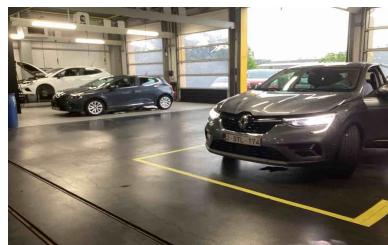
118 - The vehicle inspection area is present and complies with the recommendations

Controle zone bevindt zich in de garage en bevat niet de juiste merknaam - welkom -

KO - The vehicle inspection area is not clean and / or does not comply with the recommendations

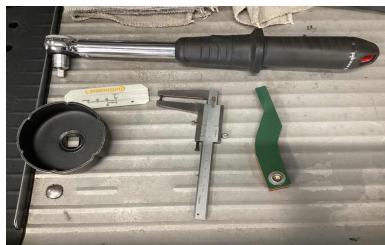
129 - The technician has the equipment and tools at their disposal to carry out vehicle maintenance ✓

OK - All the equipment and tooling is available to the technician

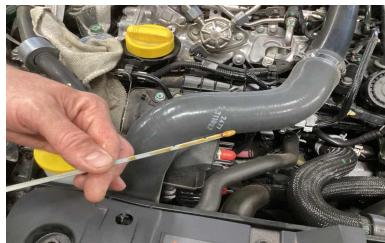
141 - Checking the oil level complies with the manufacturer's recommendations

OK - The oil level on the dipstick is correct

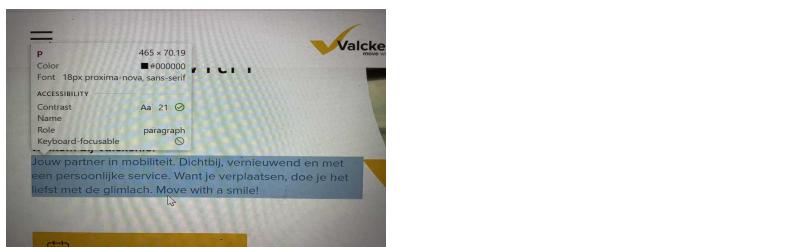
Er worden meerdere lettertypes gebruikt dan die van Renault zoals proxima-nova

KO - Either the font or/and GUIs are not the right ones
