# Dealer Quality Assessment - Detailed Report

Dealer name	Location
AUTOVIA SRL	V.VALCORRENTE, 78/80 95032 PIANO T.BELPASSO, CT Italy
Dealer code	RRG
38013059	NO
NV Renault Sales / year	NV Dacia Sales / Year
400	600
Workshop Customers / Day	Principal Audited Brand
17	RENAULT
Auditor	Audit Date
NANNETTI FILIPPO	21/05/2024

Global Score  
**97%**

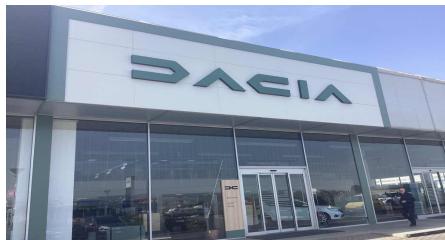
- 
- 1 - The Dacia facade and dedicated entrance comply with the brand's visual identity charter

*OK - The Dacia facade meets the brand's standards*

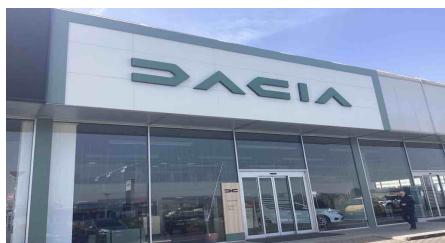
- 
- 1b - The Dacia facade is in perfect condition

*OK - The Dacia facade is in perfect condition*

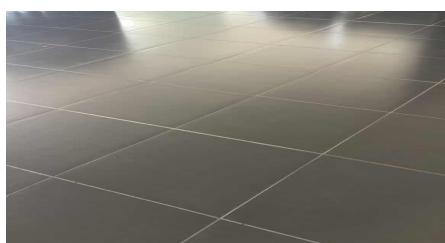
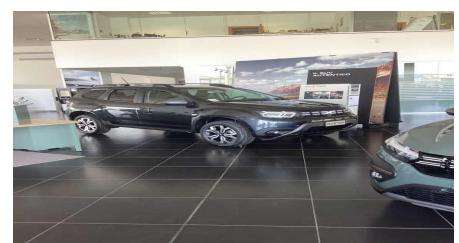
- 
- 2 - The Dacia Showroom complies with the brand's visual identity charter

*OK - The Dacia showroom complies with the brand's visual identity charter*

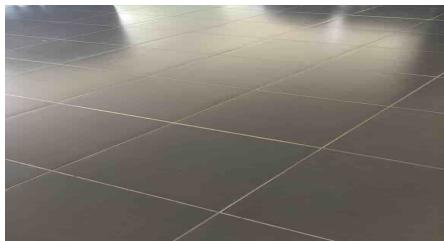
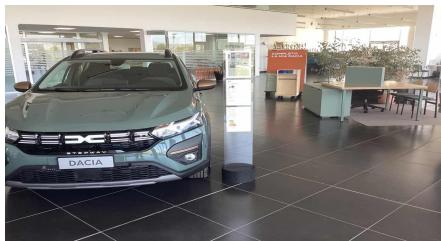
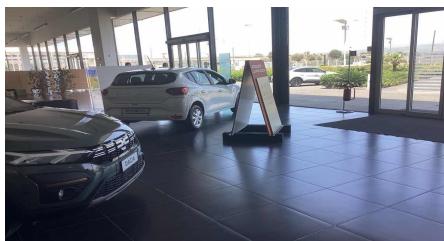
2b - The Dacia showroom is in impeccable condition

*OK - The Dacia showroom is in perfect condition*

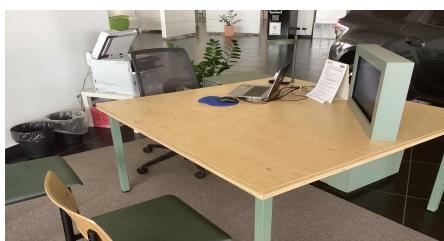
3 - Dacia sales desks are correctly positioned (away from the windows) and in perfect condition

*OK - The Dacia sales desks are correctly positioned and in perfect condition*

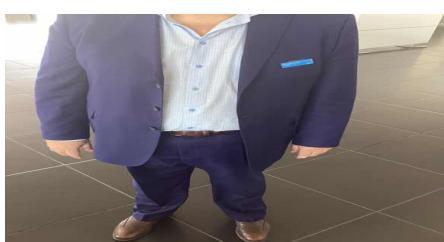
4 - Dacia sales staff wear appropriate and identifiable business attire

*Non indossa i colori conformi (bianco, beige, khaki)*

*KO - Dacia sales staff are not identifiable*

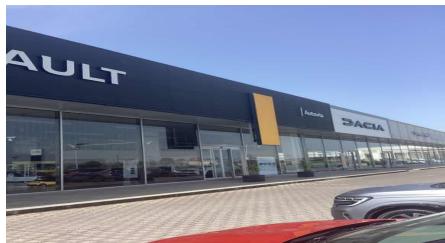
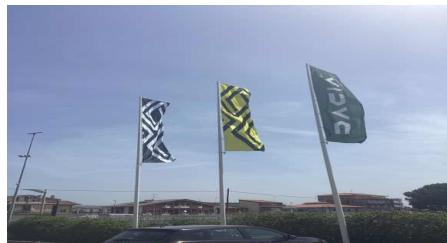
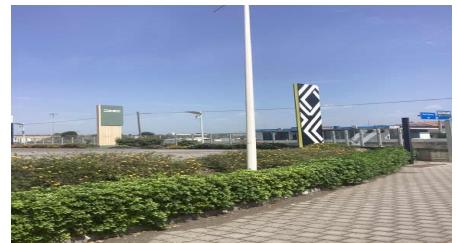
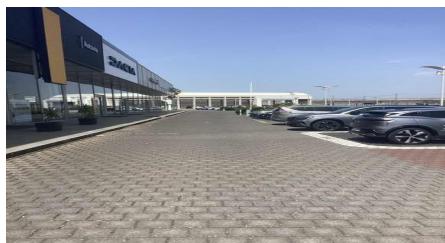
10 - The dealership exterior is in impeccable condition, is clean and is well maintained

*OK - The exterior appearance of the dealership is in impeccable condition*

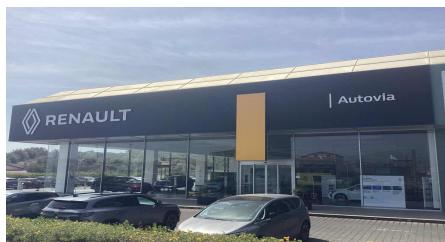
10b - The exterior area respects the visual charter of the Renault brand

*OK - The exterior area respects the visual charter of the Renault brand*

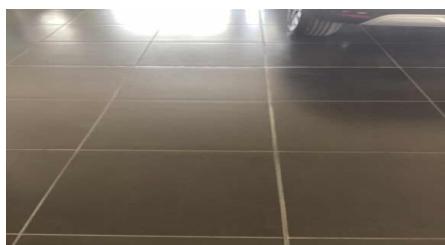
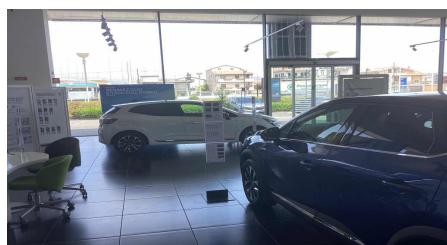
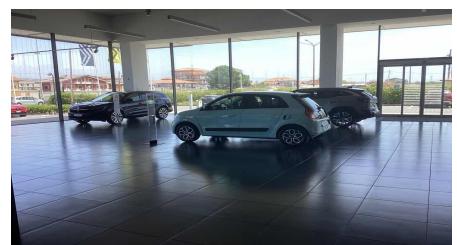
11 - The Renault Showroom Interior is in perfect condition

*OK - The interior appearance of the dealership is in perfect condition*

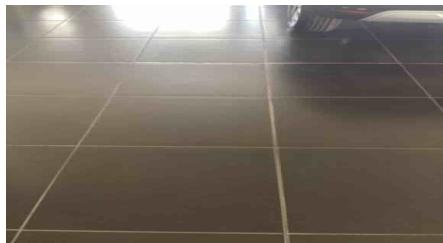
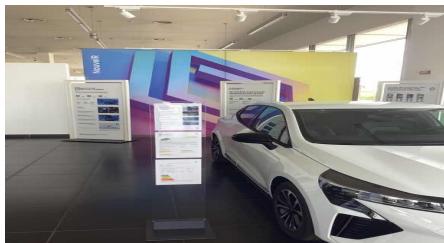
11b - The Showroom respects the visual charter of the Renault brand

***OK - The showroom respects the visual charter of the Renault brand***

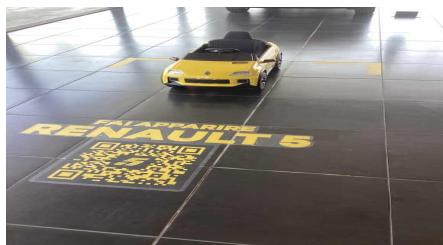
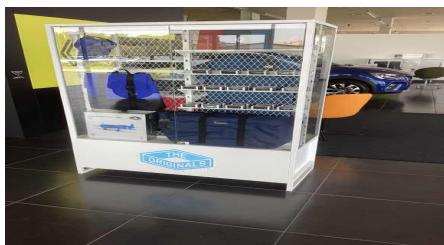
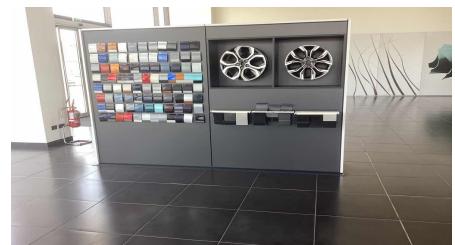
12 - The Renault showroom furniture is clean and well maintained

***OK - The showroom furniture is in good condition and properly maintained***

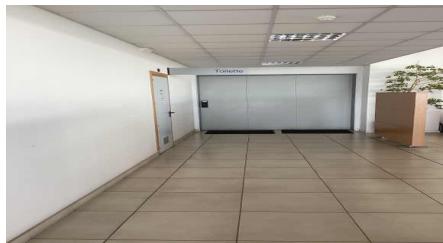
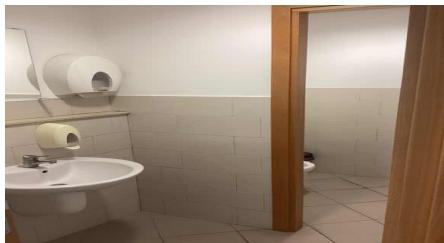
14 - Washrooms / Toilets are available for customer use. They are identified, clean, well lit and usable

***OK - The customer toilets are accessible and in a compliant state***

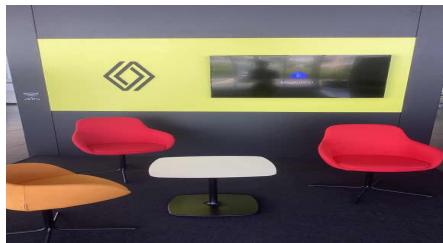
15 - The customer waiting area is suitable for waiting & up to standard

**iPad connesso a WiFi**

**OK - The furniture in the customer area is clean and compliant as a waiting area**

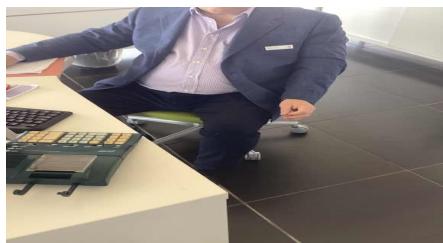
17 - Sales staff wear appropriate and identifiable business attire

**OK - Sales staff are identifiable**

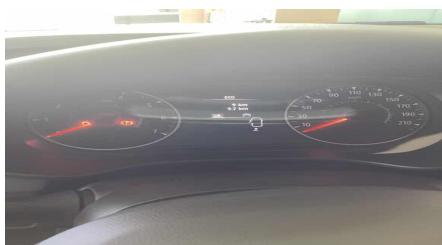
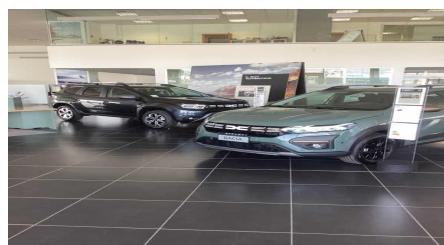
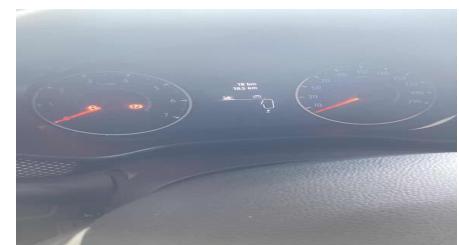
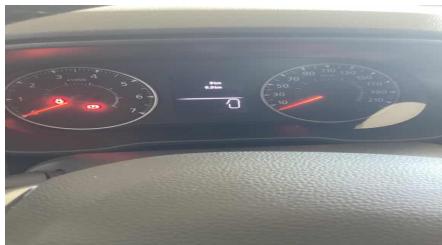
5 - New Dacia vehicles are presented according to the brand's standards

**OK - Dacia new vehicles are displayed according to the brand's standards**

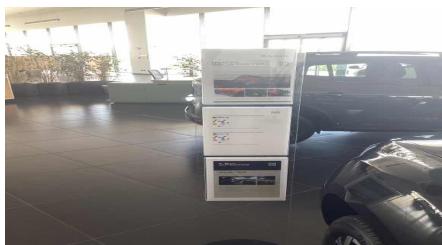
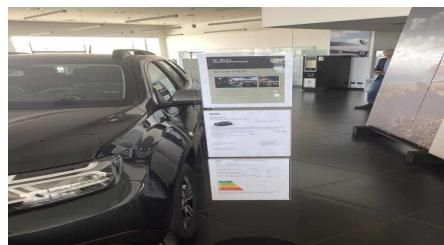
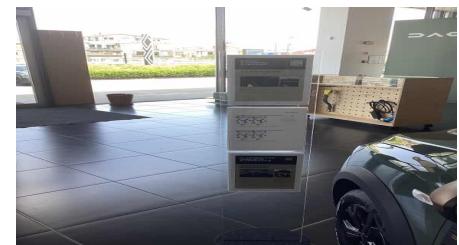
6 - The Dacia product-price display stands are compliant and contains the required information

**OK - The Dacia price display stands are compliant and contain the latest mandatory information**

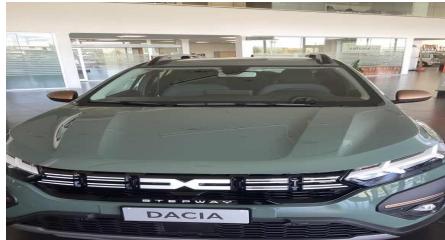
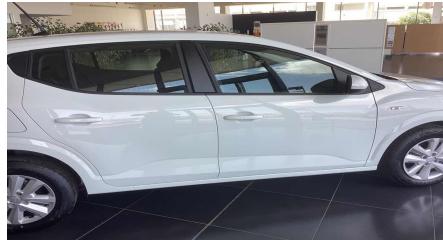
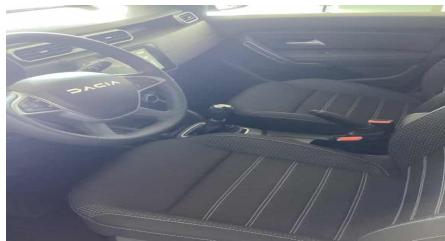
8 - The new Dacia vehicles displayed in the Showroom are in perfect condition

***OK - The Dacia vehicles on display are in perfect condition***

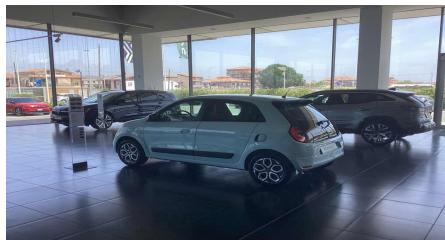
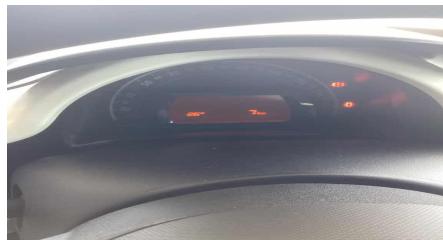
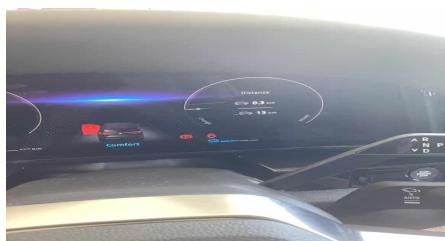
22 - New vehicles are presented according to the Renault brand's standards

***OK - New vehicles are displayed according to the brand's standards***

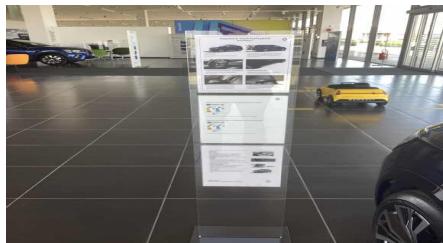
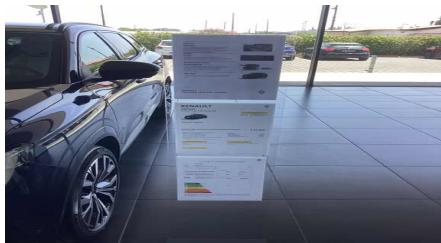
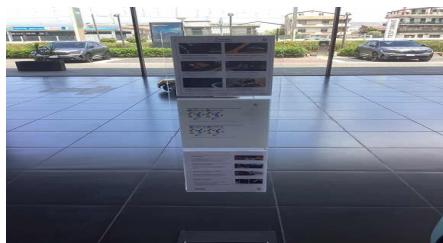
23 - The Renault price-product display stands are compliant

*OK - Renault price displays are compliant and contain all the mandatory up-to-date information*

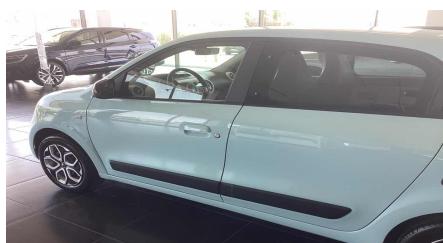
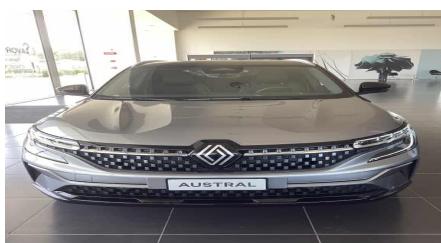
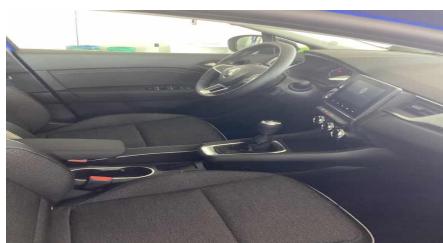
25 - The new vehicles exhibited in the Renault Showroom are in perfect condition

*OK - The vehicles on display are in perfect condition*

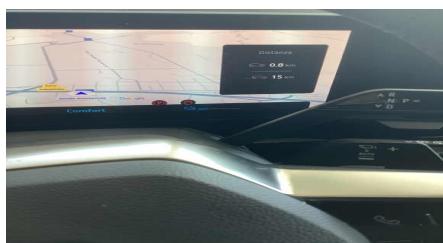
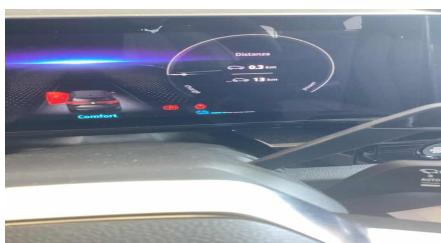
26 - The vehicles on display all have a charged battery

**OK - The vehicles on display are all charged**

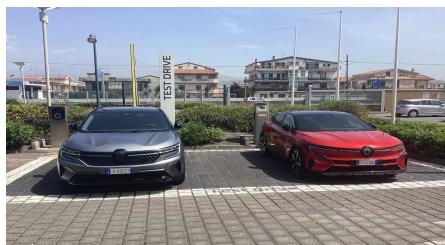
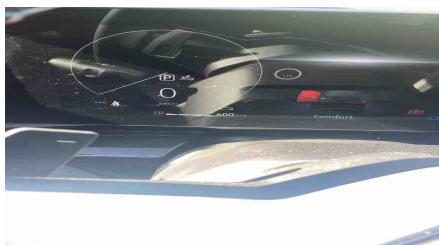
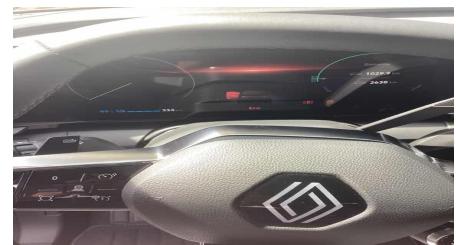
29 - Demonstrator vehicles are present in the Test Drive area and ready to be driven

*Serbatoio meno di 1/4*

**KO - The vehicles of the demonstrator fleet are not present in the dedicated area, and not ready to be driven according to the manufacturer's standards**

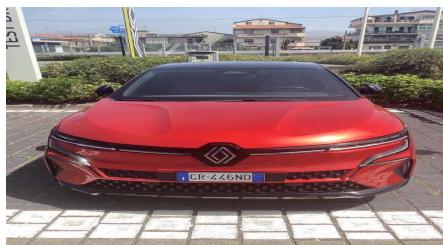
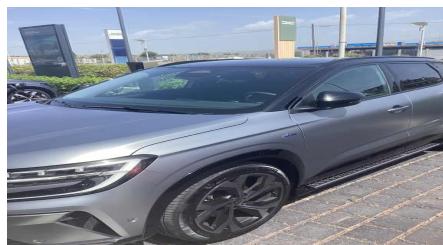
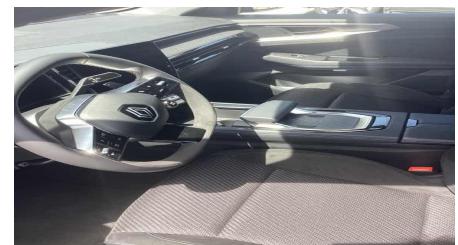
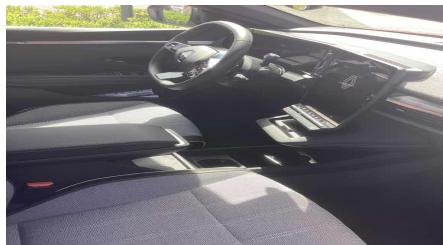
29a - The Demonstrator vehicles are clean, inside and out

**OK - Demonstrator fleet vehicles are clean and ready for use**

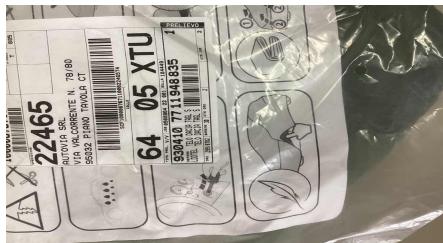
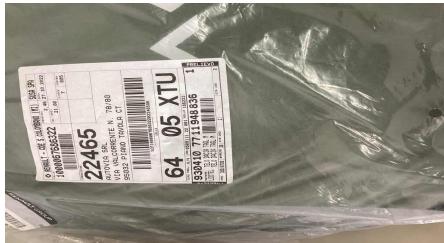
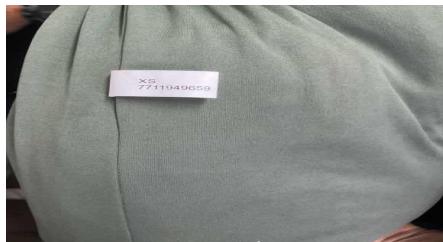
9 - Dacia vehicles to be delivered are presented to customers according to the recommendations (with compliant delivery covers)

**OK - Dacia covers are available in sufficient number and sizes**

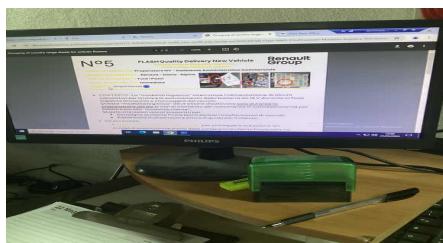
46 - The personnel in charge of preparing the vehicle are aware of the latest technical information

**OK - The person in charge of technical preparation knows the latest information**

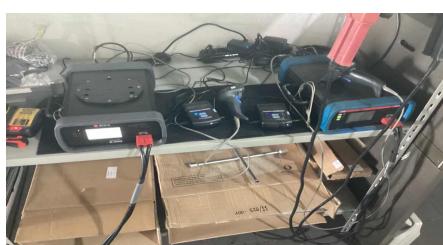
48 - The dealership has recommended chargers in sufficient number

**2 per 1000 VN**

**OK - The dealership has the regulatory battery charger and it is fully functional**

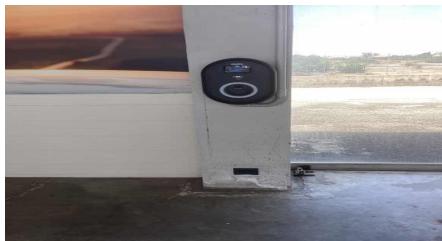
49 - There is an electric vehicle charging station for new vehicle preparation

**OK - There is a charging station for new electric vehicles and it is in good condition**

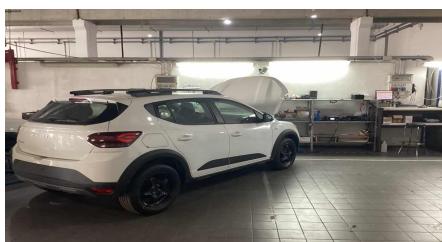
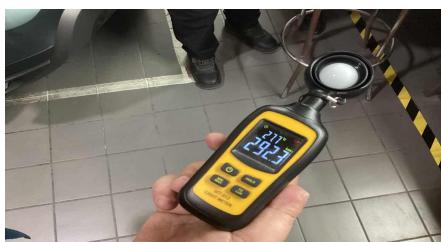
51 - The preparation area meets the manufacturer's standards

**Non illuminata**

**KO - The preparation area does not comply with the recommendations or is poorly maintained**

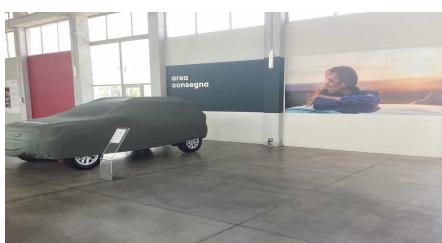
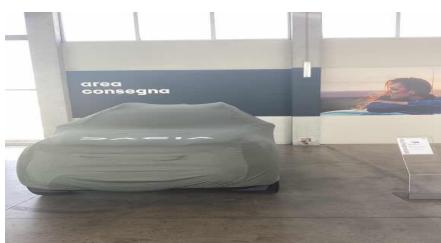
53 - The handover area meets the manufacturer's standards

**OK - The handover area complies with manufacturer standards**

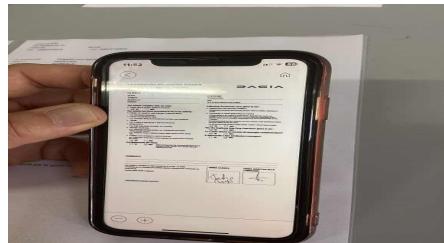
55 - The staff that perform handovers are aware of the latest product innovations and respect manufacturer's recommendations

**OK - The person in charge of the handover knows and uses the 5-step method, & knows the latest product innovations**

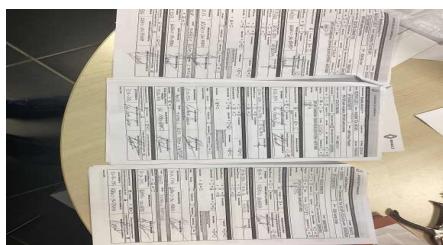
40 - Customer files are complete

**OK - The customer files checked were complete and contained all the standard documents expected**

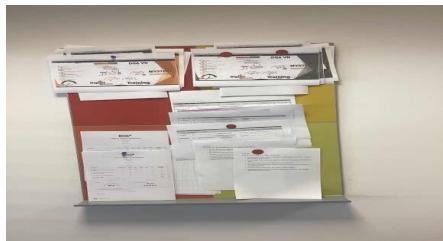
63 - There are brief daily meetings to drive sales and quality

***OK - The Sales Manager leads a short daily meeting in front of a tracking board or digital support***

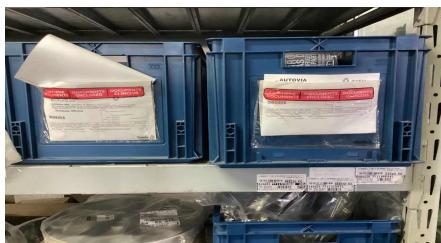
109 - Spare parts are prepared in advance & are made available to the workshop in a compliant manner

**OK - Spare parts are always prepared in advance and are made available to the workshop in labelled boxes or lockers**

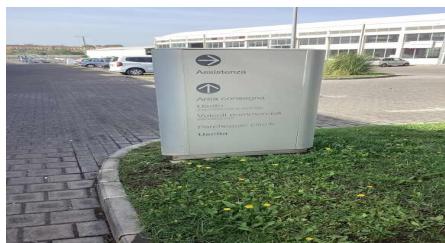
113 - Access to the after-sales services is identifiable upon arrival at the dealership

**OK - Access to the after-sales services is identifiable upon arrival at the dealership**

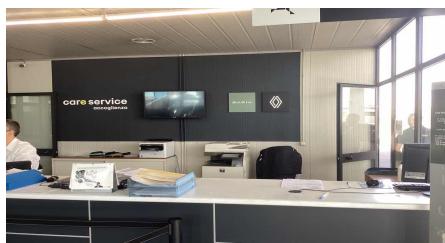
114 - The reception area complies with the brand's recommendations and is in impeccable condition

**OK - The reception area complies with the standards and is perfectly maintained**

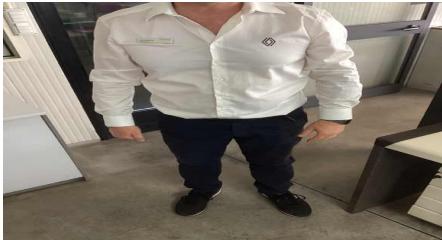
115 - Front-office staff wear appropriate business attire to allow customers to identify them

**OK - All front-office staff wear standard badges and uniforms**

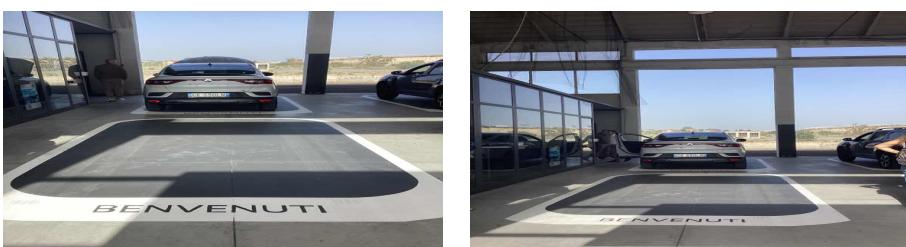
118 - The vehicle inspection area is present and complies with the recommendations

**OK - The vehicle inspection area is in perfect condition and complies with the recommendations**

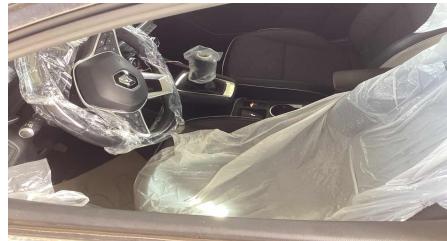
120 - Customer vehicles are properly protected and disinfected

*OK - All the driving seat position protections are fitted correctly*

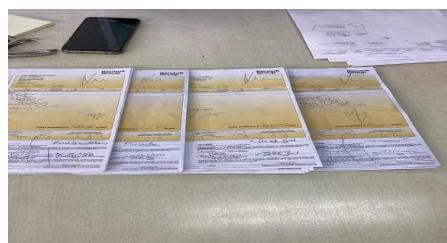
124 - For each intervention there is a price commitment to the customer

*OK - Overall price and detailed prices are correctly noted in checked files and Repair Orders are signed by customers*

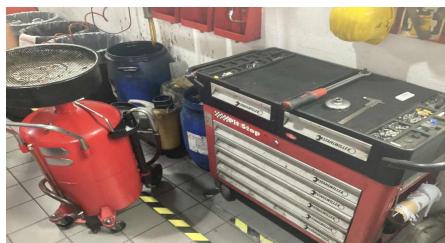
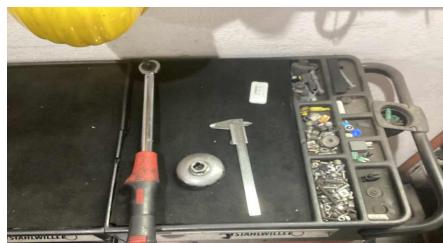
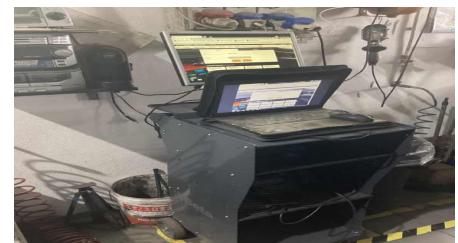
129 - The technician has the equipment and tools at their disposal to carry out vehicle maintenance ✓

***OK - All the equipment and tooling is available to the technician***

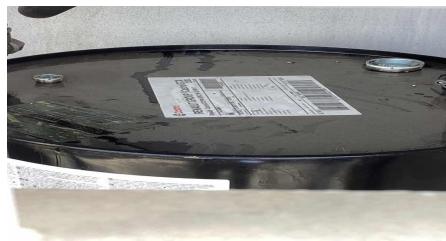
140 - The oil used conforms to the manufacturer's recommendations ✓

**Olio conforme**

**OK - The standard of oil used is in accordance with the ICM sheet**

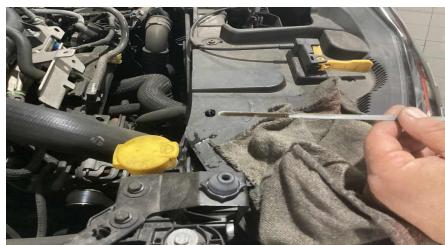
141 - Checking the oil level complies with the manufacturer's recommendations

*OK - The oil level on the dipstick is correct*

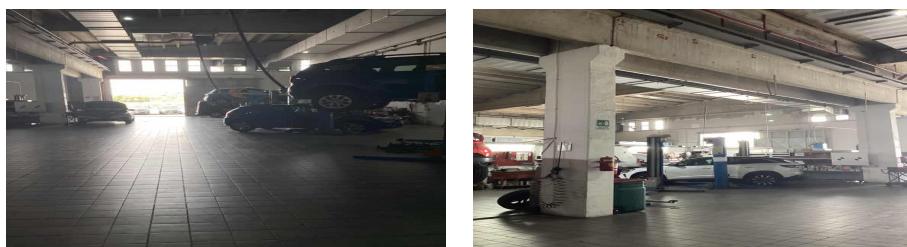
142 - The workshop is clean and tidy

*OK - The workshop is clean and tidy*

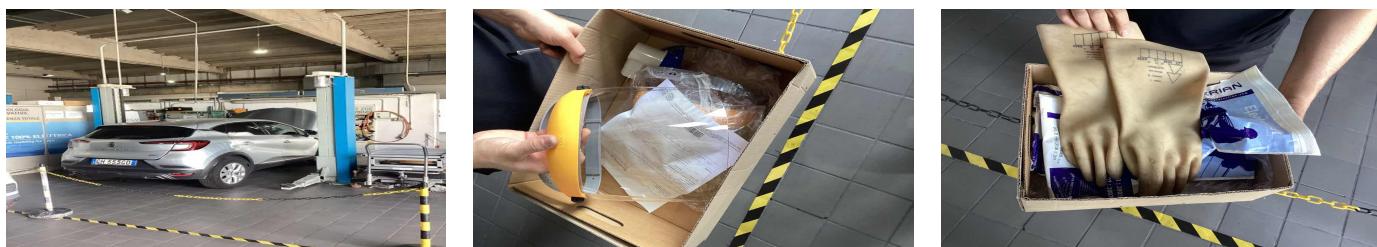
144 - There is a dedicated High Voltage Zone workstation for the maintenance of electric vehicles

*OK - The workstation and the main safety elements are present*

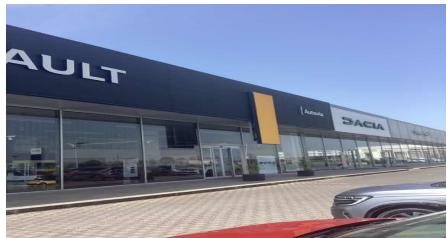
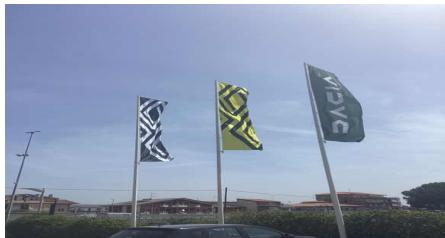
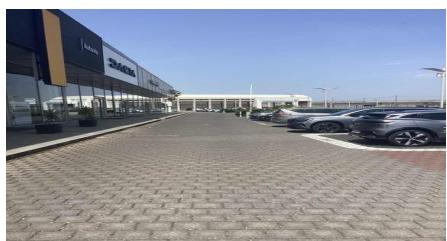
10 - The dealership exterior is in impeccable condition, is clean and is well maintained

*OK - The exterior appearance of the dealership is in impeccable condition*

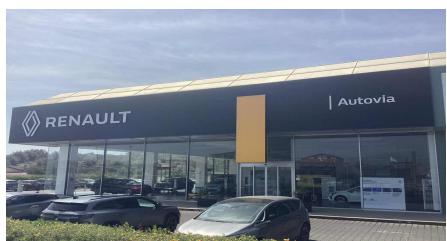
10b - The exterior area respects the visual charter of the Renault brand

*OK - The exterior area respects the visual charter of the Renault brand*

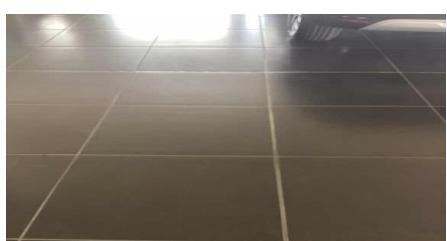
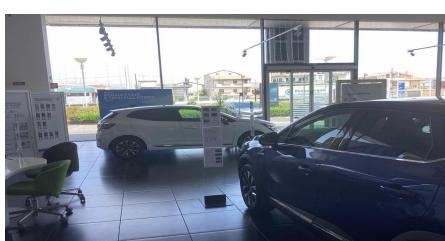
11 - The Renault Showroom Interior is in perfect condition

*OK - The interior appearance of the dealership is in perfect condition*

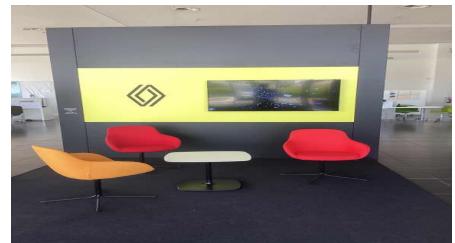
11b - The Showroom respects the visual charter of the Renault brand

***OK - The showroom respects the visual charter of the Renault brand***

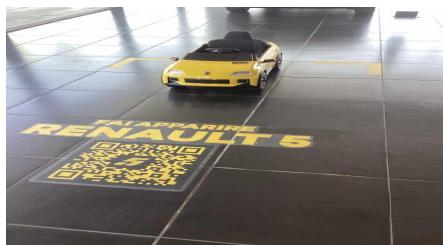
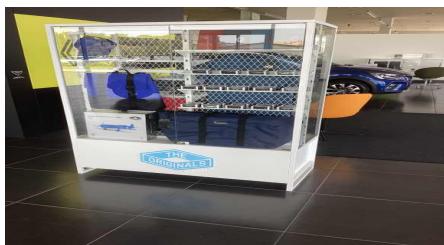
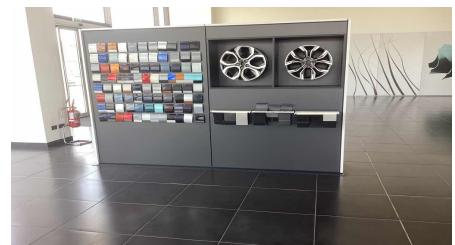
12 - The Renault showroom furniture is clean and well maintained

***OK - The showroom furniture is in good condition and properly maintained***

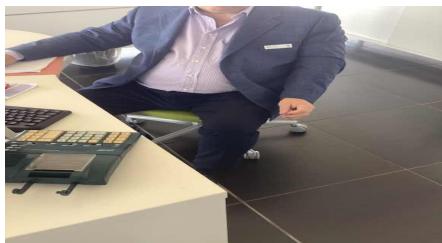
17 - Sales staff wear appropriate and identifiable business attire

**OK - Sales staff are identifiable**

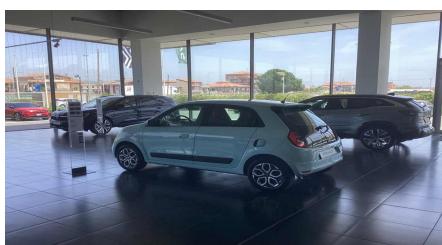
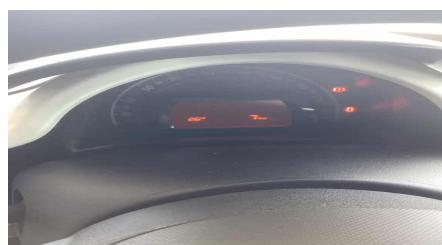
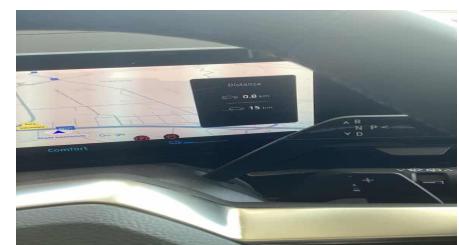
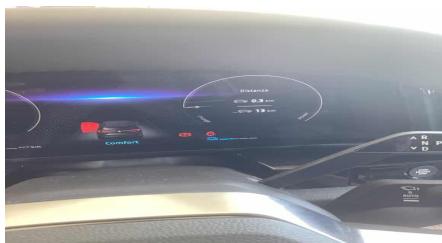
22 - New vehicles are presented according to the Renault brand's standards

**OK - New vehicles are displayed according to the brand's standards**

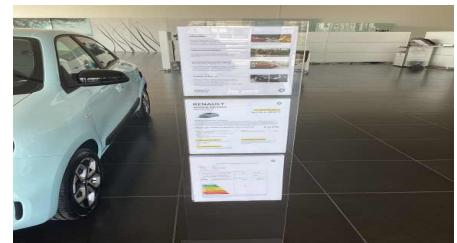
23 - The Renault price-product display stands are compliant

*OK - Renault price displays are compliant and contain all the mandatory up-to-date information*

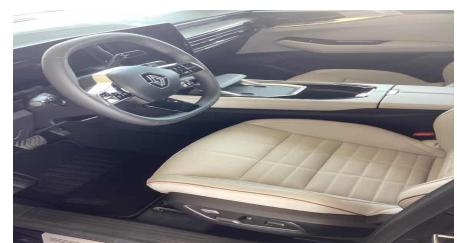
25 - The new vehicles exhibited in the Renault Showroom are in perfect condition

*OK - The vehicles on display are in perfect condition*

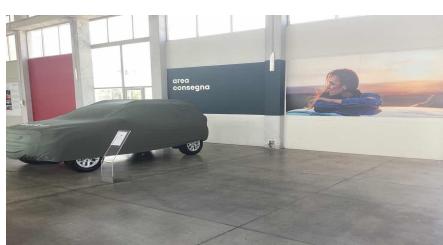
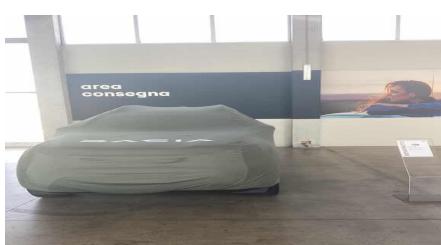
53 - The handover area meets the manufacturer's standards

**OK - The handover area complies with manufacturer standards**

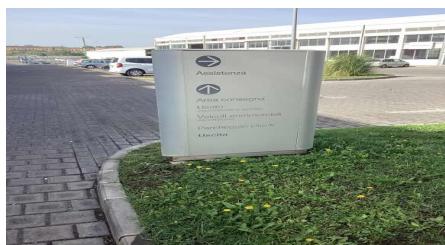
113 - Access to the after-sales services is identifiable upon arrival at the dealership

**OK - Access to the after-sales services is identifiable upon arrival at the dealership**

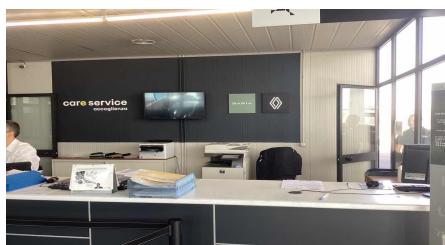
114 - The reception area complies with the brand's recommendations and is in impeccable condition

**OK - The reception area complies with the standards and is perfectly maintained**

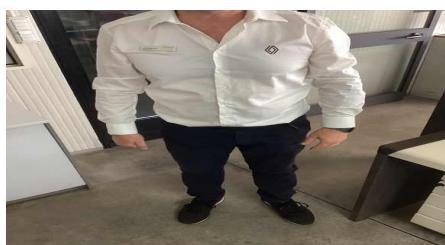
115 - Front-office staff wear appropriate business attire to allow customers to identify them

**OK - All front-office staff wear standard badges and uniforms**

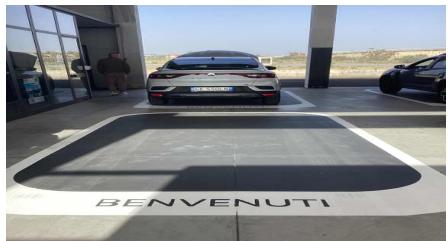
118 - The vehicle inspection area is present and complies with the recommendations

*OK - The vehicle inspection area is in perfect condition and complies with the recommendations*

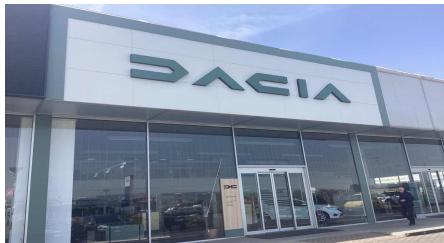
- 1 - The Dacia facade and dedicated entrance comply with the brand's visual identity charter

*OK - The Dacia facade meets the brand's standards*

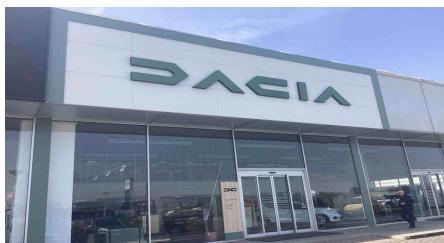
- 1b - The Dacia facade is in perfect condition

*OK - The Dacia facade is in perfect condition*

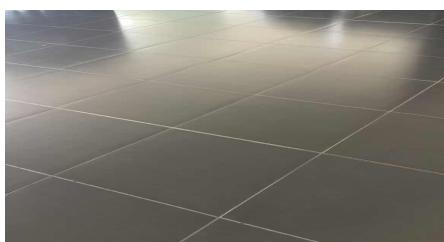
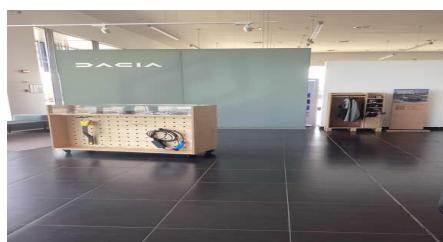
- 2 - The Dacia Showroom complies with the brand's visual identity charter

*OK - The Dacia showroom complies with the brand's visual identity charter*

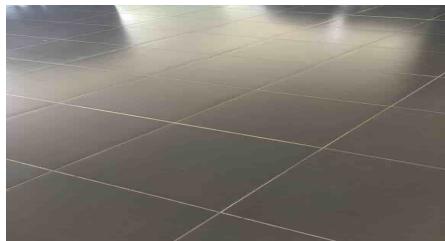
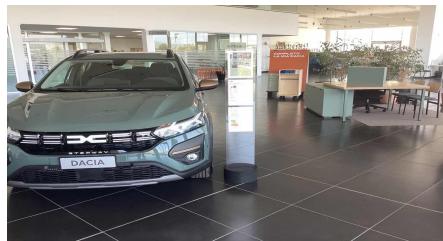
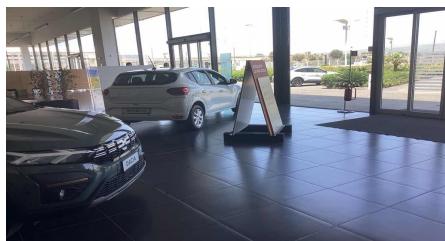
2b - The Dacia showroom is in impeccable condition

***OK - The Dacia showroom is in perfect condition***

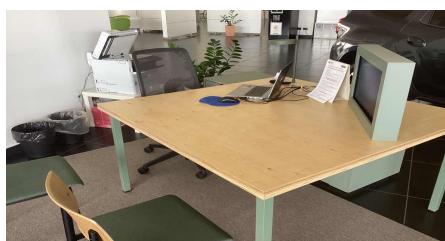
3 - Dacia sales desks are correctly positioned (away from the windows) and in perfect condition

***OK - The Dacia sales desks are correctly positioned and in perfect condition***

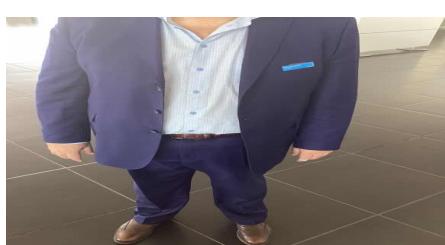
4 - Dacia sales staff wear appropriate and identifiable business attire

***Non indossa i colori conformi (bianco, beige, khaki)***

***KO - Dacia sales staff are not identifiable***

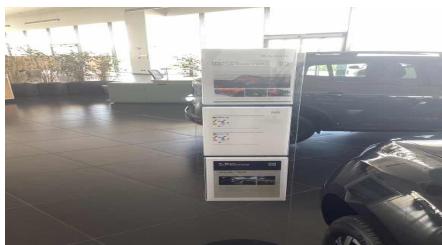
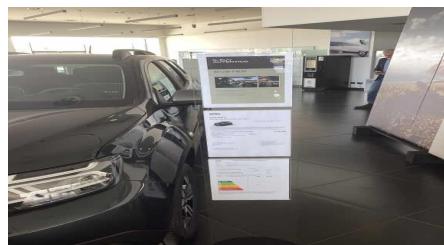
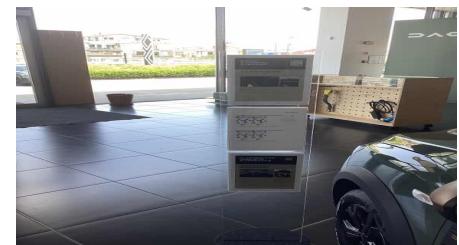
6 - The Dacia product-price display stands are compliant and contains the required information

**OK - The Dacia price display stands are compliant and contain the latest mandatory information**

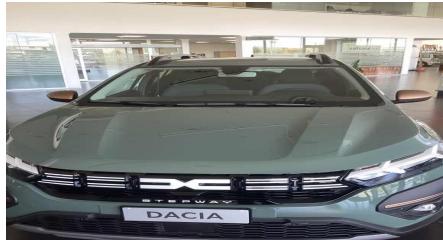
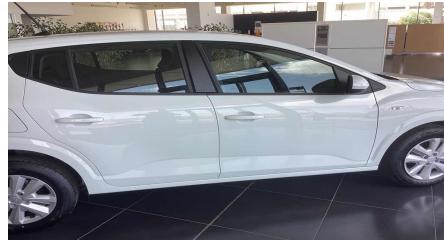
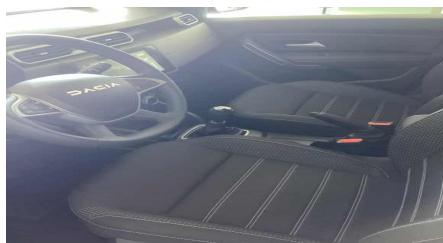
8 - The new Dacia vehicles displayed in the Showroom are in perfect condition

*OK - The Dacia vehicles on display are in perfect condition*

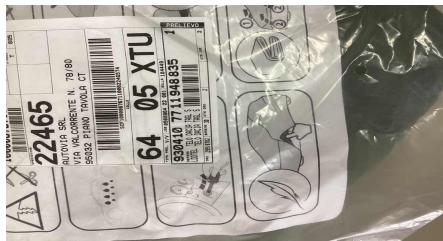
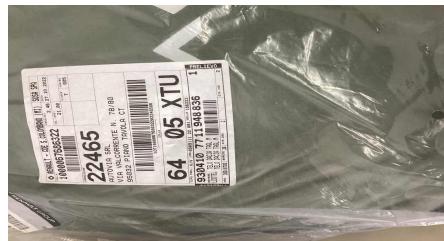
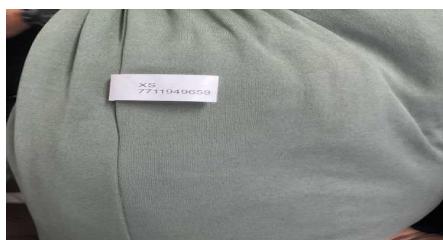
9 - Dacia vehicles to be delivered are presented to customers according to the recommendations (with compliant delivery covers)

*OK - Dacia covers are available in sufficient number and sizes*

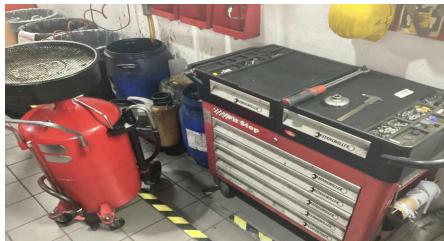
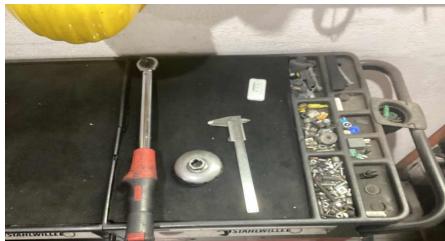
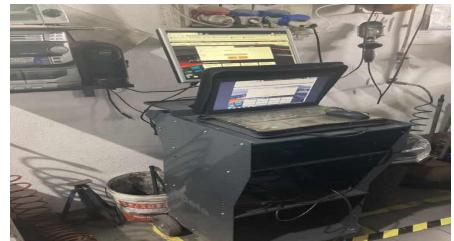
129 - The technician has the equipment and tools at their disposal to carry out vehicle maintenance

**OK - All the equipment and tooling is available to the technician**

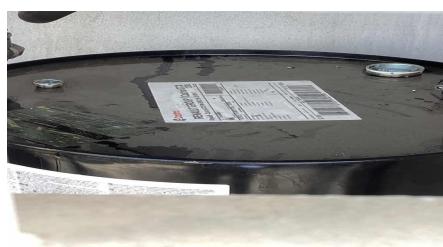
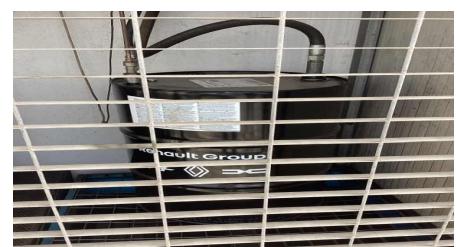
140 - The oil used conforms to the manufacturer's recommendations

***Olio conforme***

***OK - The standard of oil used is in accordance with the ICM sheet***

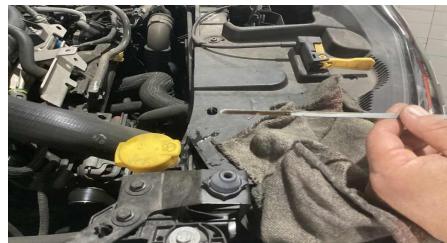
141 - Checking the oil level complies with the manufacturer's recommendations

*OK - The oil level on the dipstick is correct*

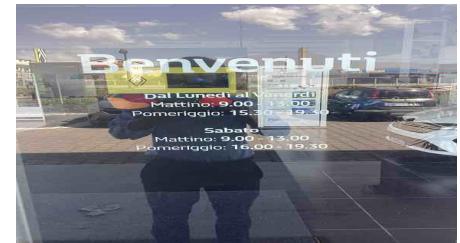
201 - The dealer is correctly represented by Google via his GMB profile X

*Nel GMB è ancora presente la vecchia identità*

**KO - GMB (Google My Business) is not correctly used**

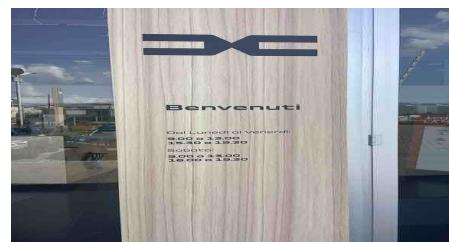
**Non è presente la nuova identità sul GMB**

**KO - GMB (Google My Business) is not correctly used**

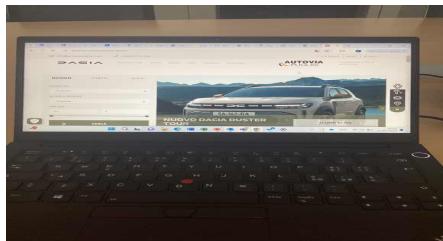
214 - The link in the GMB section redirects to the correct dealer website (ONLY Dacia + group + city) ✓

**OK - The GMB link redirects to the dealer Renault website**

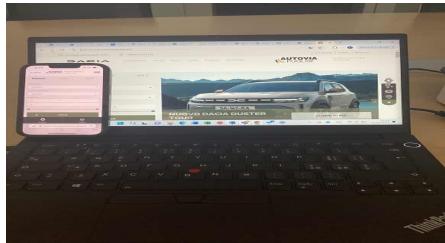
215 - The dealer's website is properly viewable on a tablet or mobile device and images/elements are adjusting and adapting to the specific sizes

**OK - The dealer website works smoothly either on a pc screen, mobile screen, or tablet screen**

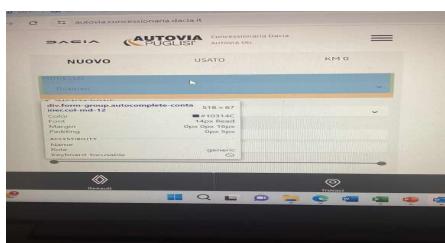
**Colore non conforme**

**KO - as soon as either a color or/and logotype used is/are not the correct one(s)**

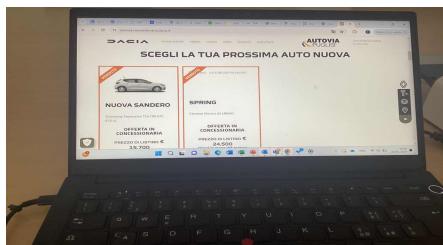
### ***Veicolo assente Veicolo non in posizione 3/4***

**PA - new vehicles visuals respects partially the standards**
