# Dealer Quality Assessment - Detailed Report

| Dealer name | Location |
|---|---|
| BR FRANCE COLORADO | ST SHTQ Trecho 01 Avenida Comercial,<br>Loja 11 - SN<br>71551-010 Brasilia<br>Brazil |
| MENEZES-DAVID CRISTIANE | 14/06/2024 |

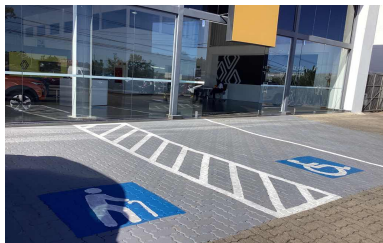
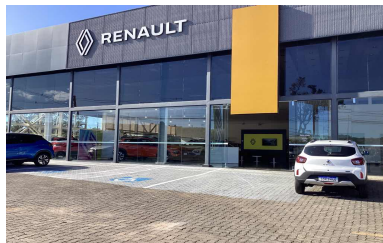
10 - The dealership exterior is in impeccable condition, is clean and is well maintained

*Parte externa atende aos padrões em termos de limpeza e conservação*

*OK - The exterior appearance of the dealership is in impeccable condition*

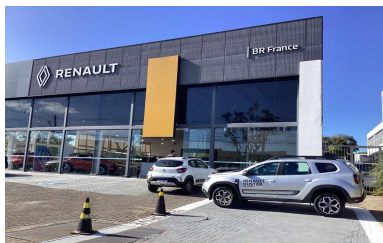
10b - The exterior area respects the visual charter of the Renault brand

*Fachada encontra-se em conformidade com os padrões de identidade visual da marca*

*OK - The exterior area respects the visual charter of the Renault brand*

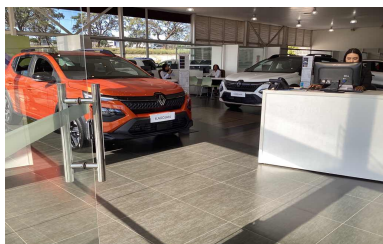
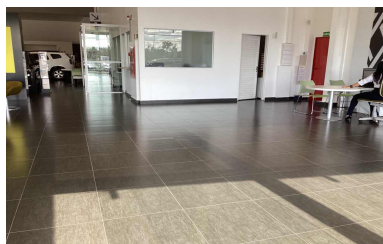
11 - The Renault Showroom Interior is in perfect condition

*OK - The interior appearance of the dealership is in perfect condition*

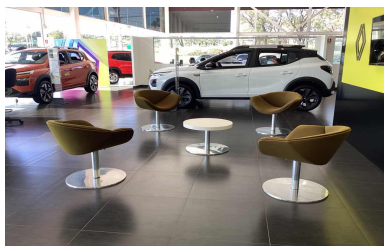
11b - The Showroom respects the visual charter of the Renault brand

***OK - The showroom respects the visual charter of the Renault brand***

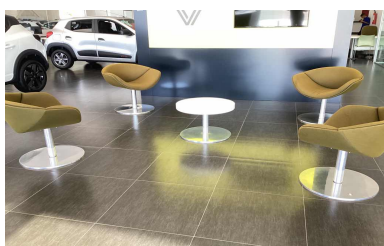
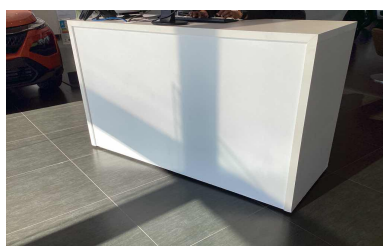
12 - The Renault showroom furniture is clean and well maintained

***OK - The showroom furniture is in good condition and properly maintained***

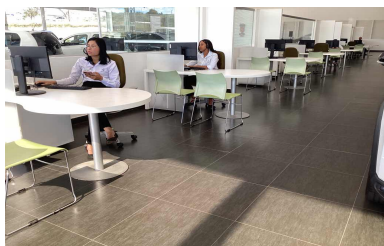
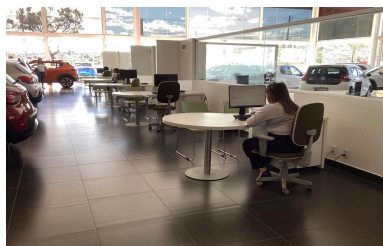
13 - The Renault sales desks are correctly positioned (away from the windows) and in perfect condition

***OK - The sales desk are correctly positioned and in perfect condition***

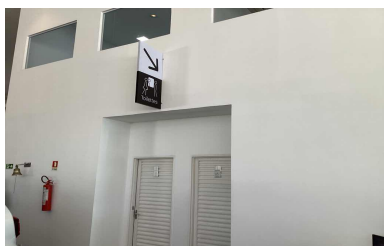
14 - Washrooms / Toilets are available for customer use. They are identified, clean, well lit and usable

***OK - The customer toilets are accessible and in a compliant state***

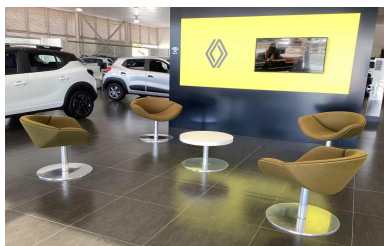
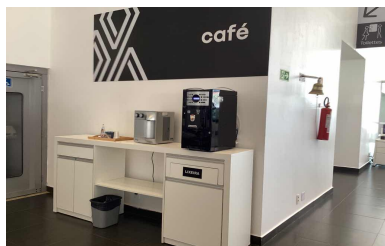
15 - The customer waiting area is suitable for waiting & up to standard

***OK - The furniture in the customer area is clean and compliant as a waiting area***

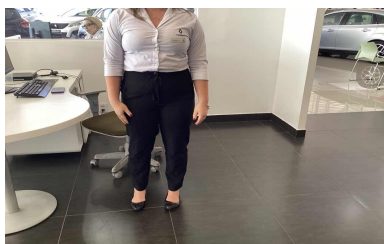
17 - Sales staff wear appropriate and identifiable business attire

***OK - Sales staff are identifiable***

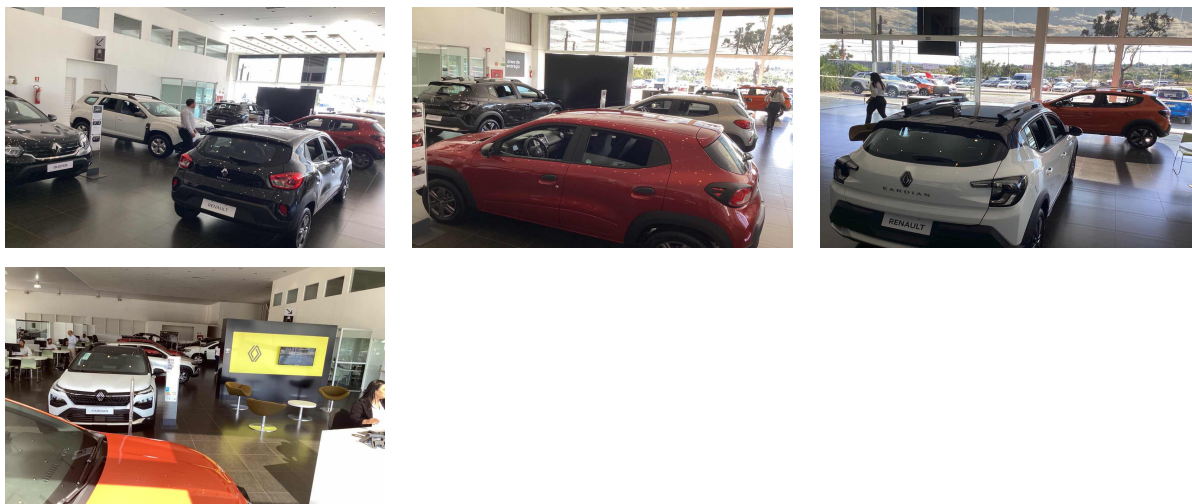
22 - New vehicles are presented according to the Renault brand's standards

**OK - New vehicles are displayed according to the brand's standards**

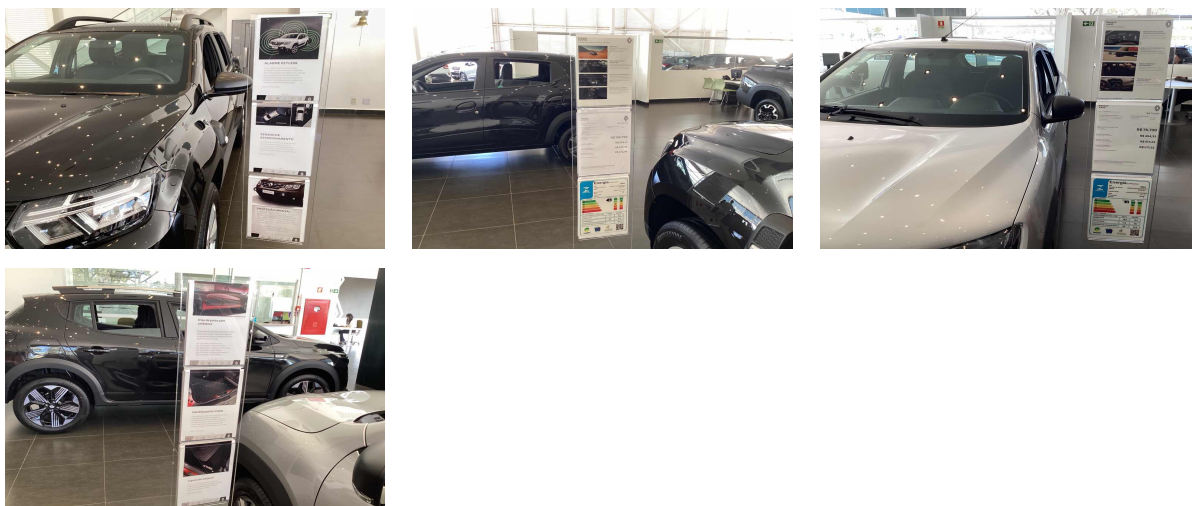
23 - The Renault price-product display stands are compliant

**1 dos totens estava com as informações invertidas (na frente os acessórios, no verso, ficha técnica, preço e emissões)**

**KO - The Renault price displays are not compliant or do not contain the current mandatory information**

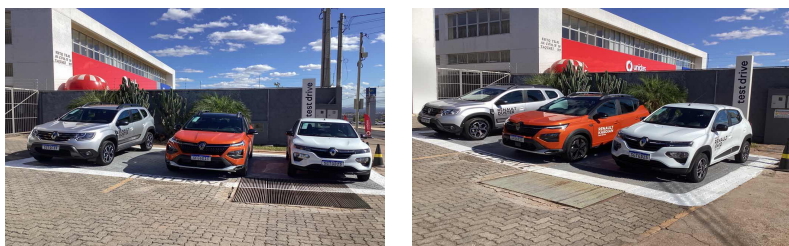
28 - The demonstrator fleet adheres to the model / engine recommendations

**Concessionária segue as orientações da marca para a frota do test drive**

**OK - There is a demonstrator vehicle fleet compliant with the recommendations of the subsidiary**

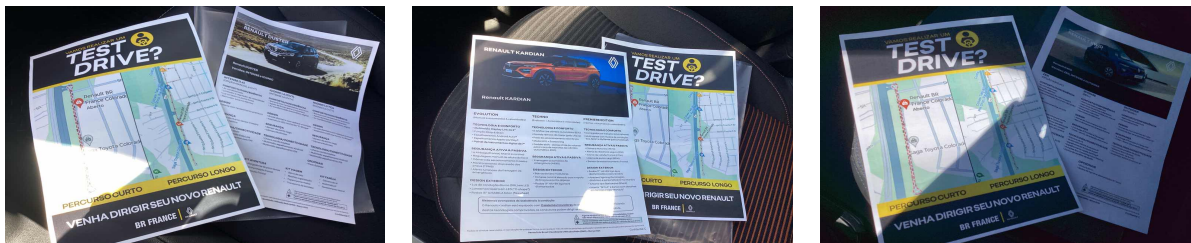
29 - Demonstrator vehicles are present in the Test Drive area and ready to be driven

**OK - The vehicles of the demonstrator fleet are present in the dedicated area, ready to be driven according to the manufacturer's standards**

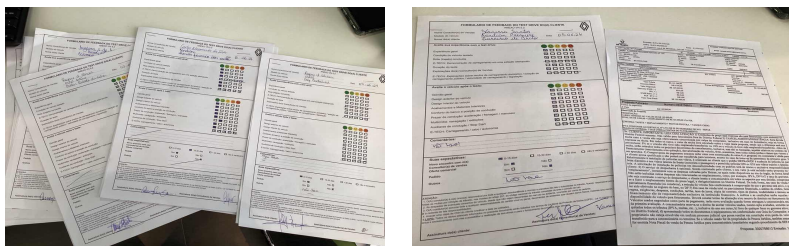
**Fichas são preenchidas e utilizadas para conversão de vendas**

**OK - The qualitative reports following the vehicle tests are all carried out and are in conformity**

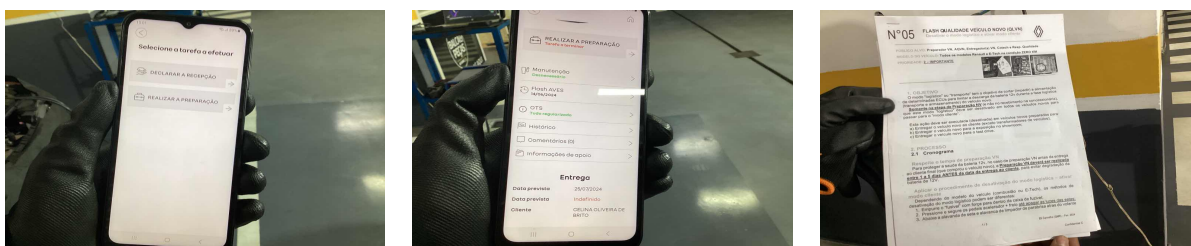
46 - The personnel in charge of preparing the vehicle are aware of the latest technical information

**OK - The person in charge of technical preparation knows the latest information**

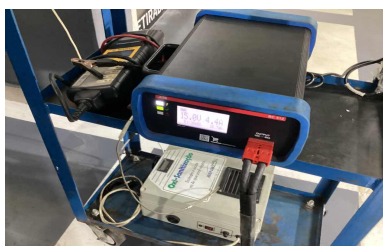
48 - The dealership has recommended chargers in sufficient number

**Concessionária dispõe de 1 carregador Ateq BC512**

**OK - The dealership has the regulatory battery charger and it is fully functional**

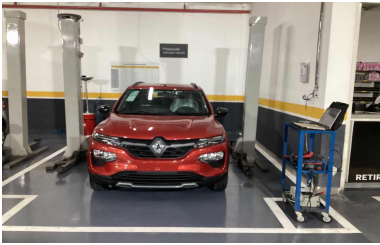
51 - The preparation area meets the manufacturer's standards

**OK - The preparation area complies with the recommendations and is clean and tidy**

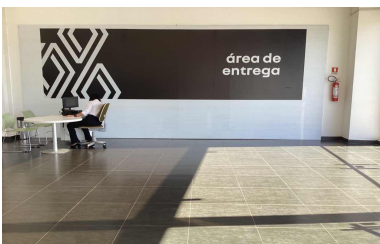
53 - The handover area meets the manufacturer's standards

**OK - The handover area complies with manufacturer standards**

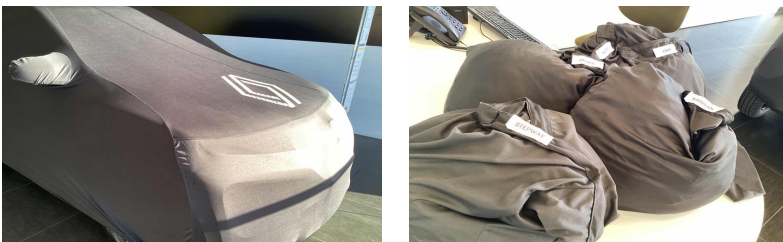
54 - The Renault vehicles to be delivered are presented to the customer according to the recommendations, with the appropriate delivery covers

**OK - covers are present in good number (4 different sizes) and are in good condition**

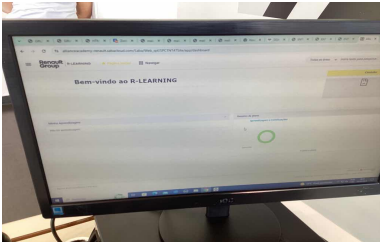
55 - The staff that perform handovers are aware of the latest product innovations and respect manufacturer's recommendations

**Entregadora técnica demonstrou as 5 de acordo com os padrões estabelecidos, entretanto não soube dizer prontamente que consulta os guias de entrega para conhecer os produtos e se atualizar. Citou e mostrou que usa as plataformas da Renault, como o R-Learning.**

**KO - The person in charge of the handover doesn't know the 5-step method, and/or doesn't know the latest product innovations**

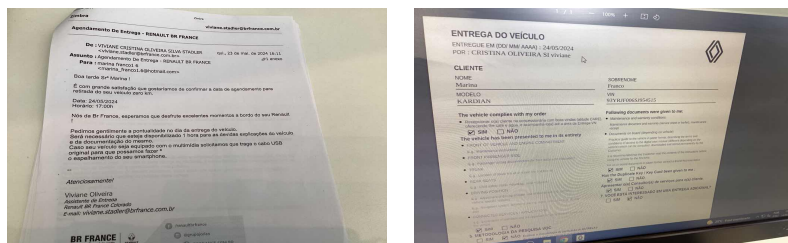
**Mensagem de confirmação é enviada ao cliente 24 horas antes da entrega do VN**

**OK - Customers are systematically contacted 24 hours before delivery as a reminder**

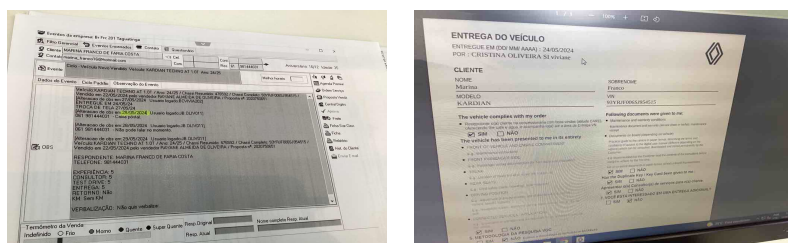
41b - The delivery date is planned taking into account the preparation process of the vehicle (assembly of accessories)

**Mensagem é enviada ao cliente em tempo hábil**

**OK - Customers systematically receive a post-delivery call and this is followed up by the Sales Manager**

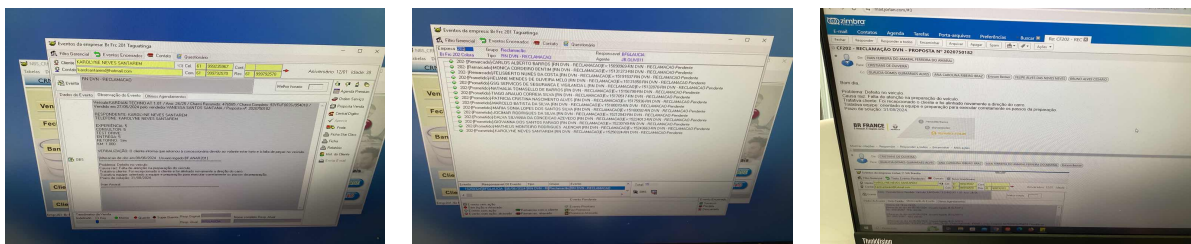
57 - There is an internal or company procedure for dealing with customer issues or complaints

**Reclamações são registradas no CRM, que envia os eventos ao gestor e à gerente de qualidade e acompanha as tratativas.**

**OK - There is an up-to-date customer complaints log**

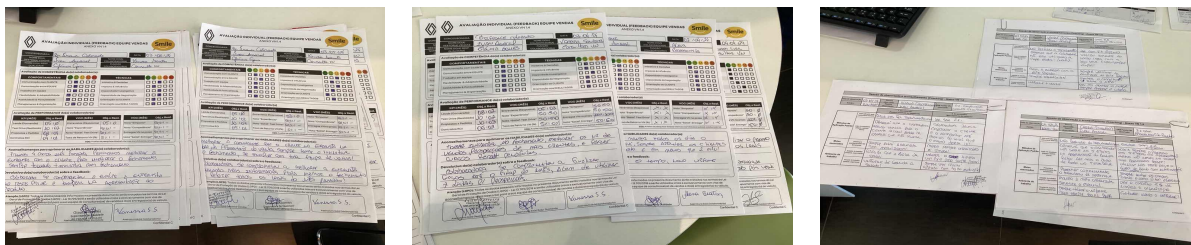
58 - The Sales Manager organizes individual reviews regularly & specific coaching sessions to improve the skills of the team

**Avaliações individuais de desempenho e reuniões de feedback são realizadas mensalmente, bem como sessões de aconselhamento ocorrem regularmente**

**OK - There is a planned and formalized coaching approach for sales staff**

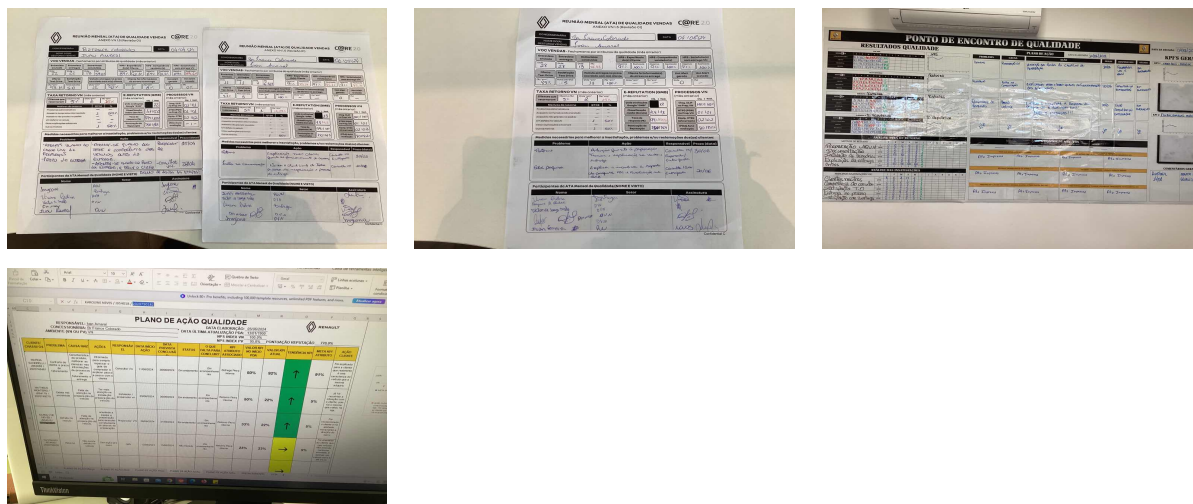
60 - There is a monthly meeting to review the latest quality data on NV activity & gives rise to the necessary measures to improve the situation

**Reuniões de qualidade ocorrem uma vez ao mês e geram planos de ação**

**OK - A formalized quality meeting is carried out every month & give rise to measurable action plans**

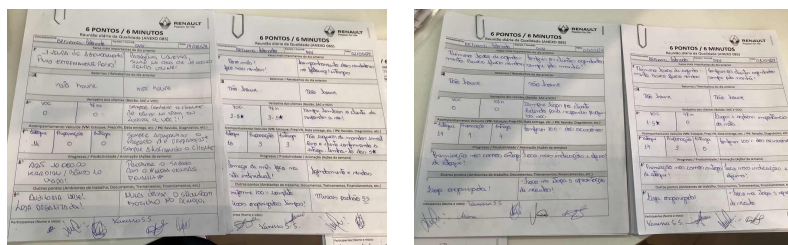
63 - There are brief daily meetings to drive sales and quality

**Reuniões diárias são conduzidas sistematicamente**

**OK - The Sales Manager leads a short daily meeting in front of a tracking board or digital support**

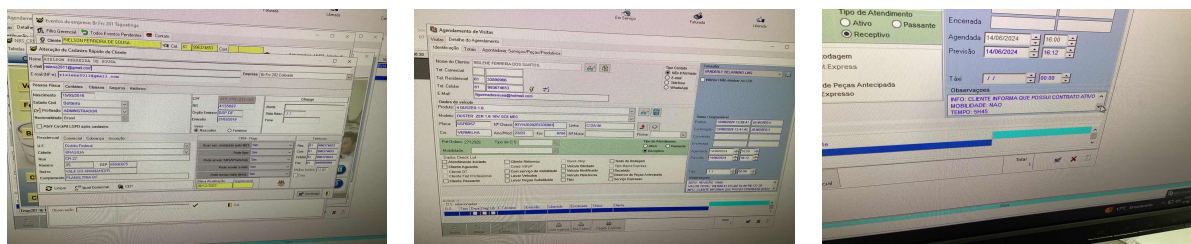
*Dados do cliente e informações do veículo são registrados e confirmados, assim como soluções de mobilidade são oferecidas e confirmadas na recepção*

*OK - When making the appointment, all customer data/vehicle information is are documented and alternative mobility solutions are offered*

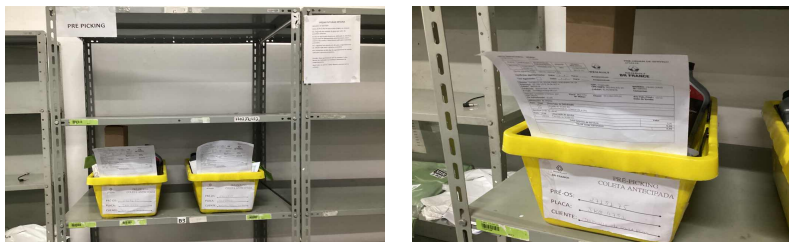
***Peças são separadas no dia anterior e estão disponibilizadas corretamente***

***OK - Spare parts are always prepared in advance and are made available to the workshop in labelled boxes or lockers***

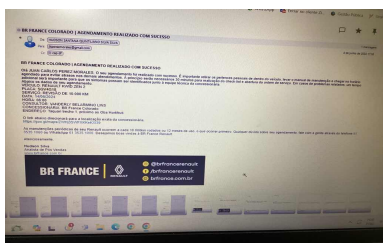
111 - The customer receives confirmation of their appointment by SMS or email

***Mensagem de confirmação do agendamento é enviada sistematicamente ao cliente***

***OK - The customer systematically receives an appointment confirmation***

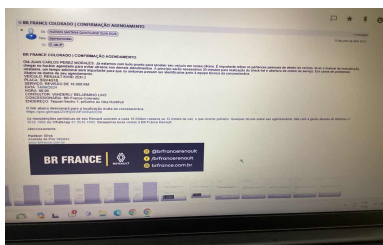
112 - The customer is contacted the day before as a reminder of their appointment

***Lembrete do agendamento é enviado em D-1***

***OK - The customer is systematically contacted the day before the appointment and there is a trace of the confirmation***

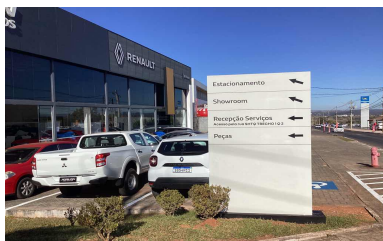
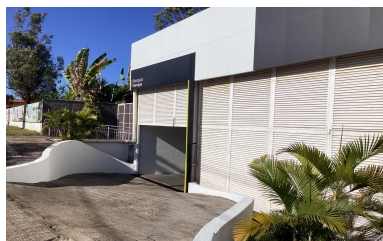
113 - Access to the after-sales services is identifiable upon arrival at the dealership

***Acesso de fácil identificação***

***OK - Access to the after-sales services is identifiable upon arrival at the dealership***

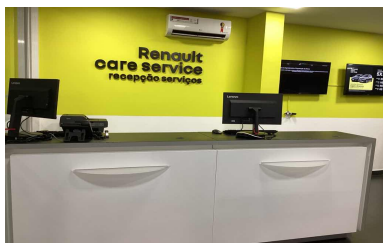
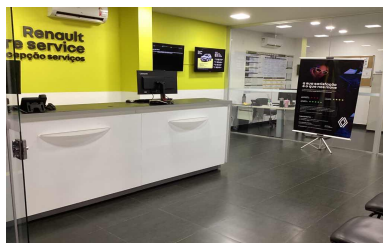
114 - The reception area complies with the brand's recommendations and is in impeccable condition

***OK - The reception area complies with the standards and is perfectly maintained***

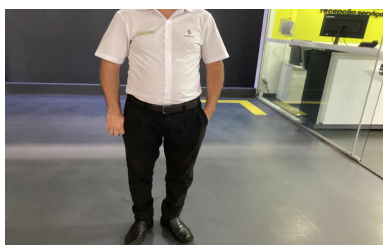
115 - Front-office staff wear appropriate business attire to allow customers to identify them

***OK - All front-office staff wear standard badges and uniforms***

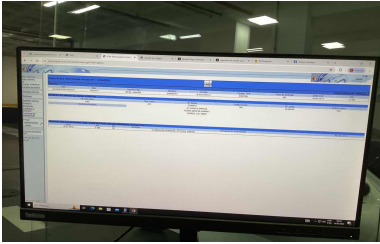
*OTS consultada na recepção na presença do cliente*

*OK - The Service Advisor consults the OTS screen in ICM*

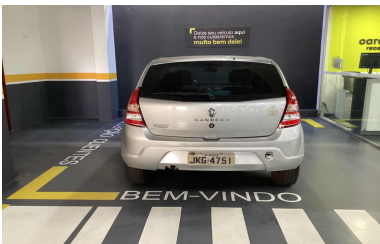
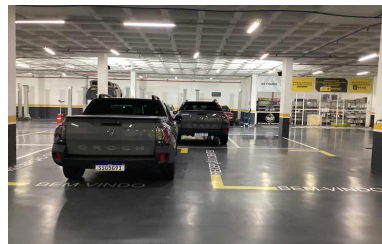
118 - The vehicle inspection area is present and complies with the recommendations

*OK - The vehicle inspection area is in perfect condition and complies with the recommendations*

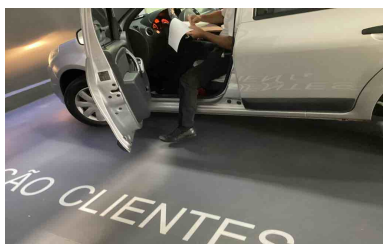
119 - During the reception, a vehicle inspection done according to the standard is systematically carried out

***OK - The vehicle inspection is systematically carried out respecting the manufacturer standards***

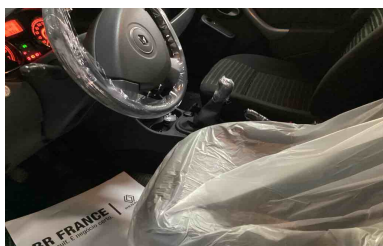
120 - Customer vehicles are properly protected and disinfected

***OK - All the driving seat position protections are fitted correctly***

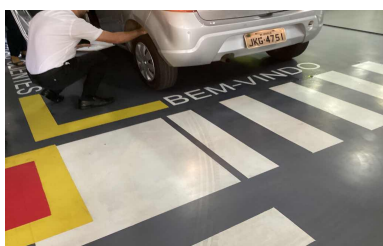
122 - The Service Advisor checks all points outside the vehicle

***OK - All of the vehicle's exterior points are checked as per the standards***

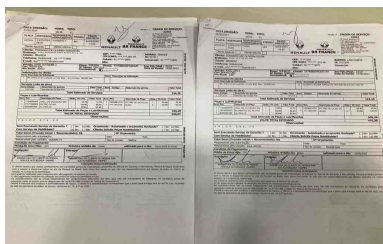
124 - For each intervention there is a price commitment to the customer

**Preço total e detalhado presente em todas as OSs checadas**

**OK - Overall price and detailed prices are correctly noted in checked files and Repair Orders are signed by customers**

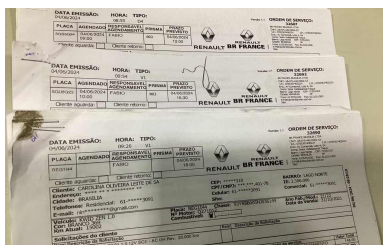
125 - In the files, estimated collection times are noted and personalized

**Horários previstos para retirada são personalizados**

**OK - In the files, the estimated collection times are noted and personalized to the customer**

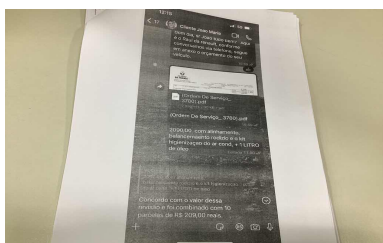
**Mensagem é enviada ao cliente quando há serviço adicional**

**OK -The customer is systematically contacted to inform them of additional work**

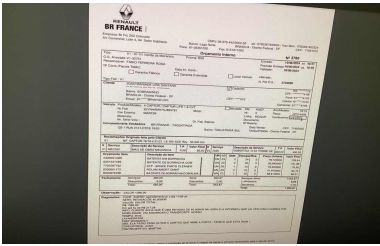
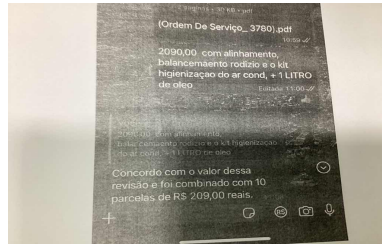
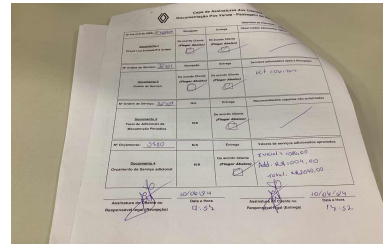
128 - In case of additional work, a quote is systematically done and transmitted to the customer

**Orçamento é enviado ao cliente e aprovação ou reprovação são registrados**

**OK - An additional estimate is systematically sent to the customer**

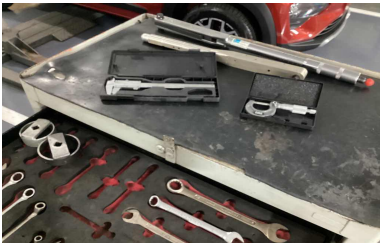
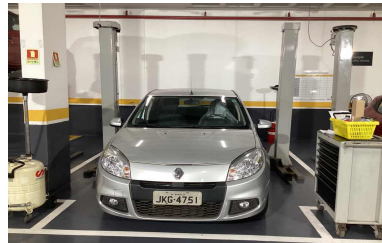
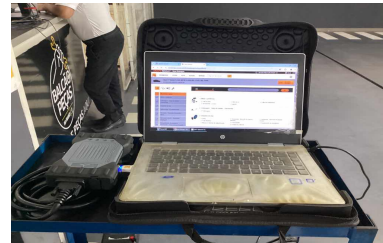
129 - The technician has the equipment and tools at their disposal to carry out vehicle maintenance

**OK - All the equipment and tooling is available to the technician**

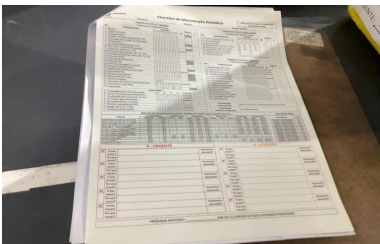
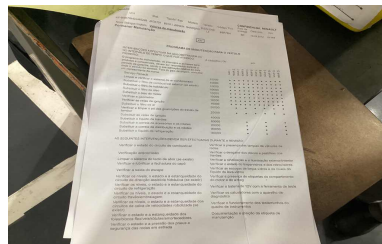
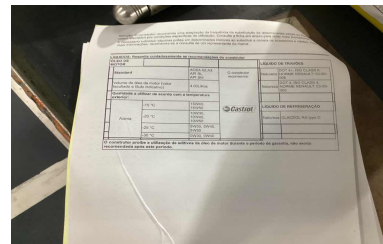
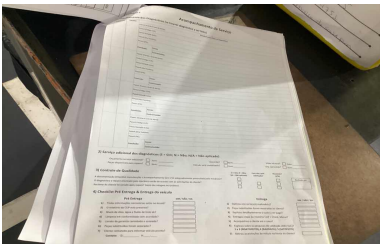
130 - The technician has all the documents at their disposal to carry out vehicle maintenance

**OK - The technician has the documents necessary to carry out the service and refers to them**

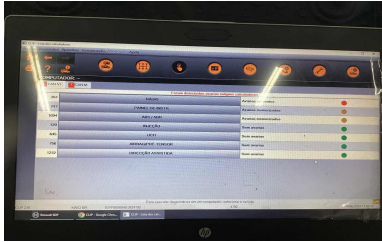
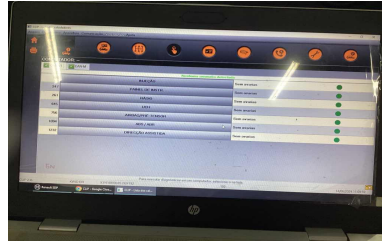
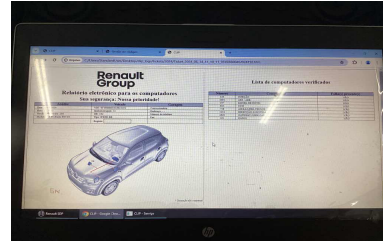
133 - An electronic assessment of the vehicle is carried out (only for RENAULT cars)

***OK - The assessment of the vehicle's electronic control units (ECU) was carried out during the observed service***

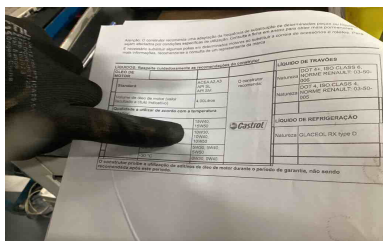
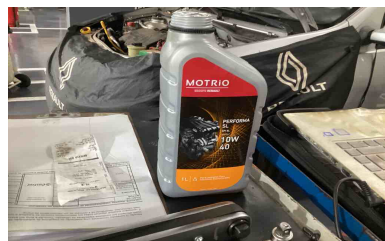
140 - The oil used conforms to the manufacturer's recommendations

**Técnico mecânico demonstra utilizar o programa de manutenção do ICM para verificar o óleo a ser utilizado (no serviço presente: 10W40)**

**OK - The standard of oil used is in accordance with the ICM sheet**

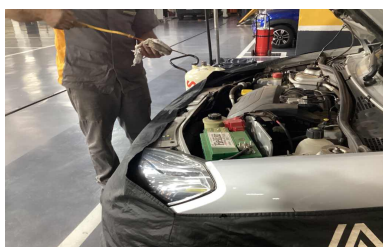
141 - Checking the oil level complies with the manufacturer's recommendations

**OK - The oil level on the dipstick is correct**

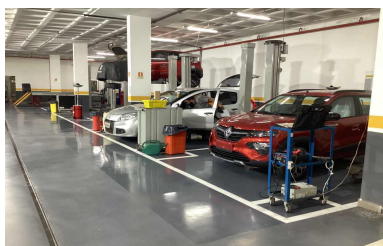
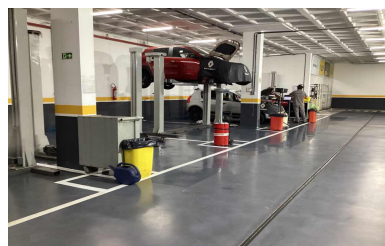
142 - The workshop is clean and tidy

**OK - The workshop is clean and tidy**

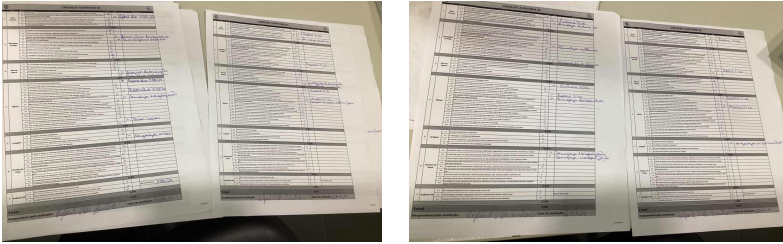
143 - Measures exist to ensure workshop cleanliness

**Concessionária utiliza metodologia 5S para o controle da limpeza e organização da oficina**

**OK - There are procedures in place to ensure long-term workshop cleanliness**

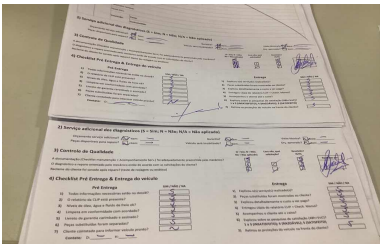
145 - The quality of the work carried out is checked

**OK - A quality control of the work carried out is performed regularly using the standard document**

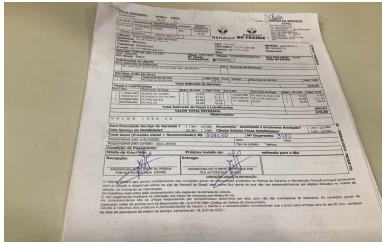
**1 dossiê de serviço executado não continha o relatório da avaliação eletrônica com a Clip (revisão 50.000KM)**

**PA - One of the files checked was incomplete**

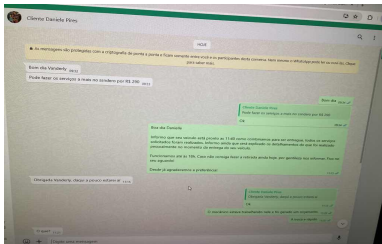
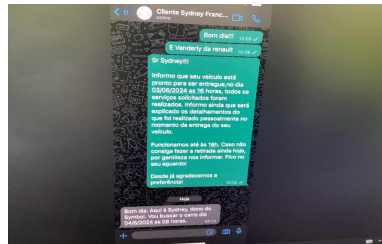
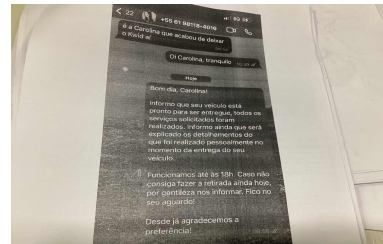
148 - A message is sent to inform the customer of the availability of their vehicle

**Cliente é contatado quando veículo está pronto para retirada**

**OK - The call or text message to the customer to let them know that their vehicle is ready for collection is evidenced in the file**

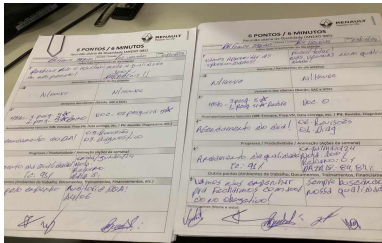
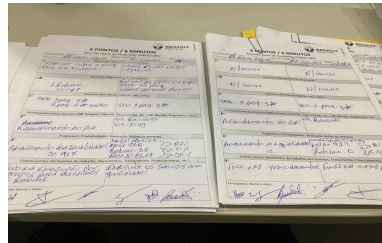
**Reuniões diárias são conduzidas sistematicamente**

**OK - A daily briefing is carried out**

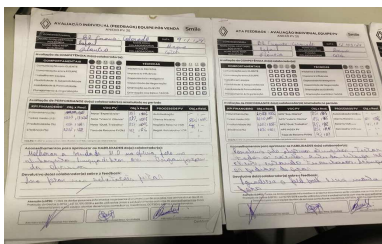
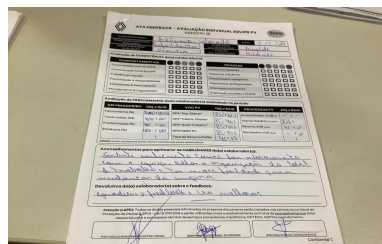
**Gestor realiza bimestralmente avaliações individuais de desempenho, utiliza também como base comportamento observado no período**

**OK - Coaching sessions are organised regularly**

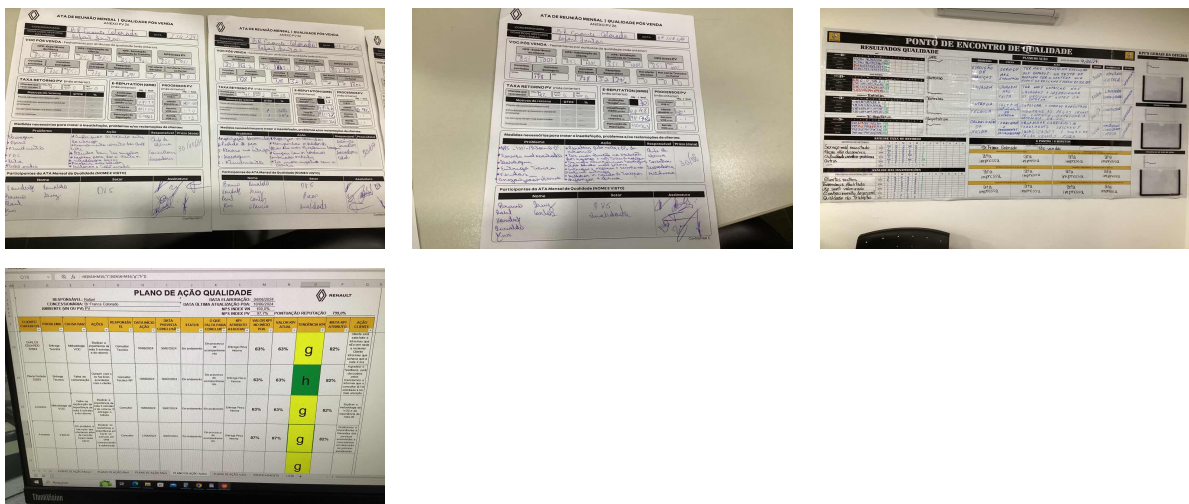
151 - A formalized AFS quality meeting is carried out every month & actions to improve quality have been put in place

**Reuniões de qualidade ocorrem 1 vez ao mês e geram planos de ação**

**OK - Quality meetings are organised every month with measurable actions**

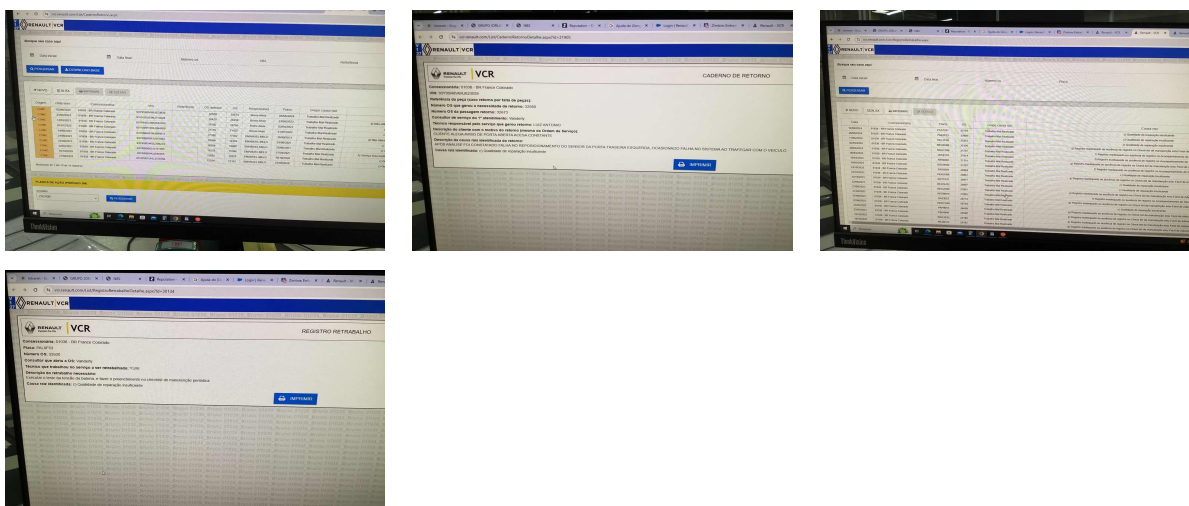
156 - There is a follow-up of returns and alterations for non-compliance of work

**Retornos e retrabalhos são registrados e acompanhados no sistema VCR**

**OK - The returns log/booklet is compliant and up to date**

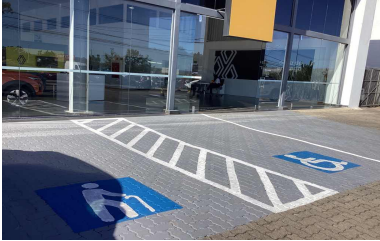
10 - The dealership exterior is in impeccable condition, is clean and is well maintained

*Parte externa atende aos padrões em termos de limpeza e conservação*

*OK - The exterior appearance of the dealership is in impeccable condition*

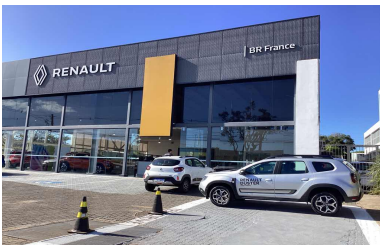
10b - The exterior area respects the visual charter of the Renault brand

*Fachada encontra-se em conformidade com os padrões de identidade visual da marca*

*OK - The exterior area respects the visual charter of the Renault brand*

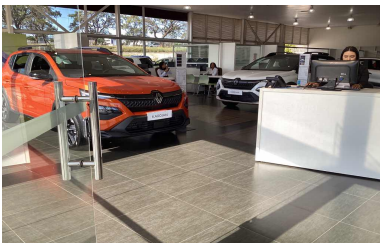
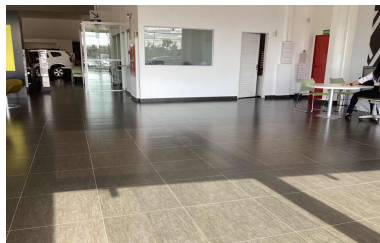
11 - The Renault Showroom Interior is in perfect condition

*OK - The interior appearance of the dealership is in perfect condition*

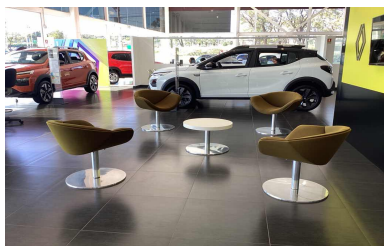
11b - The Showroom respects the visual charter of the Renault brand

***OK - The showroom respects the visual charter of the Renault brand***

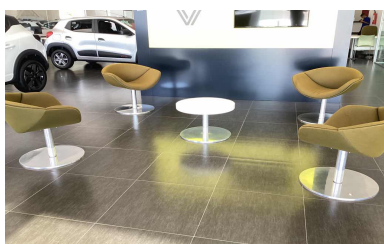
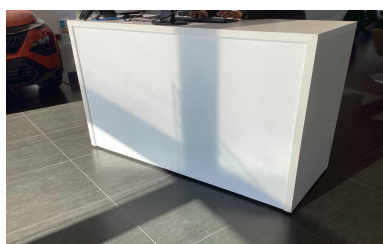
12 - The Renault showroom furniture is clean and well maintained

***OK - The showroom furniture is in good condition and properly maintained***

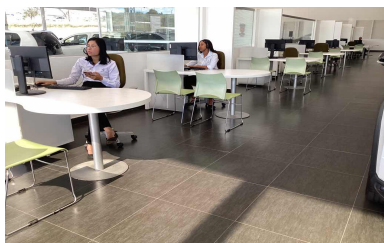
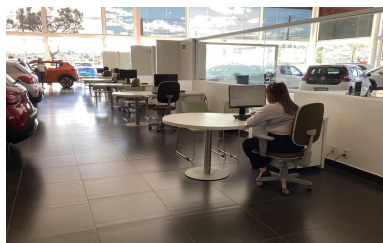
13 - The Renault sales desks are correctly positioned (away from the windows) and in perfect condition

***OK - The sales desk are correctly positioned and in perfect condition***

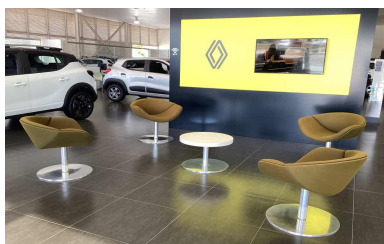
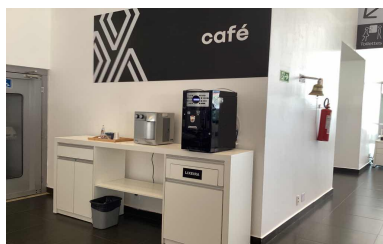
15 - The customer waiting area is suitable for waiting & up to standard

***OK - The furniture in the customer area is clean and compliant as a waiting area***

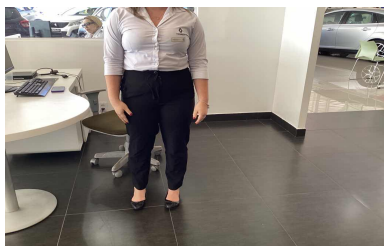
17 - Sales staff wear appropriate and identifiable business attire

***OK - Sales staff are identifiable***

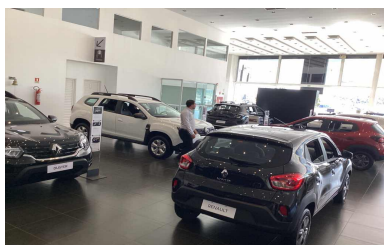
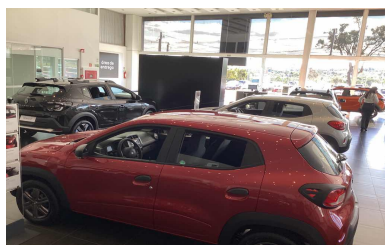
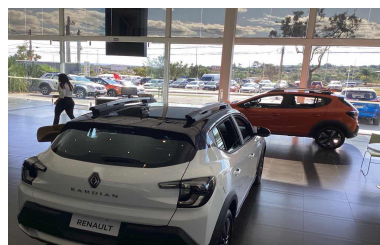
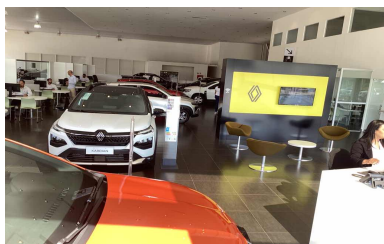
22 - New vehicles are presented according to the Renault brand's standards

***OK - New vehicles are displayed according to the brand's standards***

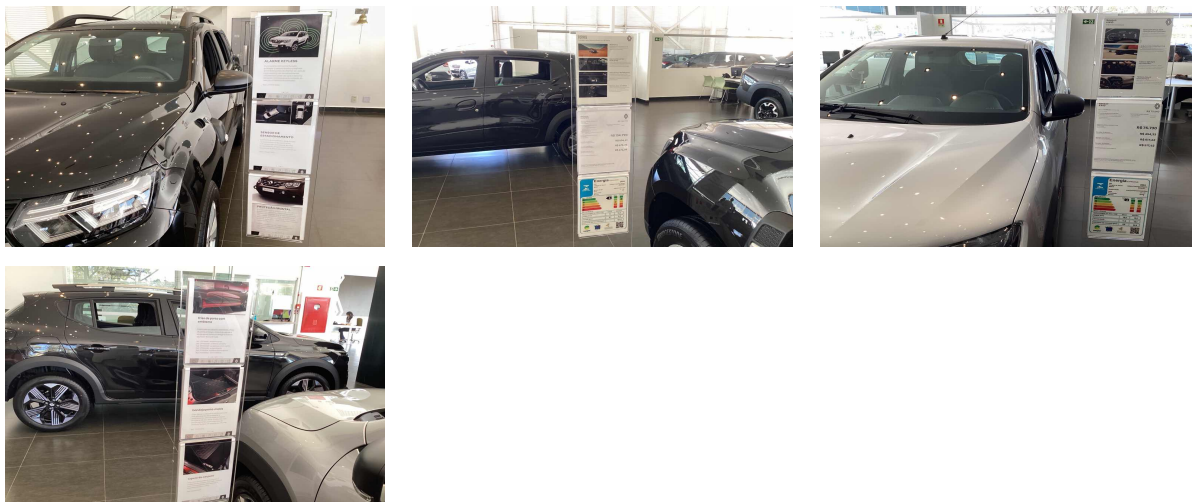
*1 dos totens estava com as informações invertidas (na frente os acessórios, no verso, ficha técnica, preço e emissões)*

**KO - The Renault price displays are not compliant or do not contain the current mandatory information**

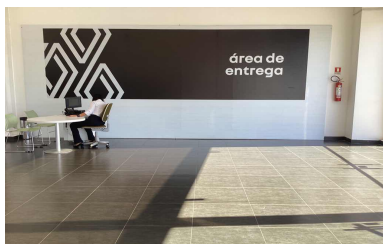
53 - The handover area meets the manufacturer's standards

**OK - The handover area complies with manufacturer standards**

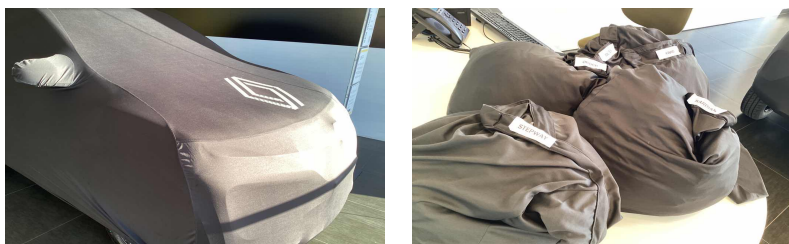
54 - The Renault vehicles to be delivered are presented to the customer according to the recommendations, with the appropriate delivery covers

***OK - covers are present in good number (4 different sizes) and are in good condition***

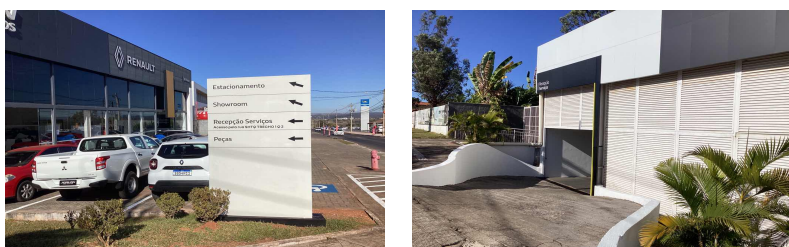
113 - Access to the after-sales services is identifiable upon arrival at the dealership

***Acesso de fácil identificação***

***OK - Access to the after-sales services is identifiable upon arrival at the dealership***

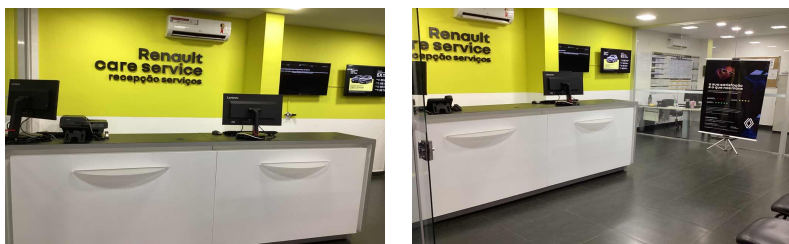
114 - The reception area complies with the brand's recommendations and is in impeccable condition

***OK - The reception area complies with the standards and is perfectly maintained***

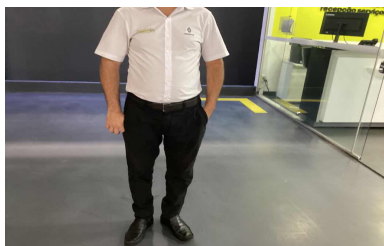
115 - Front-office staff wear appropriate business attire to allow customers to identify them

***OK - All front-office staff wear standard badges and uniforms***

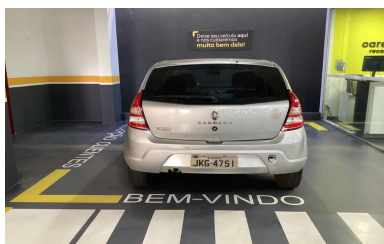
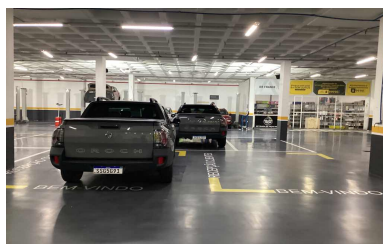
118 - The vehicle inspection area is present and complies with the recommendations

***OK - The vehicle inspection area is in perfect condition and complies with the recommendations***

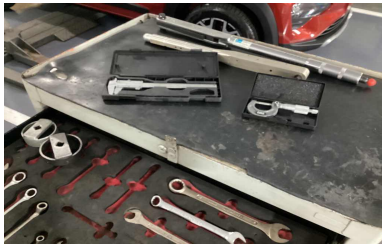
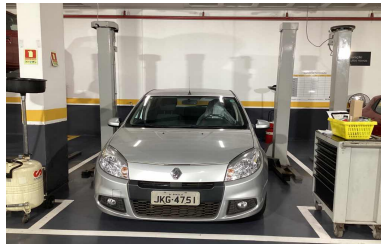
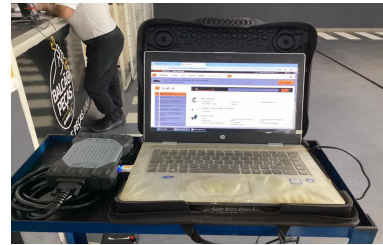
129 - The technician has the equipment and tools at their disposal to carry out vehicle maintenance

**OK - All the equipment and tooling is available to the technician**

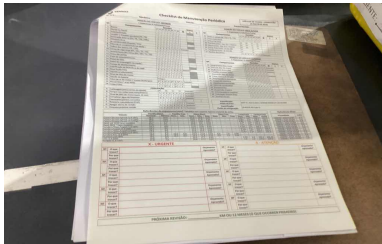
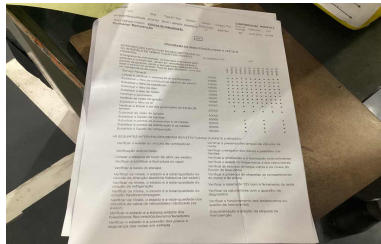
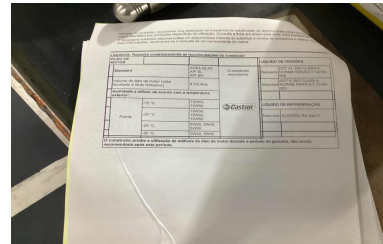
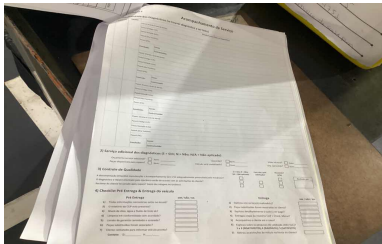
130 - The technician has all the documents at their disposal to carry out vehicle maintenance

**OK - The technician has the documents necessary to carry out the service and refers to them**

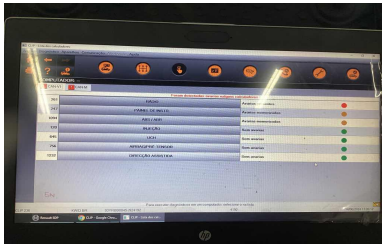
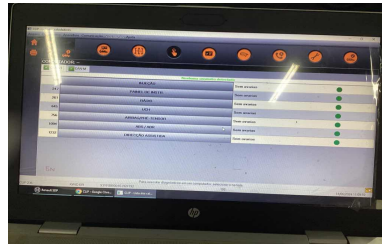
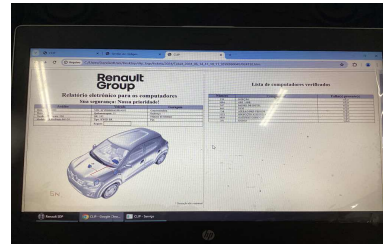
133 - An electronic assessment of the vehicle is carried out (only for RENAULT cars)

***OK - The assessment of the vehicle's electronic control units (ECU) was carried out during the observed service***

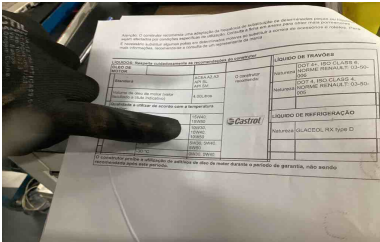
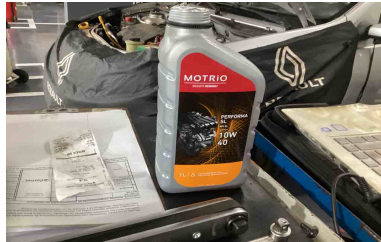
140 - The oil used conforms to the manufacturer's recommendations

***Técnico mecânico demonstra utilizar o programa de manutenção do ICM para verificar o óleo a ser utilizado (no serviço presente: 10W40)***

***OK - The standard of oil used is in accordance with the ICM sheet***

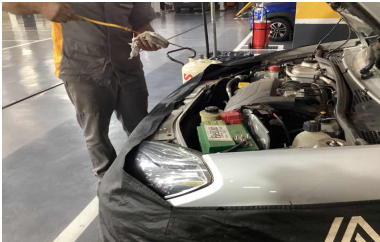
141 - Checking the oil level complies with the manufacturer's recommendations

***OK - The oil level on the dipstick is correct***

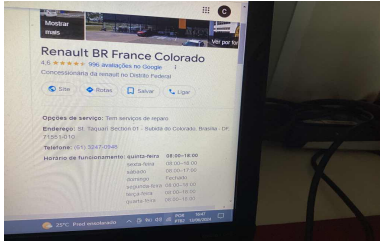
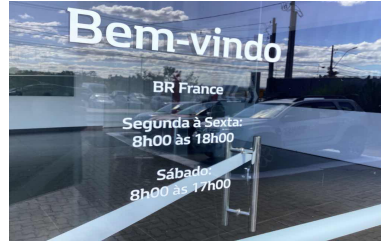
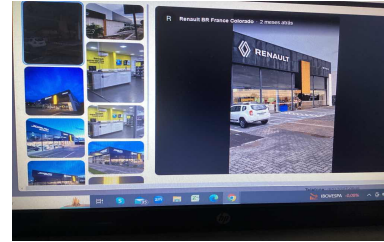
201 - The dealer is correctly represented by Google via his GMB profile

**OK - GMB (Google My Business) is correctly used**

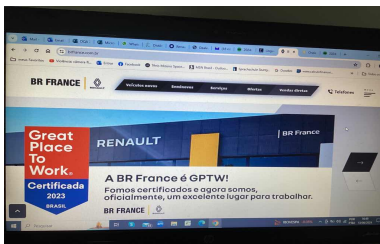
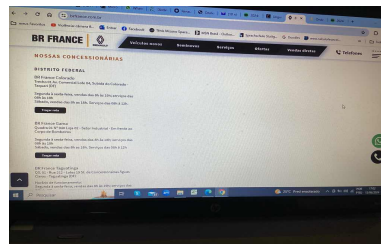
202 - The link in the GMB section redirects to the correct dealer website (ONLY Renault + group + city)

**Link do GMB direciona o cliente para o site do grupo**

**KO - The GMB link does not redirect (directly) to the good dealer Renault website**

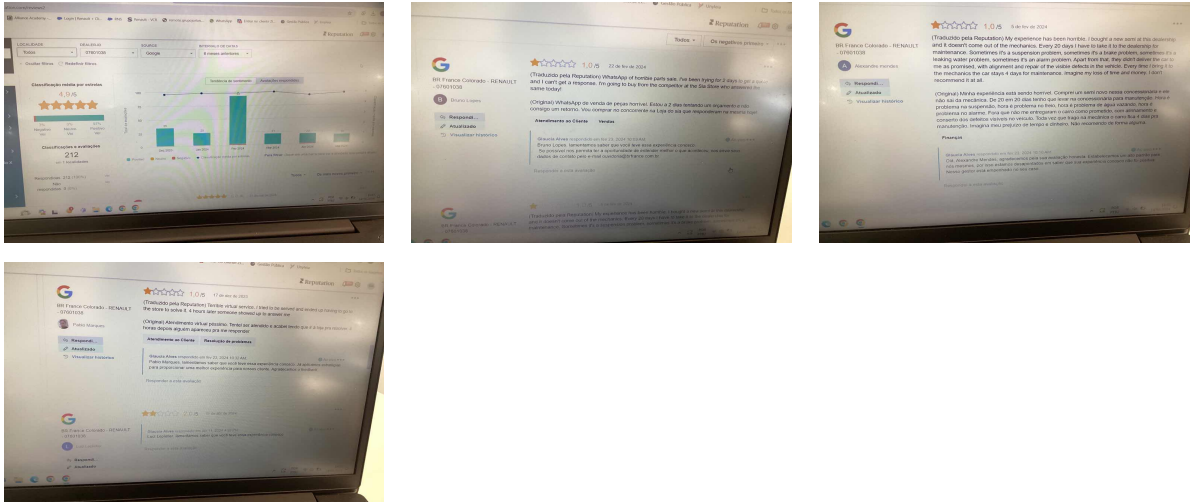
211 - The Sales and After Sales Manager ensures all customer-submitted Google RENAULT Reviews are responded on time and answers are qualitative

**Avaliações são 100% respondidas, porém as respostas parecem não ser personalizadas**

**KO - review(s) do(es)n't have a response on time or the answer(s) is/are not qualitative**

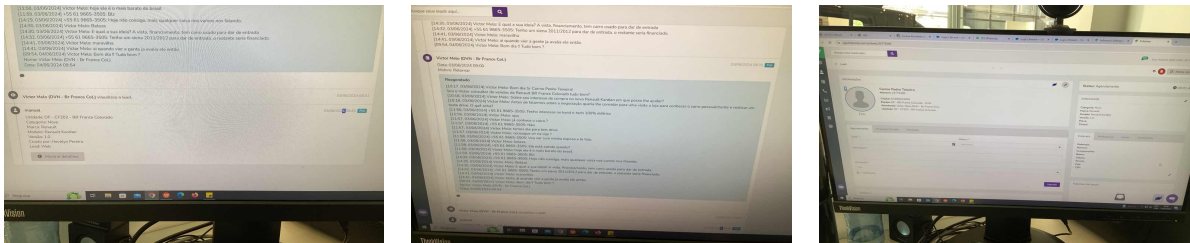
212 - Renault Internet customer requests are processed according to the standard

**Leads são atendidos em tempo hábil e de acordo com os padrões**

**OK - Internet requests are processed on time and personalized**

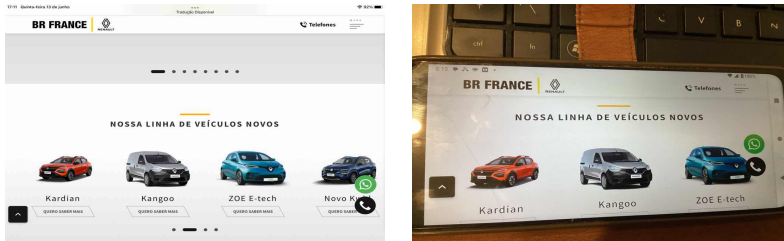
**Site não apresenta alterações quando acessado de outros dispositivos. Avaliação feita no site do grupo.**

**OK - The dealer website works smoothly either on a pc screen, mobile screen, or tablet screen**

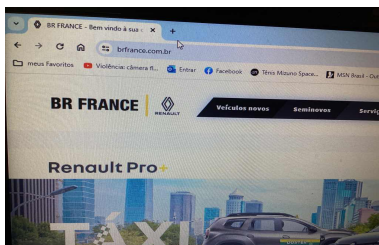
204 - The URL specify RENAULT with the correct RENAULT favicon

**Ícone da Renault na URL não corresponde ao padrão; nome Renault não é visível. Avaliação feita no site do grupo.**

**KO - favicon & 'Renault' in the URL don't appear**

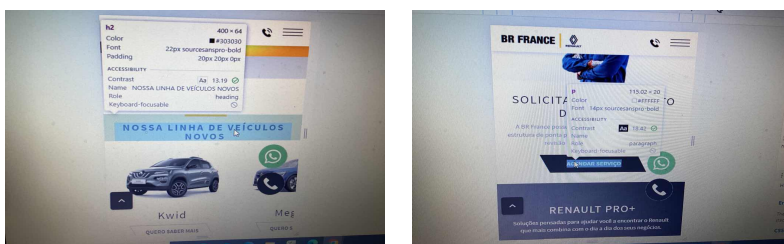
205 - The website uses the official Renault colors and logotypes

**Logotipos estão corretos, mas as cores do site não atendem aos padrões. Avaliação feita no site do grupo.**

**KO - as soon as either a color or/and logotype used is/are not the correct one(s)**

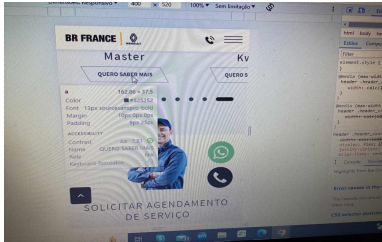
206 - The website has only the official Renault fonts and graphical user interface (GUIs)

**Fontes utilizadas e GUIs não estão em conformidade com os padrões da marca. Avaliação feita no site do grupo.**

**KO - Either the font or/and GUIs are not the right ones**
