# Dealer Quality Assessment - Detailed Report

| Dealer name | Location |
|---|---|
| BR FRANCE COLORADO | ST SHTQ Trecho 01 Avenida Comercial,<br>Loja 11 - SN<br>71551-010 Brasilia<br>Brazil |
| MENEZES-DAVID CRISTIANE | 14/06/2024 |

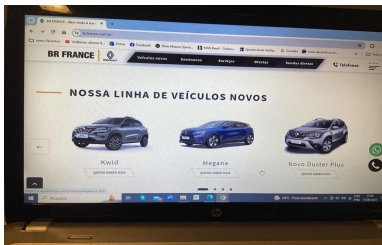
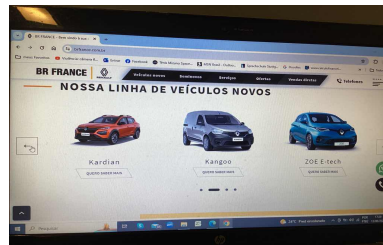
**Angulação dos veículos não corresponde à preconizada (3/4); ordem de apresentação dos veículos não é a correta, além de não estarem separados por tipo de veículo (passeio, comercial, e-tech). Avaliação feita no site do grupo.**

**KO - new vehicles visuals don't respect the standards**

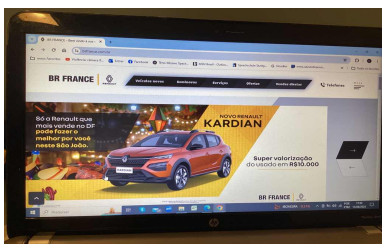
208 - The elements (navigation, hero, etc) on the homepage are in the recommended position

**Logotipos não estão corretamente posicionados; nome da cidade/bairro não vem descrito. Avaliação feita no site do grupo.**

**KO - The dealer website doesn't respects the recommendations in the guides and all criterias are not met**

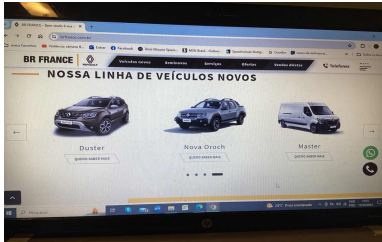
*Avaliação feita no site do grupo.*

*OK - brand exclusivity and price display policy are respected*

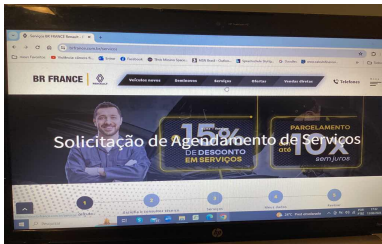
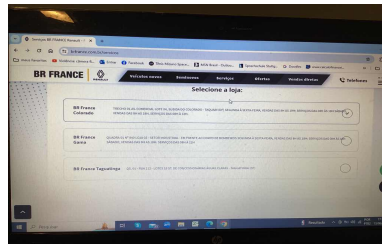
*O horário do serviço oferecido não está presente Avaliação feita no site do grupo.*

*PA - all offers & services are presented, but there is some missing information*
