# Kinematic and Dynamic Behavior of a Coastal Colluvial Landslide in a Low-Elevation Forest

Chia-Cheng Fan <sup>1,\*</sup>, Chung-Jen Yang <sup>1</sup>, Tsung-Hsien Wang <sup>2</sup> and Kuo-Wei Huang <sup>3</sup><sup>1</sup> Department of Construction Engineering, National Kaohsiung University of Science and Technology, Kaohsiung 824, Taiwan<sup>2</sup> SINOTECH Engineering Consultants, Ltd., Taipei 105, Taiwan; f107106111@gmail.com<sup>3</sup> Water Resources Bureau, Kaohsiung City Government, Kaohsiung 824, Taiwan

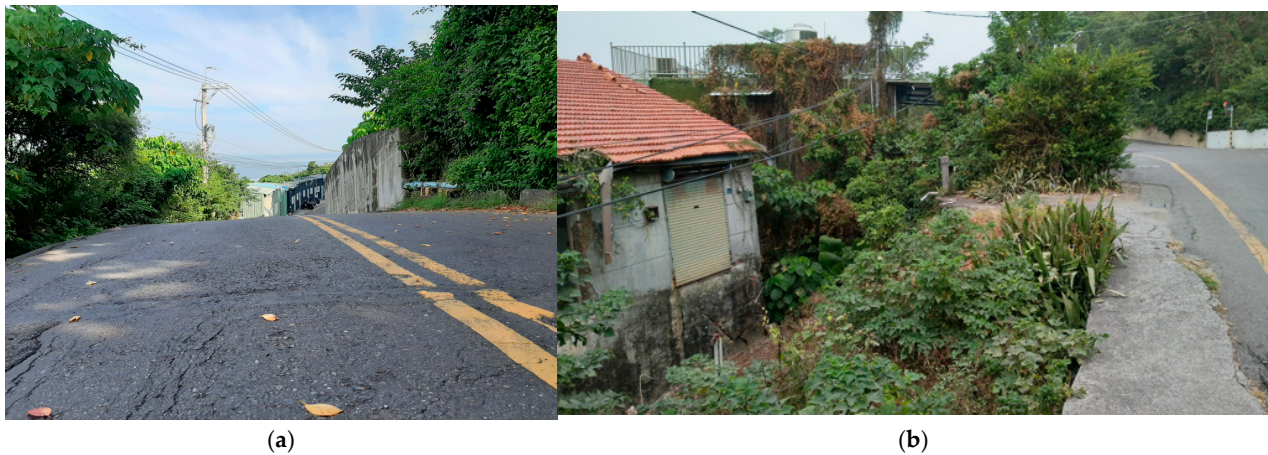
not available. Figure 2b depicts a building that has undergone lateral displacement of 3–4 m from its original location adjacent to the road.

**Figure 2.** Slope displacement at the landslide site: (a) significant subsidence on the paved road and (b) significant lateral movement and subsidence of a village house (away from the paved road).
