| | <b>QUALITY REPORT - FINAL INSPECTION</b><br><b>QUALITY CONTROL DEPARTMENT</b> | CODIGO/CODE | CORP-CAL-CF-001 |

| <b>CERTIFICATE NUMBER :</b> | <b>716108</b> | | |
| <b>CLIENT:</b> | BENTELER DE MEXICO SA DE CV | <b>PRODUCTION ORDER:</b> | 000011316133 |
| <b>VEHICLE:</b> | BMW X5 4D UTILITY | <b>COMPOSITION:</b> | L31-1 |

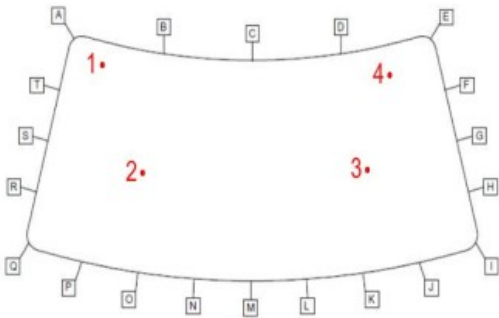
| ITEM | ZONE | DEFECT | SIZE |
| 1 | B | Slight contamination | 0.00 |
| 2 | A | Impurity | 0.60 |
| 3 | A | Impurity | 0.80 |
| 4 | B | Contamination | 0.00 |

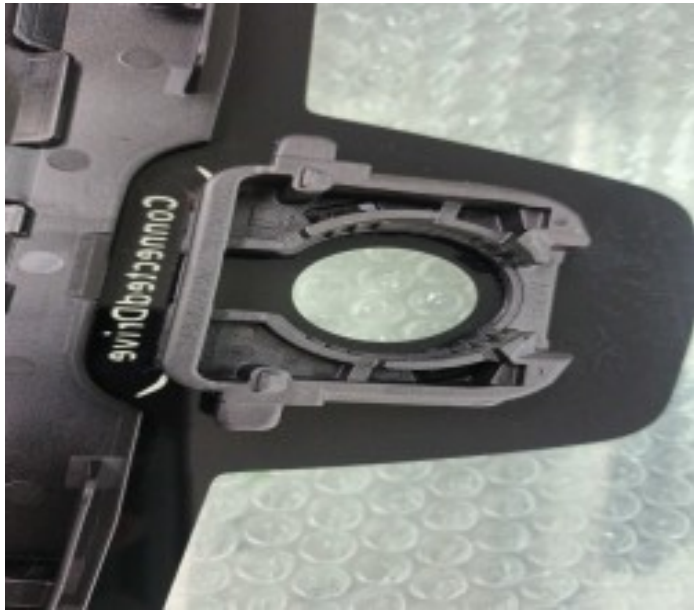
MIRROR BRACKET

| Mirror bracket | OK | Terminals insulation | OK |
