| | <b>QUALITY REPORT - FINAL INSPECTION</b><br><b>QUALITY CONTROL DEPARTMENT</b> | CODIGO/CODE | CORP-CAL-CF-001 |

| <b>CLIENT:</b> | AGP SGLASS EUROPE GMBH | <b>PRODUCTION ORDER:</b> | 000011247567 | <b>COLOR:</b> | GREEN LIGHT |
| <b>VEHICLE:</b> | LAND ROVER SENTINEL 4D UTILITY | <b>COMPOSITION:</b> | L40-2 | <b>THICKNESS(mm):</b> | 42.000 |

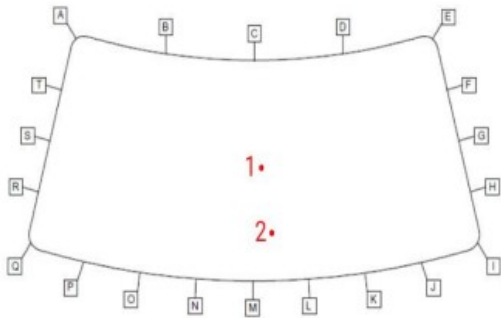
| ITEM | ZONE | DEFECT | SIZE |
| 1 | B | Intern Scratch | 20.00 |
| 2 | B | Internal stain | 0.00 |
