# PROPERTY INSPECTION REPORT

251 N Bristol Ave, Los Angeles, CA 90049

Inspection Date: August 13, 2025

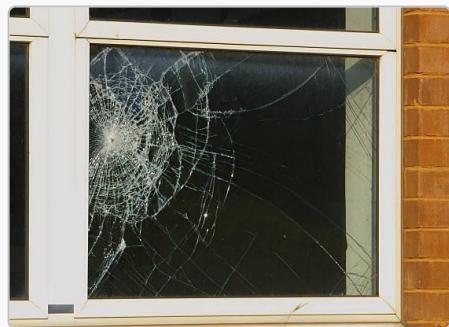
**Location:** Front room / Master bedroom / First Floor

#### Broken Window Pane

A glass pane on one or more windows was broken. It is recommended to replace broken windows to restore their intended function.

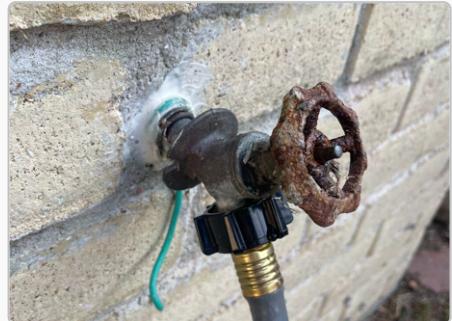
**Missing Vapor/Moisture Barrier****Location:** Hose bib

A vapor or moisture barrier appears to be missing or not installed behind the stucco finish system. This condition could allow moisture to penetrate to the interior framing and cause damage. It is recommended that a qualified licensed contractor further evaluate and perform necessary repairs.

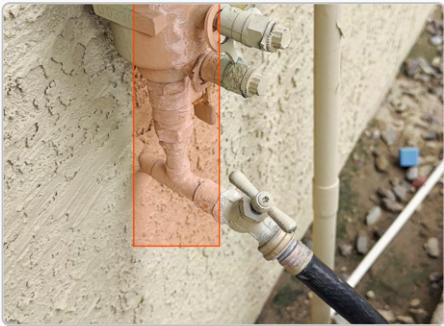
**Hose Bib Replacement Recommended****Location:** Front of house

The exterior hose bib located at the front of the house requires replacement. Replace the damaged/failed exterior faucet to prevent leaks and potential water intrusion. It is recommended that a qualified plumber or licensed contractor replace the unit and verify the isolation valve operation.

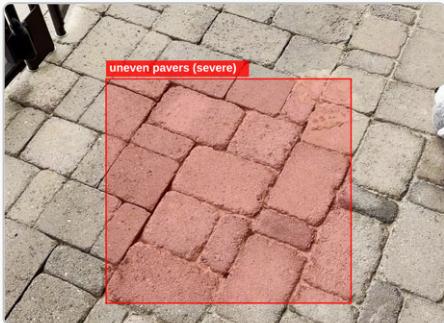
**Location:** Back Yard

### Uneven Pavers — Trip Hazard

Uneven paver stones were observed in the backyard, creating a potential trip hazard to occupants and visitors. This condition presents an immediate safety concern and should be corrected. Recommend evaluation and repair by a qualified hardscape contractor or landscaper to re-level, reset, or replace affected pavers to eliminate the trip hazard.

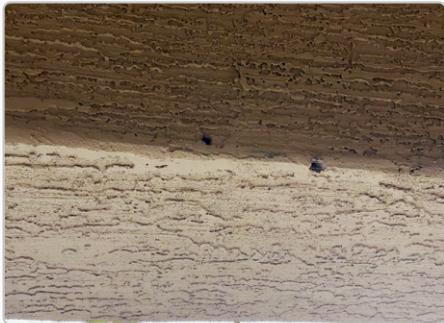
#### Previous Exterior Repairs Observed

Evidence of prior repairs was noted on the exterior cladding. It is advisable to consult with the property owner to ascertain the nature of these repairs and whether any associated moisture intrusion incidents were reported.

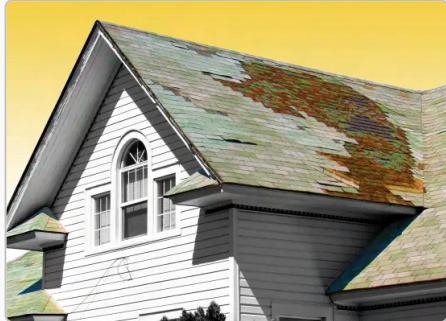
**Broken Roof Shingles****Location:** Roof

Several roof shingles were observed to be broken. This condition may lead to water intrusion and should be addressed promptly to maintain the roof's integrity.

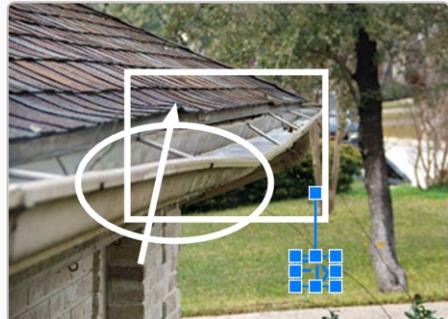
**Hanging Gutter****Location:** Gutters

One of the gutters was observed to be improperly installed and hanging off the structure. This can lead to ineffective drainage and potential water damage to the property.

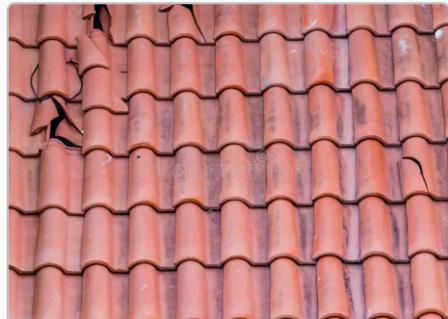
**Cracked/Brittle Composition Shingles****Location:** Roof

One or more composition roof shingles exhibited cracking and/or brittleness. Cracked and brittle shingles typically indicate that the roof is nearing the end of its useful life. It is recommended to have a qualified licensed roofing contractor further evaluate and perform necessary repairs.

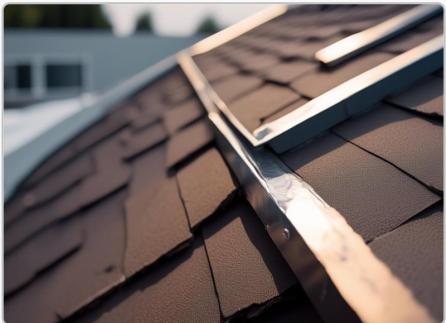
**Location:** Living Room

### Compromised Flashing or Sealant Integrity

Observations indicate the presence of openings or gaps within the flashing or sealant materials. Such breaches can compromise the water-resistant barrier of the roof, potentially leading to water penetration. It is recommended to engage a certified roofing contractor to address and repair these areas to prevent future moisture intrusion.

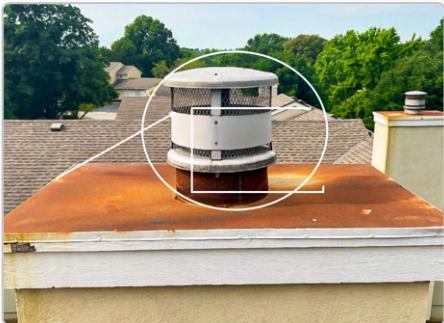
**Location:** 1st Floor Bedroom

### Vent Cover Damaged or Missing

A damaged or missing vent cover could allow debris and small pests to enter. It is recommended to repair or replace the vent cover to ensure proper operation.

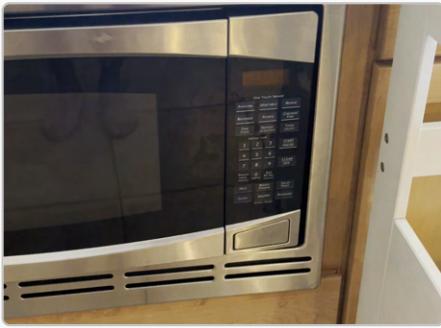
**Location:** Kitchen

### Unit Non-Functional or Malfunctioning

The microwave oven appeared to be non-operational or was malfunctioning. It is advised that a qualified appliance technician evaluate and perform necessary repairs or replacement.

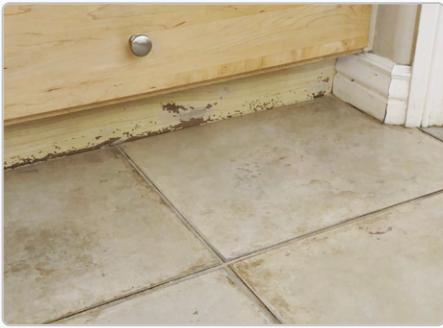
**Failing or Peeling Paint**  
**Location:** Kitchen 1st Floor

The paint finish exhibited signs of failure or peeling in one or more locations. It is recommended that a qualified contractor perform the necessary repairs.

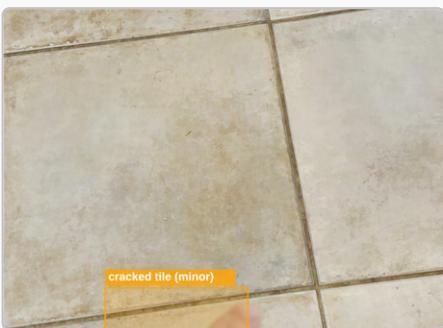
**Cracked Floor Tile**  
**Location:** Kitchen

Two small cracks were observed in the kitchen floor tile. Cracked tile can allow moisture to penetrate the substrate and may deteriorate further over time. Recommend repair or replacement of the affected tile(s) by a qualified flooring contractor and verify the integrity of the surrounding substrate and grout. Obtain estimates as needed.

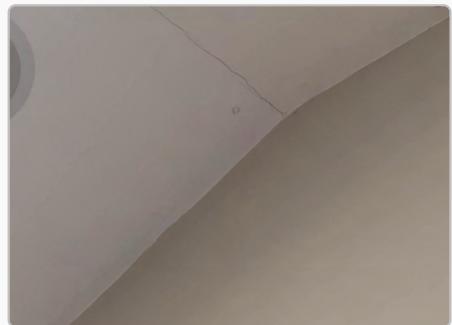
**Location:** Living Room

### Significant Drywall Cracking

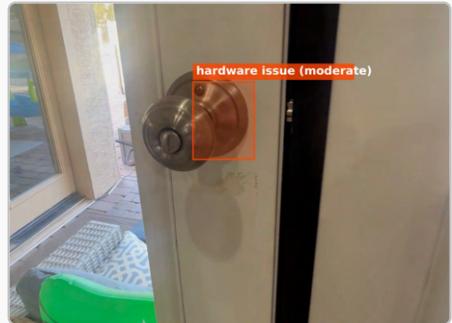
**Location:** Living Room

### Inoperable or Difficult Door Handle Lock

The handle lock on one or more exterior entryways was found to be inoperable or challenging to use. Replacement of the locking doorknob by a qualified professional is recommended.

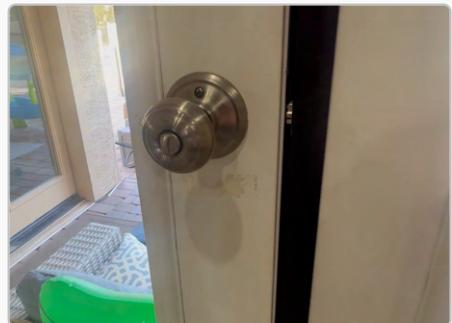
**Location:** Living Room

### Loose, Damaged, or Missing Door Hardware

Various exterior door hardware components, including locksets, hinges, and pulls, were observed to be inoperable, damaged, loose, or absent. It is advised that a qualified contractor perform necessary repairs or replacements.

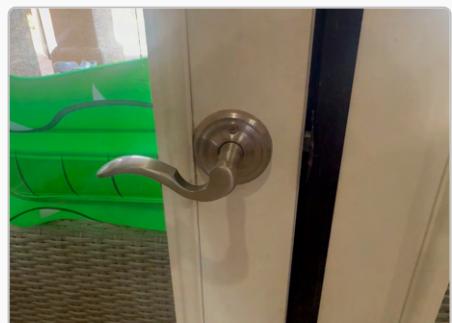
**Location:** Living Room

### Damaged or Missing Door Hardware

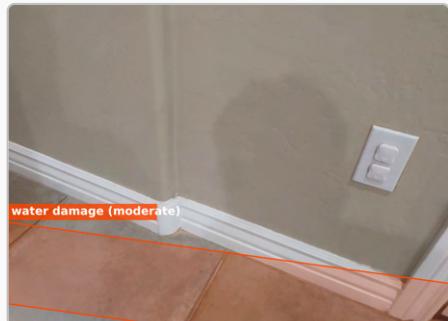
Location: Living Room

#### Subflooring Water Damage

Water damage was observed on the subflooring during the assessment. This damage may signify a historical or ongoing leak. It is advised to consult with the seller regarding the nature of the damage and any prior repairs. Alternatively, monitor the affected area for any subsequent deterioration.

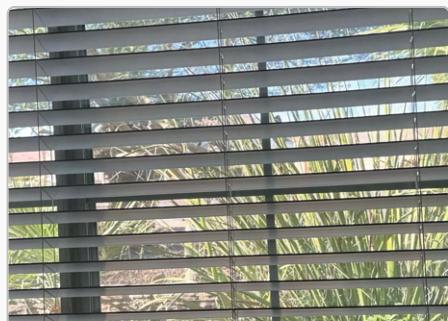
Location: 1st Floor Southeast

#### Potential Wood-Destroying Insect Damage

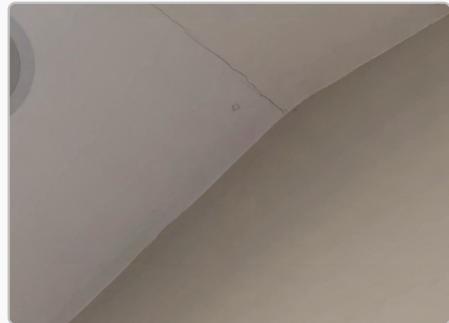
**Ceiling Crack – Possible Structural Concern****Location:** Living Room

Significant cracking was observed in the ceiling in the Living Room that may indicate underlying structural movement or damage. A licensed contractor or structural engineer should be engaged to evaluate the extent and cause of the cracking and to recommend necessary repairs. This condition may represent a safety risk and should be addressed promptly.

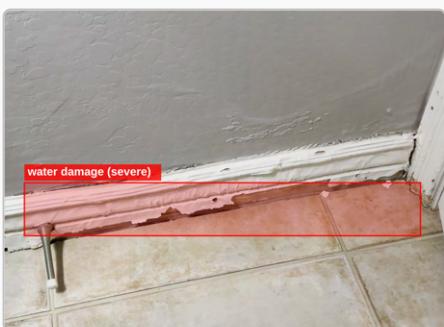
#### Evidence of Active Moisture Intrusion Location: Master Bathroom

The observed leakage could cause additional damage to the framing member and floor decking. Water staining and dampness were noted in one or more areas, as confirmed by a moisture meter. This condition increases the risk of insect infestation, mildew, and decay. It is recommended to consult a licensed contractor to identify and rectify the source of the dampness, which may involve improving exterior drainage, installing a waterproofing system, or sealing foundation cracks.

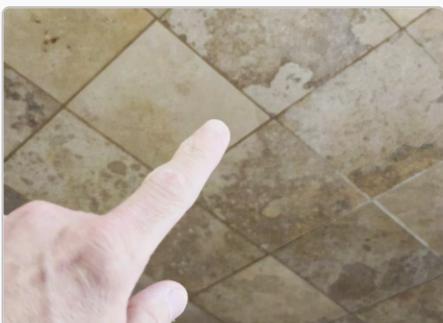
**Location:** Master Bathroom Shower

### Loose Shower Wall Tiles — Safety Hazard
