PROPERTY INSPECTION REPORT FORM

Binsr Demo <i>Name of Client</i>	08/13/2025 6:00AM <i>Date of Inspection</i>
251 N Bristol Ave, Los Angeles, CA 90049 <i>Address of Inspected Property</i>	
Binsr <i>Name of Inspector</i>	N/A <i>TREC License #</i>
N/A <i>Name of Sponsor (if applicable)</i>	N/A <i>TREC License #</i>

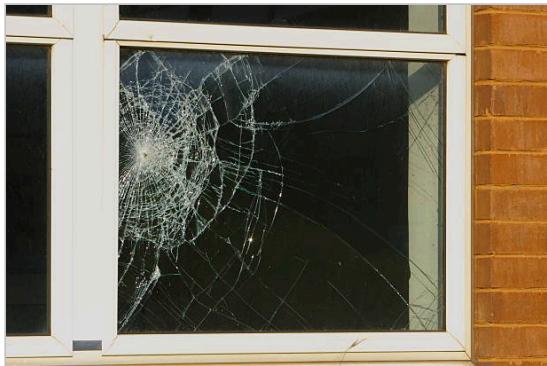
Location: Back Yard

Cracked Window Pane:

The damaged glass pane may expose sharp edges and reduce the thermal barrier against the elements. Further evaluation by a qualified contractor is recommended to repair or replace the damaged window as needed.

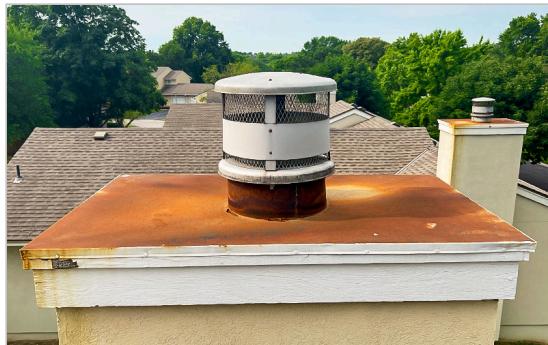
Corroded Chimney Cap:

The chimney cap displayed signs of corrosion. Regular maintenance, such as sealing, is recommended to prevent further damage and extend its longevity.

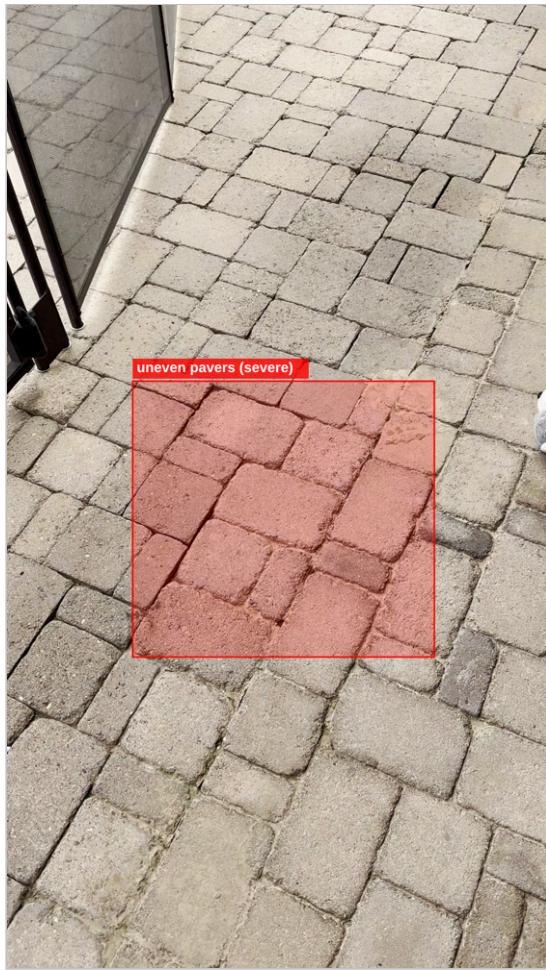
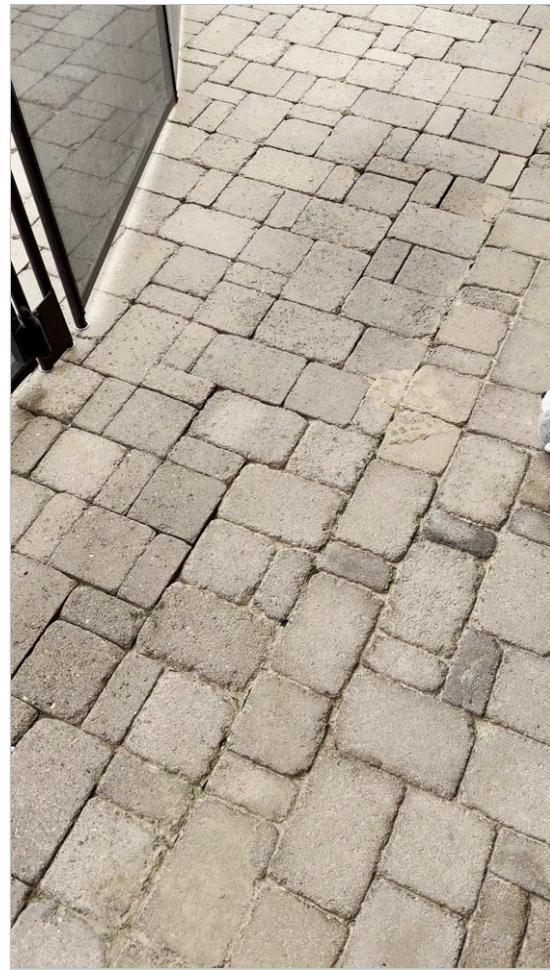
Location: Back Yard

Uneven Pavers — Trip Hazard:

Uneven paver stones were observed in the backyard, creating a potential trip hazard to occupants and visitors. This condition presents an immediate safety concern and should be corrected. Recommend evaluation and repair by a qualified hardscape contractor or landscaper to re-level, reset, or replace affected pavers to eliminate the trip hazard.

Annotated image: uneven pavers at Back Yard

Original image: uneven pavers at Back Yard

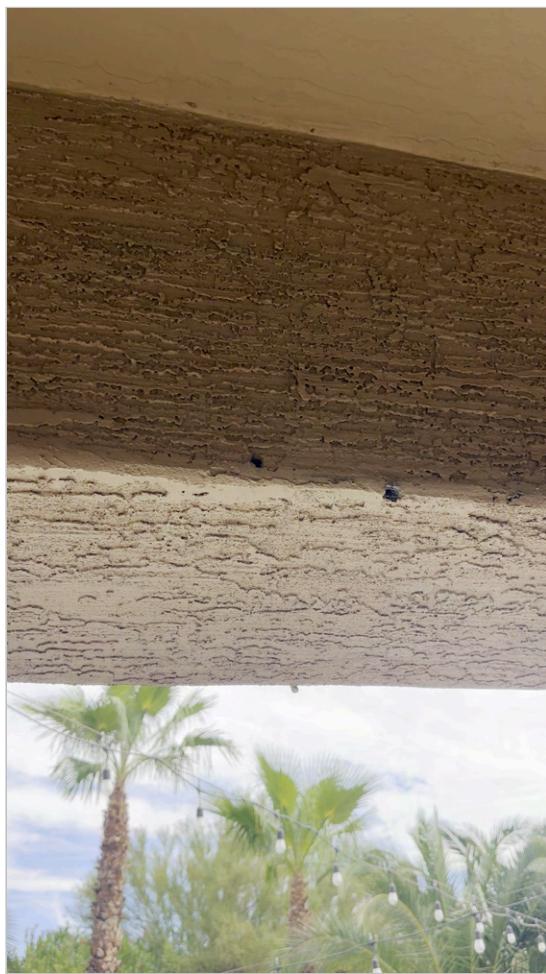
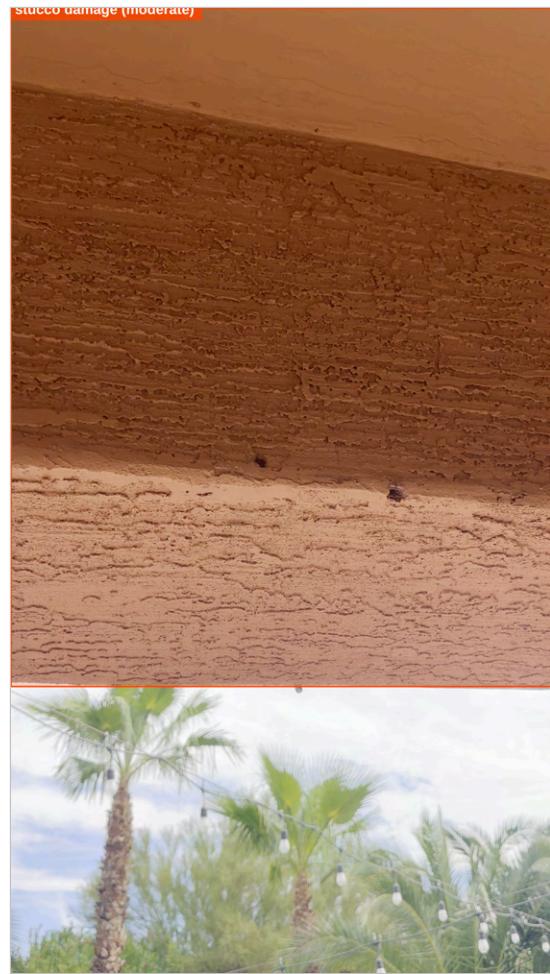
Location: Back Yard

***Stucco Cracks/Damage:***

Stucco damage was observed. Gaps or cracks in stucco can allow for moisture intrusion, accelerating deterioration. It is recommended that a qualified contractor evaluate and perform necessary repairs.

*Original image: stucco damage at Back Yard*

*Annotated image: stucco damage at Back Yard****Exterior Surface Material Type:*** Brick Vinyl Siding

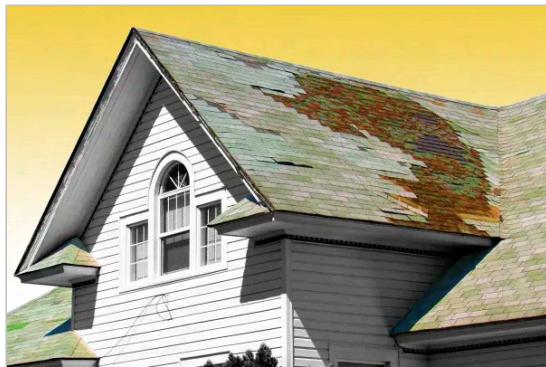
Location: Roof

Roof Covering Beyond Lifespan - Replacement Recommended:

Based on the age and type of shingle, the roof has exceeded its expected service life. Even with current repairs, the design of the shingle is beyond its intended lifespan. It is recommended to consult a qualified roofing professional for suggestions and quotes regarding roof replacement.

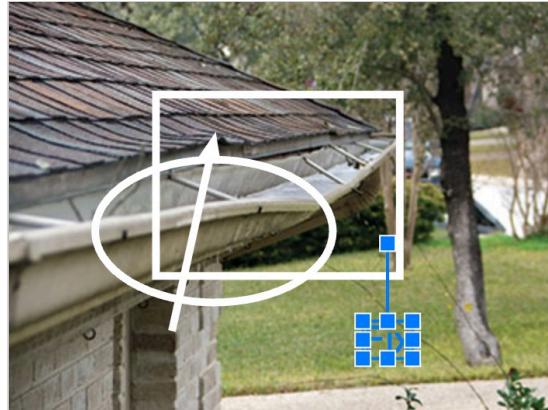
Location: Roof

Location: Gutters***Missing or Damaged Gutter Hanger:***

A gutter hanger was observed to be missing or damaged. It is recommended to properly secure or replace the gutter hangers to ensure the intended stability and proper alignment of the gutter system.

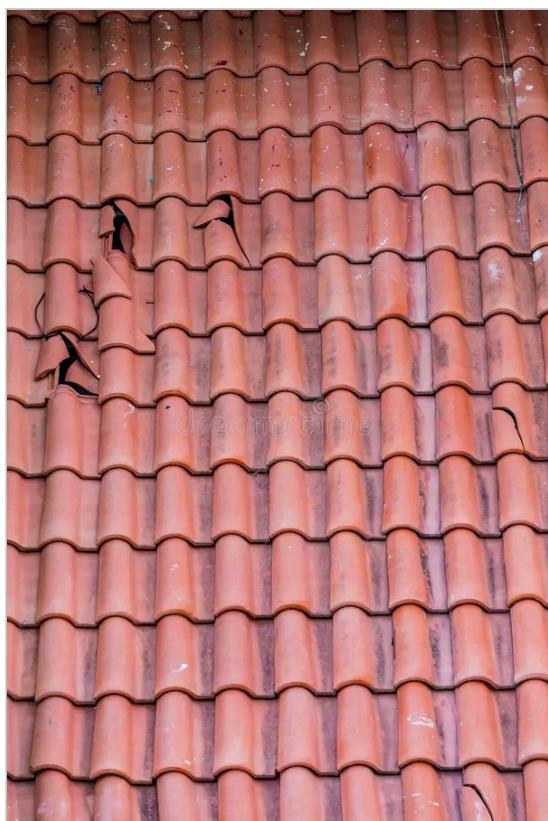
Location: Roof

Cracked Roof Tiles:

Cracked tiles were observed in various locations on the roof. It is recommended that a qualified roofing contractor assess and repair these areas as necessary. This type of roofing system typically benefits from annual evaluations and prompt repairs.

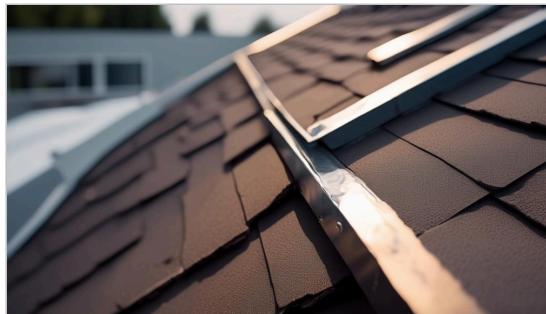
Location: Living Room

Observations indicate the presence of openings or gaps within the flashing or sealant materials. Such breaches can compromise the water-resistant barrier of the roof, potentially leading to water penetration. It is recommended to engage a certified roofing contractor to address and repair these areas to prevent future moisture intrusion.

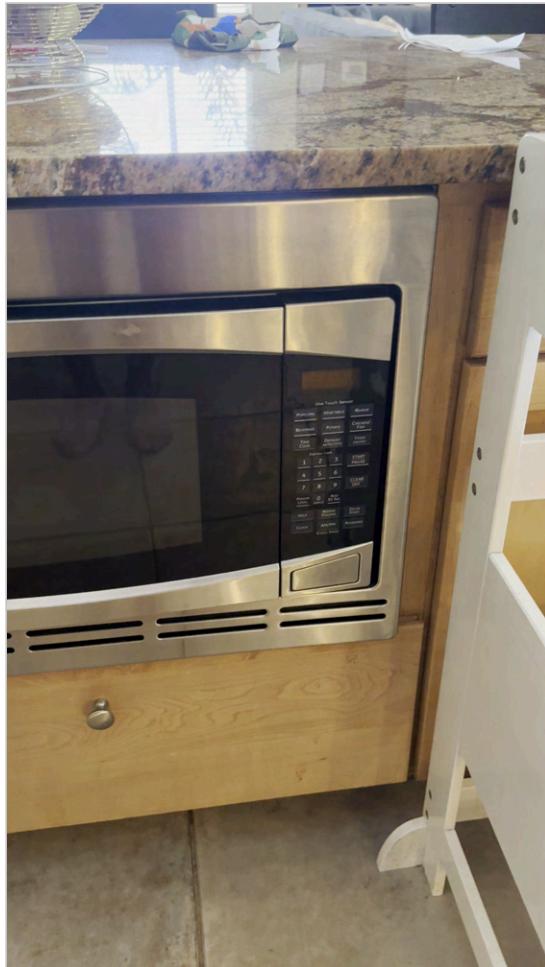
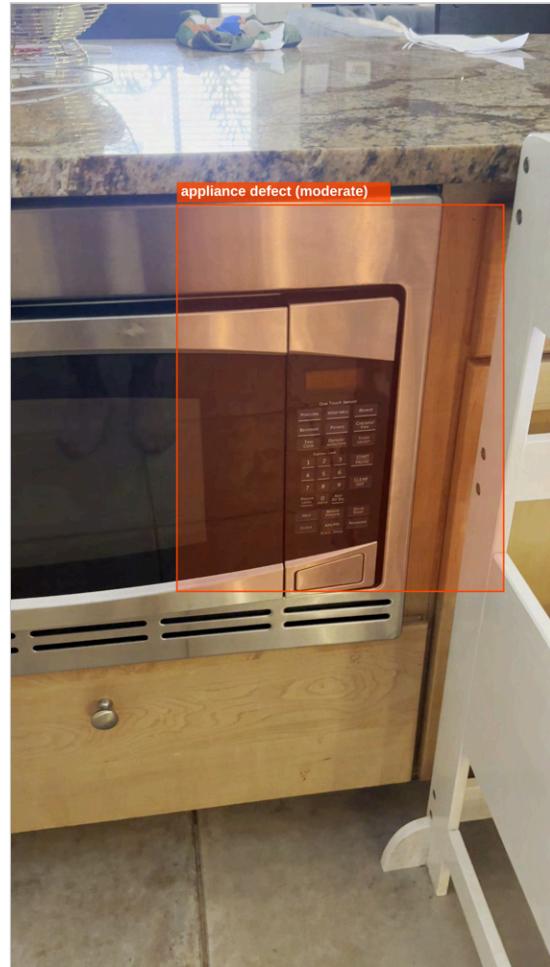
Location: Kitchen

Unit Non-Functional or Malfunctioning:

The microwave oven appeared to be non-operational or was malfunctioning. It is advised that a qualified appliance technician evaluate and perform necessary repairs or replacement.

Original image: appliance defect at Kitchen

Annotated image: appliance defect at Kitchen

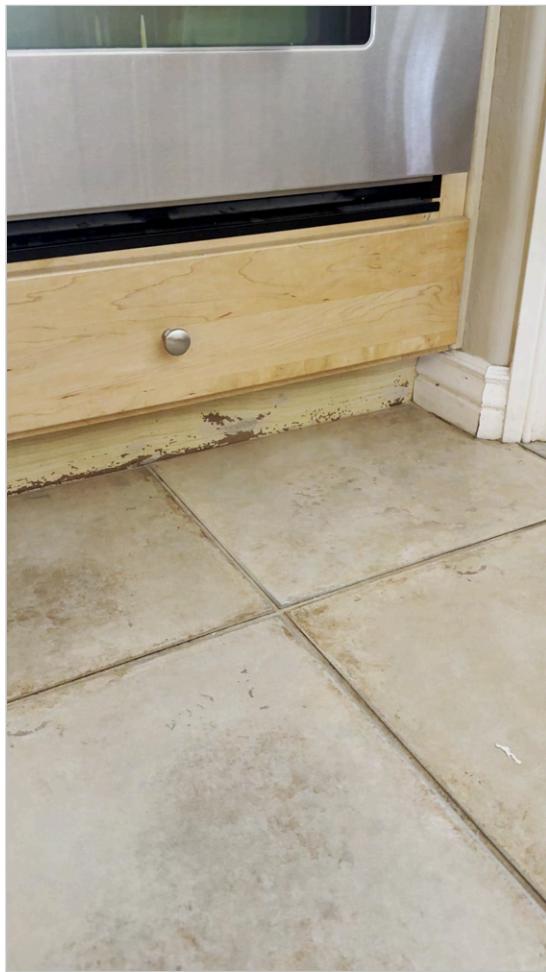
Location: Kitchen 1st Floor

The paint finish exhibited signs of failure or peeling in one or more locations. It is recommended that a qualified contractor perform the necessary repairs.

Original image: damaged toe kick at Kitchen

Annotated image: damaged toe kick at Kitchen

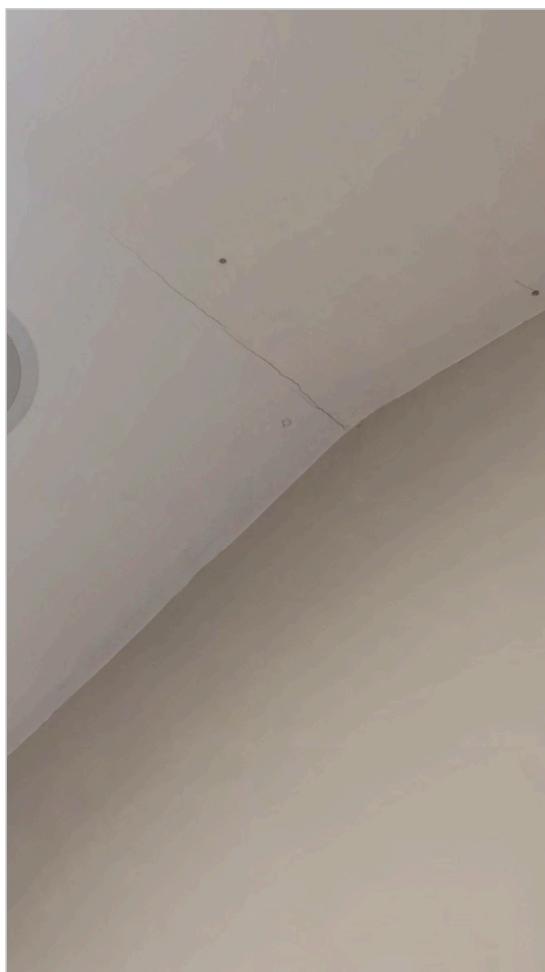
Location: Living Room

J. Ceiling Surfaces***Significant Drywall Cracking:***

Original image: ceiling crack at Living Room

Annotated image: ceiling crack at Living Room

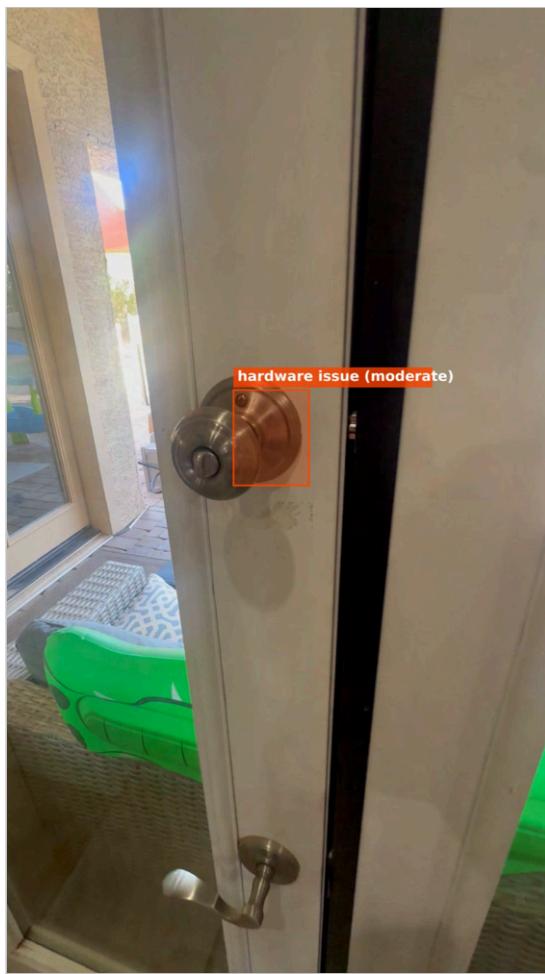
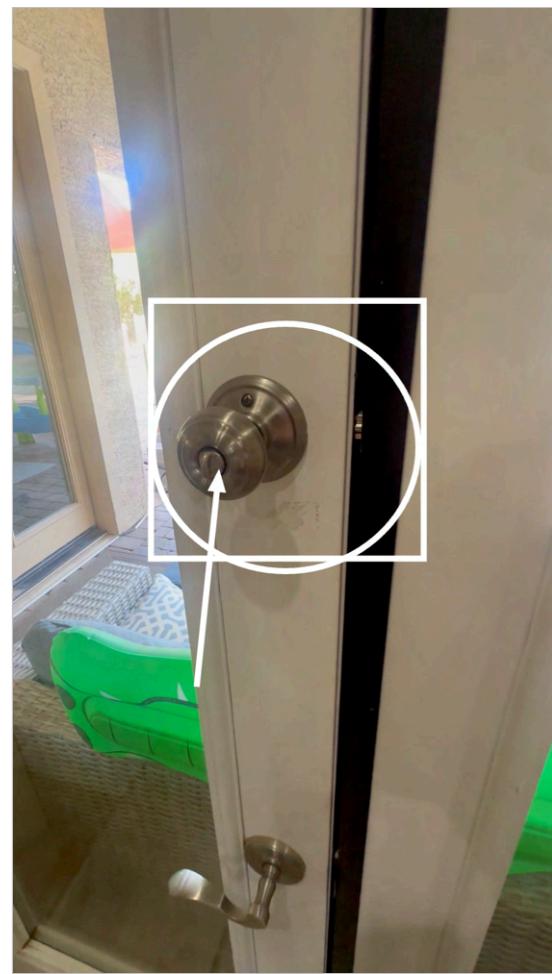
Location: Living Room

Annotated image: hardware issue at Living Room

Original image: hardware issue at Living Room

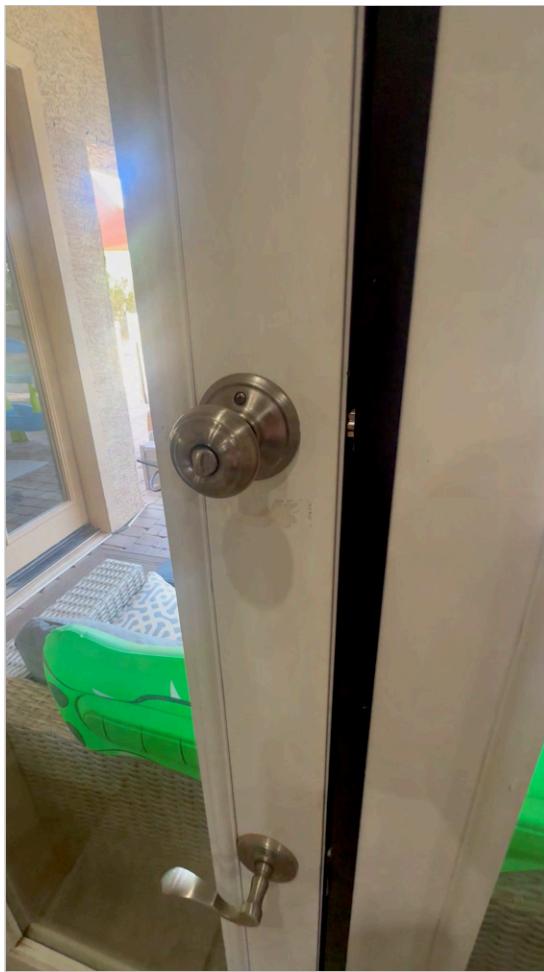
Loose, Damaged, or Missing Door Hardware:

Original image: broken door handle at Living Room

Annotated image: broken door handle at Living Room

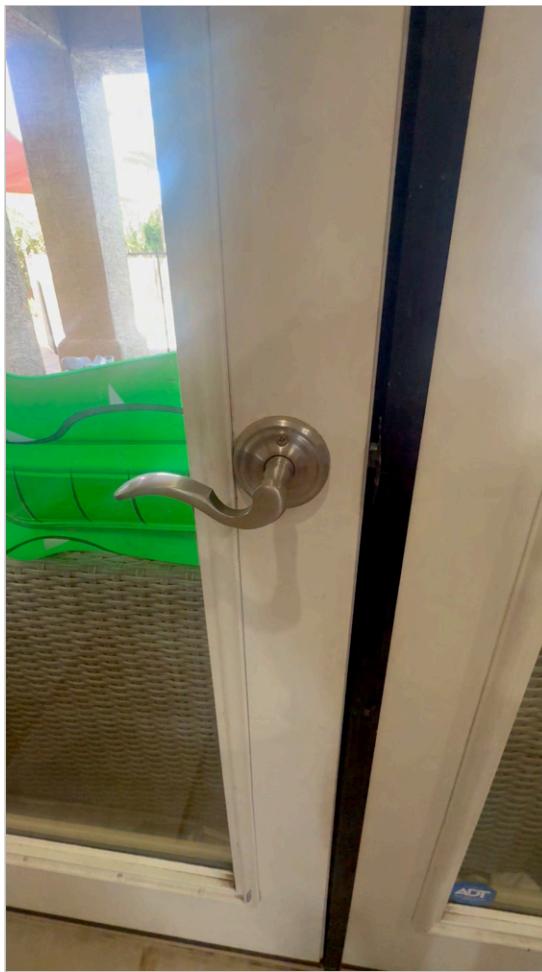
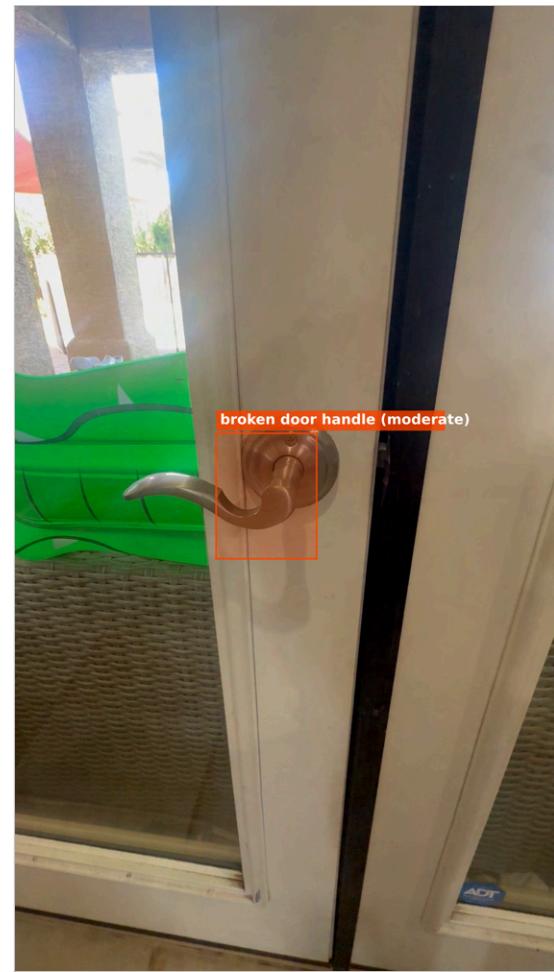
Location: Living Room

Damaged or Missing Door Hardware:

Original image: broken door handle at Living Room

Annotated image: broken door handle at Living Room

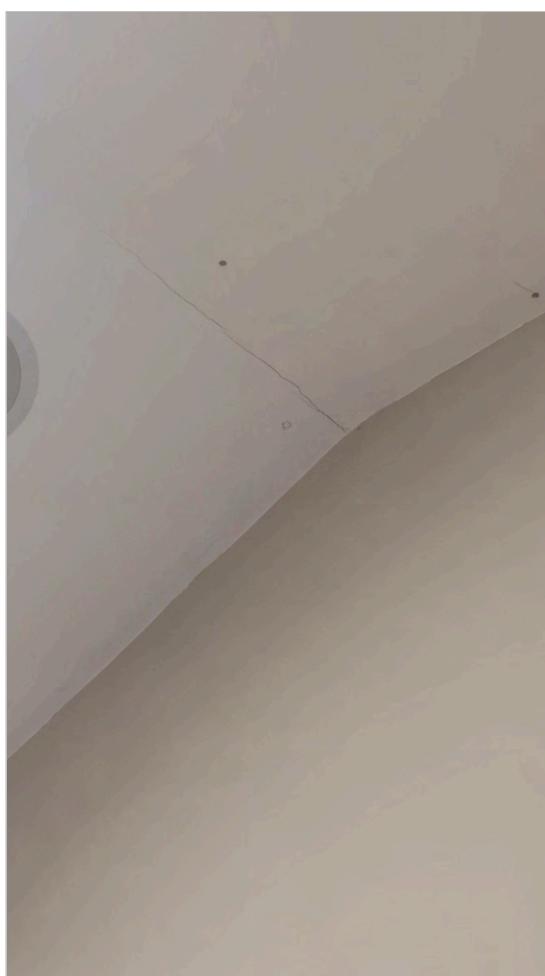
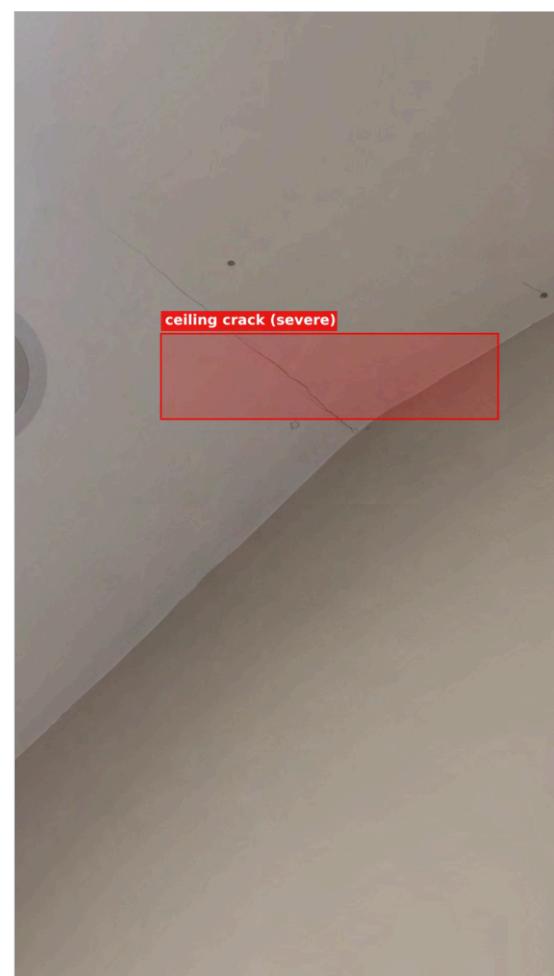
Location: Living Room

Ceiling Crack — Possible Structural Concern:

Original image: ceiling crack at Living Room

Annotated image: ceiling crack at Living Room

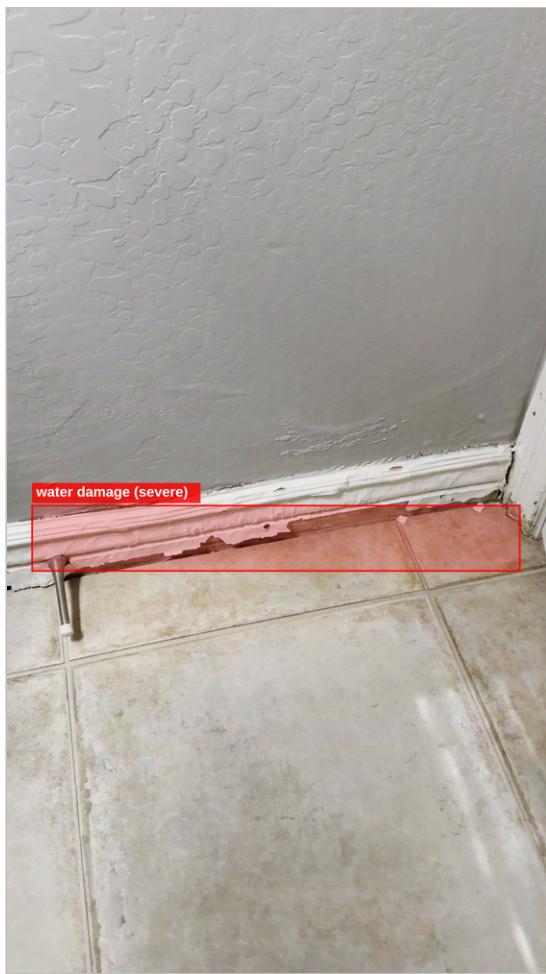
Location: Master Bathroom

Annotated image: water damage at Master Bathroom

Original image: water damage at Master Bathroom

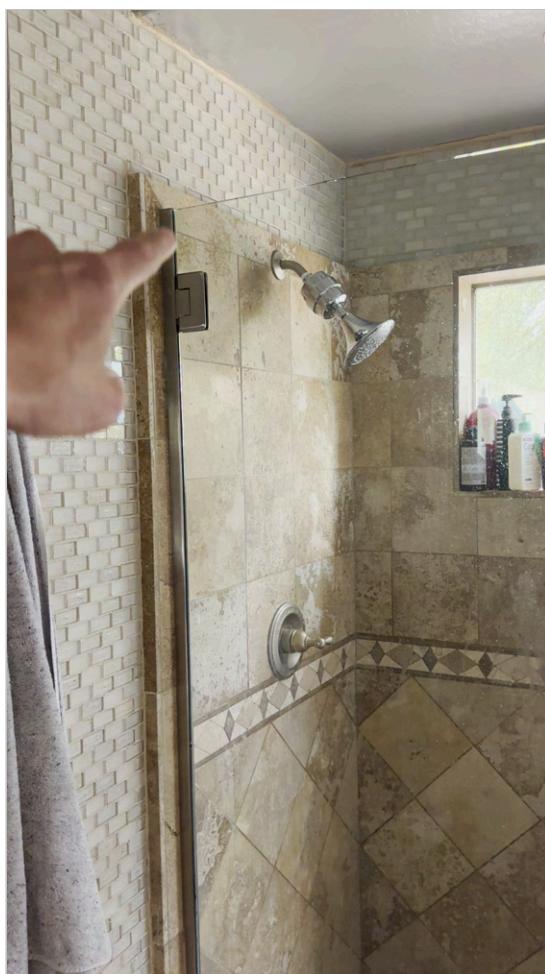
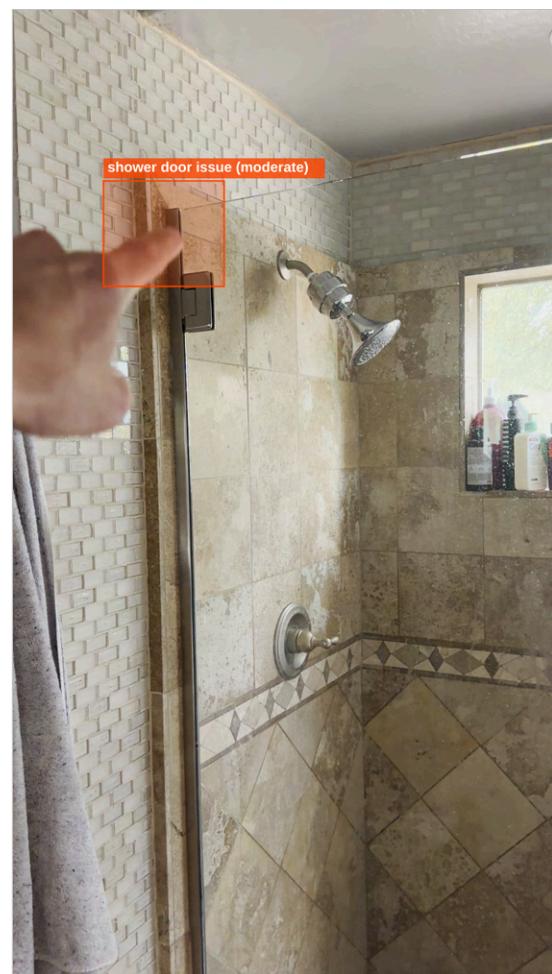
Location: Master Bathroom

Shower Door Misalignment / Impacting Glass:

Original image: shower door issue at Master Bathroom

Annotated image: shower door issue at Master Bathroom

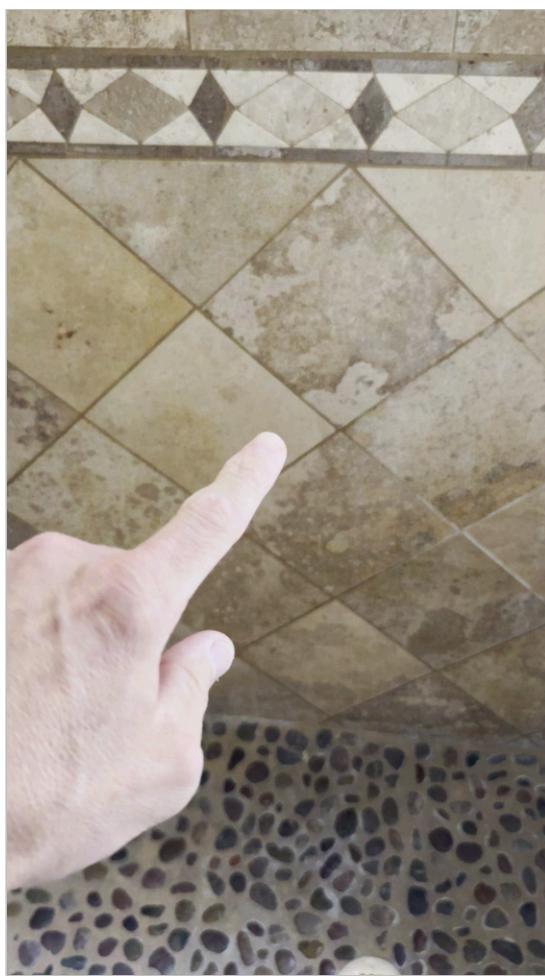
Location: Master Bathroom Shower

Loose Shower Wall Tiles — Safety Hazard:

Original image: loose tiles at Master Bathroom Shower

Annotated image: loose tiles at Master Bathroom Shower
