PROPERTY INSPECTION REPORT

251 N Bristol Ave, Los Angeles, CA 90049

Inspection Date: August 13, 2025

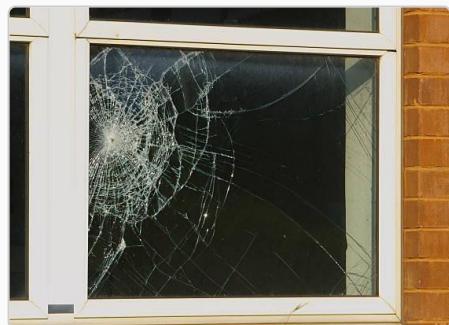
Location: Front room / Master bedroom / First Floor

Broken Window Pane

A glass pane on one or more windows was broken. It is recommended to replace broken windows to restore their intended function.

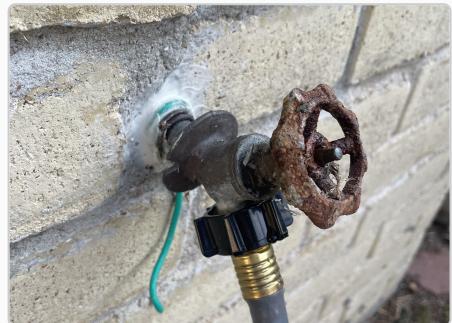
Missing Vapor/Moisture Barrier**Location:** Hose bib

A vapor or moisture barrier appears to be missing or not installed behind the stucco finish system. This condition could allow moisture to penetrate to the interior framing and cause damage. It is recommended that a qualified licensed contractor further evaluate and perform necessary repairs.

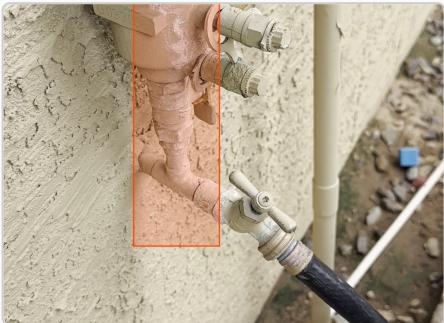
Hose Bib Replacement Recommended**Location:** Front of house

The exterior hose bib located at the front of the house requires replacement. Replace the damaged/failed exterior faucet to prevent leaks and potential water intrusion. It is recommended that a qualified plumber or licensed contractor replace the unit and verify the isolation valve operation.

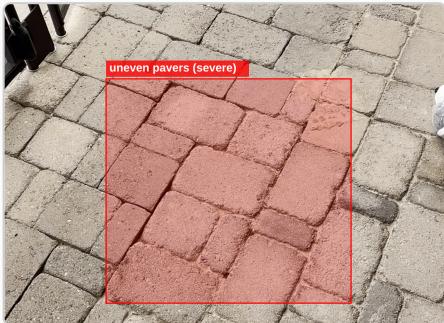
Location: Back Yard

Uneven Pavers — Trip Hazard

Uneven paver stones were observed in the backyard, creating a potential trip hazard to occupants and visitors. This condition presents an immediate safety concern and should be corrected. Recommend evaluation and repair by a qualified hardscape contractor or landscaper to re-level, reset, or replace affected pavers to eliminate the trip hazard.

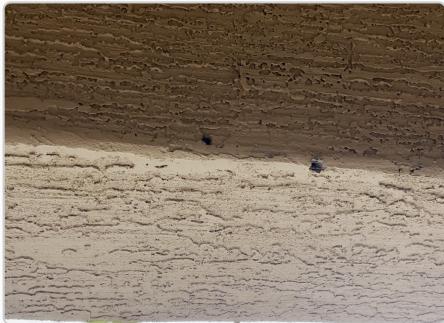
Previous Exterior Repairs Observed

Evidence of prior repairs was noted on the exterior cladding. It is advisable to consult with the property owner to ascertain the nature of these repairs and whether any associated moisture intrusion incidents were reported.

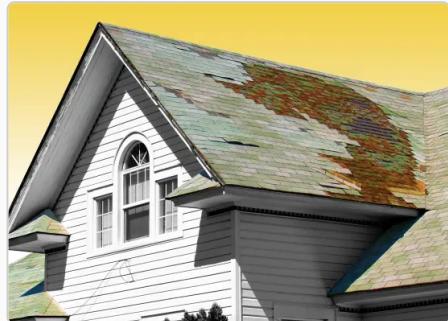
Broken Roof Shingles**Location:** Roof

Several roof shingles were observed to be broken. This condition may lead to water intrusion and should be addressed promptly to maintain the roof's integrity.

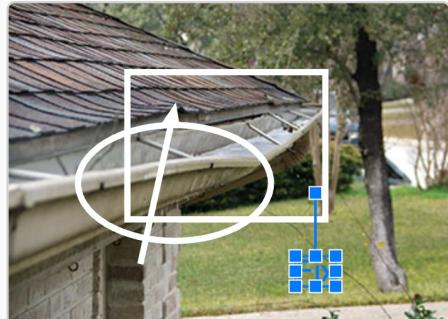
Hanging Gutter**Location:** Gutters

One of the gutters was observed to be improperly installed and hanging off the structure. This can lead to ineffective drainage and potential water damage to the property.

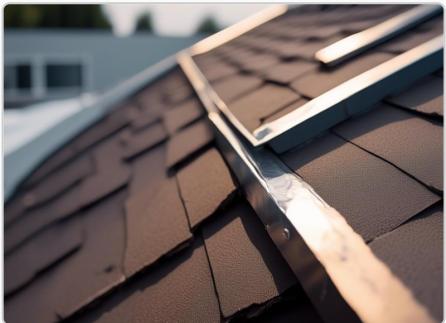
Location: Living Room

Compromised Flashing or Sealant Integrity

Observations indicate the presence of openings or gaps within the flashing or sealant materials. Such breaches can compromise the water-resistant barrier of the roof, potentially leading to water penetration. It is recommended to engage a certified roofing contractor to address and repair these areas to prevent future moisture intrusion.

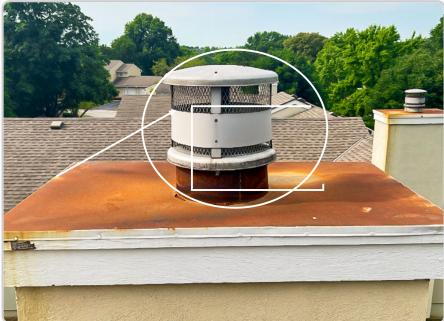
Location: 1st Floor Bedroom

Vent Cover Damaged or Missing

A damaged or missing vent cover could allow debris and small pests to enter. It is recommended to repair or replace the vent cover to ensure proper operation.

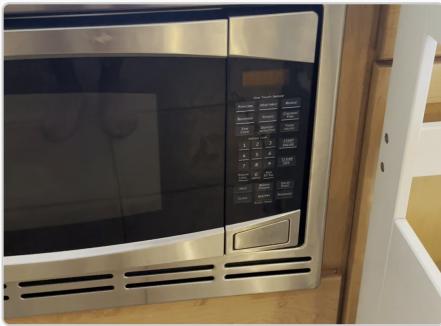
Location: Kitchen

Unit Non-Functional or Malfunctioning

The microwave oven appeared to be non-operational or was malfunctioning. It is advised that a qualified appliance technician evaluate and perform necessary repairs or replacement.

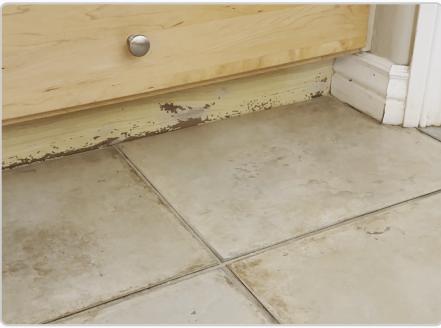
**Failing or Peeling Paint**
Location: Kitchen 1st Floor

The paint finish exhibited signs of failure or peeling in one or more locations. It is recommended that a qualified contractor perform the necessary repairs.

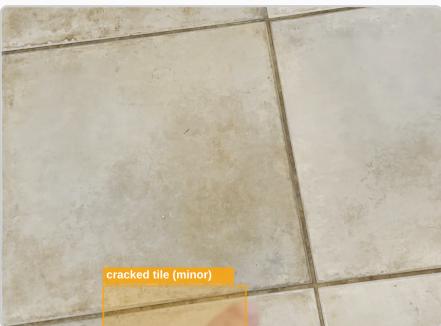
**Cracked Floor Tile**
Location: Kitchen

Two small cracks were observed in the kitchen floor tile. Cracked tile can allow moisture to penetrate the substrate and may deteriorate further over time. Recommend repair or replacement of the affected tile(s) by a qualified flooring contractor and verify the integrity of the surrounding substrate and grout. Obtain estimates as needed.

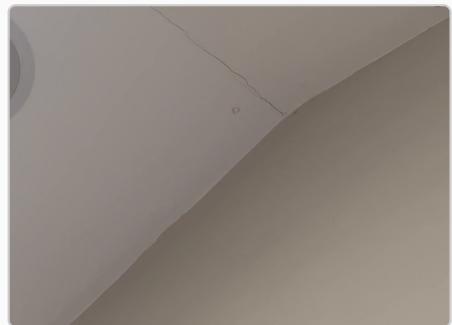
Location: Living Room

Significant Drywall Cracking

Significant drywall imperfections, including damage, cracking, or inconsistencies, were noted in the referenced area(s). It is advisable to inquire with the current homeowner(s) regarding any past alterations. Repairs should be undertaken by a drywall contractor as desired.

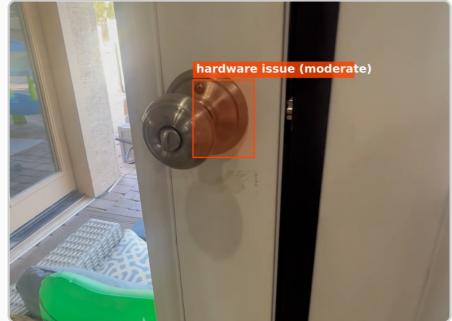
Location: Living Room

Inoperable or Difficult Door Handle Lock

The handle lock on one or more exterior entryways was found to be inoperable or challenging to use. Replacement of the locking doorknob by a qualified professional is recommended.

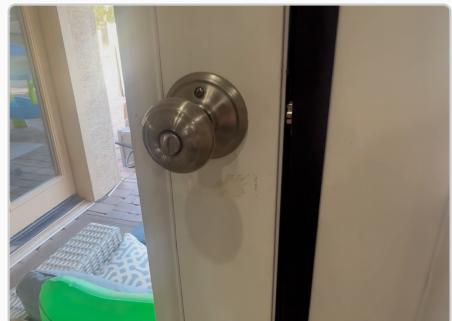
Location: Living Room

Loose, Damaged, or Missing Door Hardware

Various exterior door hardware components, including locksets, hinges, and pulls, were observed to be inoperable, damaged, loose, or absent. It is advised that a qualified contractor perform necessary repairs or replacements.

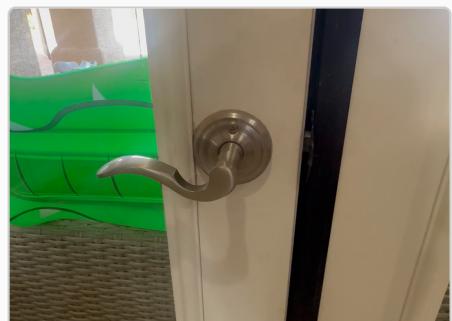
Location: Living Room

Damaged or Missing Door Hardware

The door handle is either damaged or missing. It is recommended that a qualified professional evaluate and repair or replace it as necessary.

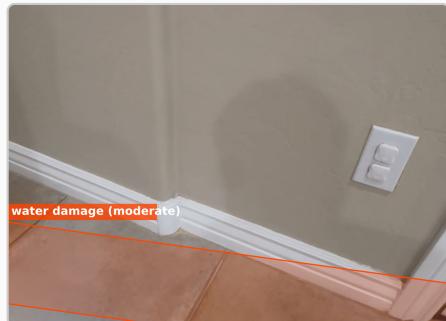
Location: Living Room

Subflooring Water Damage

Water damage was observed on the subflooring during the assessment. This damage may signify a historical or ongoing leak. It is advised to consult with the seller regarding the nature of the damage and any prior repairs. Alternatively, monitor the affected area for any subsequent deterioration.

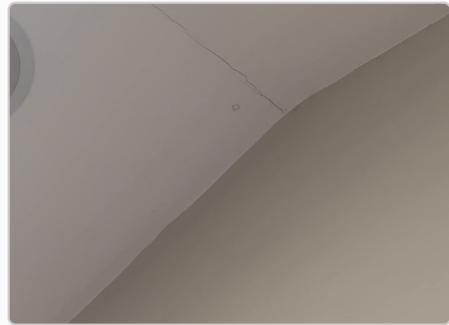
**Ceiling Crack – Possible Structural Concern****Location:** Living Room

Significant cracking was observed in the ceiling in the Living Room that may indicate underlying structural movement or damage. A licensed contractor or structural engineer should be engaged to evaluate the extent and cause of the cracking and to recommend necessary repairs. This condition may represent a safety risk and should be addressed promptly.

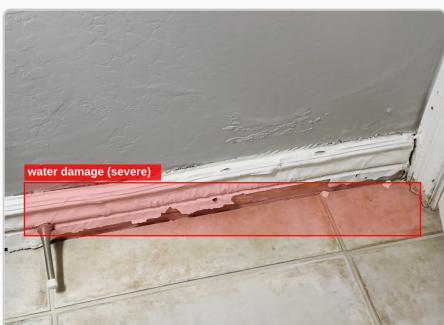
Evidence of Active Moisture Intrusion Location: Master Bathroom

The observed leakage could cause additional damage to the framing member and floor decking. Water staining and dampness were noted in one or more areas, as confirmed by a moisture meter. This condition increases the risk of insect infestation, mildew, and decay. It is recommended to consult a licensed contractor to identify and rectify the source of the dampness, which may involve improving exterior drainage, installing a waterproofing system, or sealing foundation cracks.

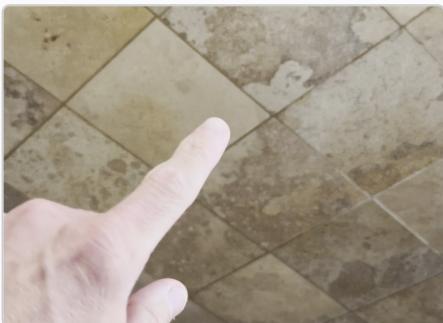
Location: Master Bathroom Shower

Loose Shower Wall Tiles — Safety Hazard
