Polymer Testing

Polymer Testing, Polymer Analysis, Plastic Testing, and Plastic Analysis by ExcelPlas

Reinforced polypropylene – Water pipes

Title	Analysis of PP-R Green Pipe
Date	2013
Objective	To analyse a sample of PP-R green pipe to determine the cause of cracking failure
Photo

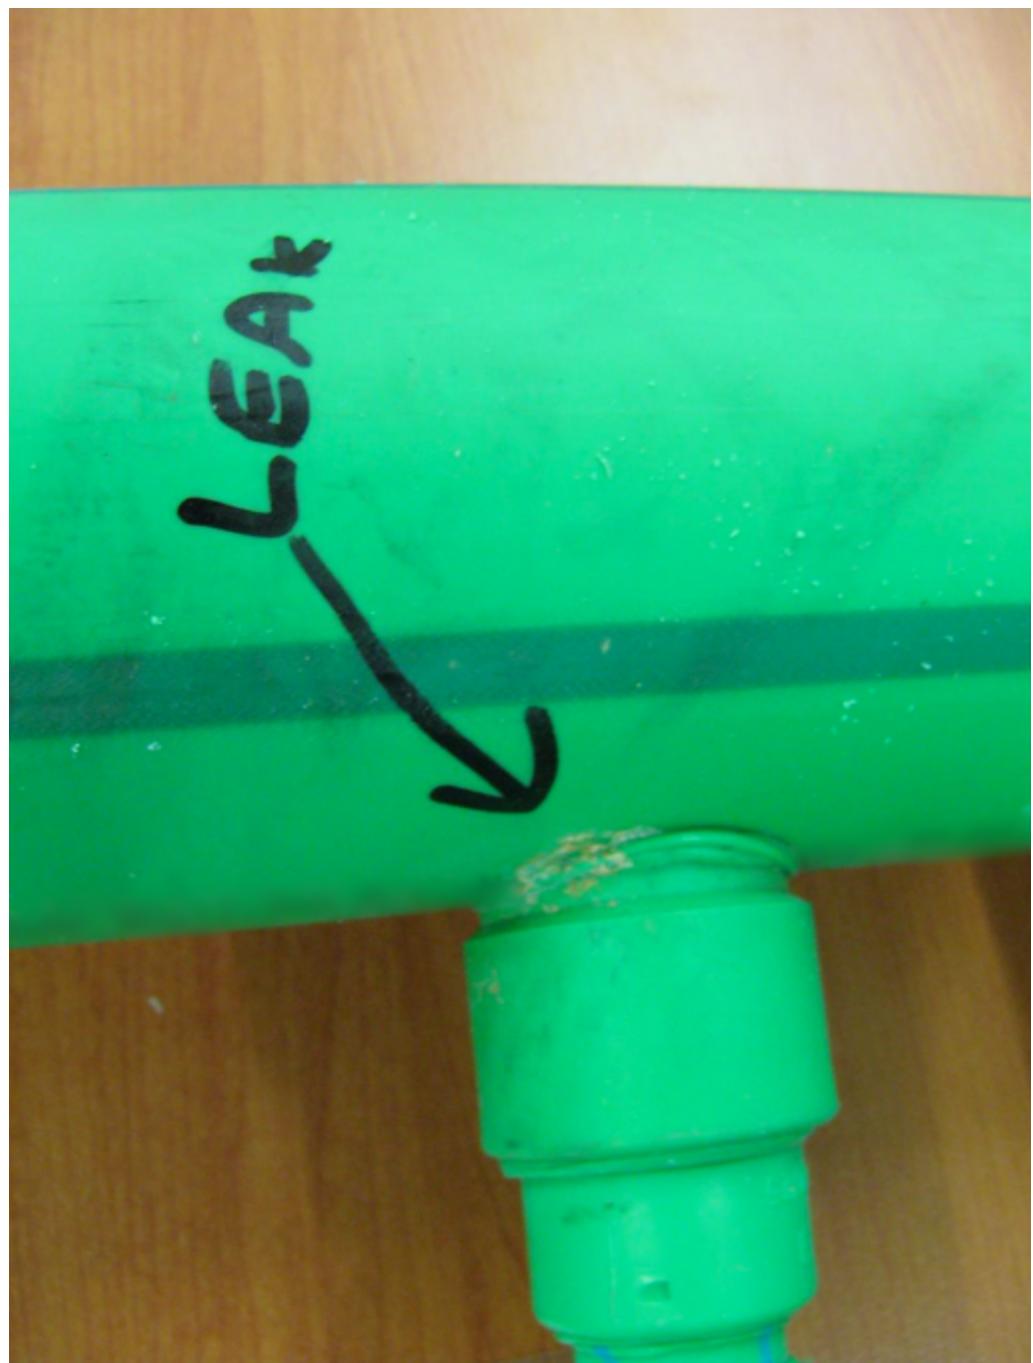
Figure 1. Position of leak on outside of pipe

Testing Undertaken	OIT as per ASTM D3895 Digital microscopy FTIR as per ASTM F2102 NMR spectroscopy
Failure Analysis	Antioxidants in the pipe were almost totally depleted (only Irganox 1010 and Irgafos 168 were present), thus the pipe was not fit for service. The severe oxidative cracking of the pipe was due to a combination of thermal oxidation and stresses associated with thermal expansion and contraction

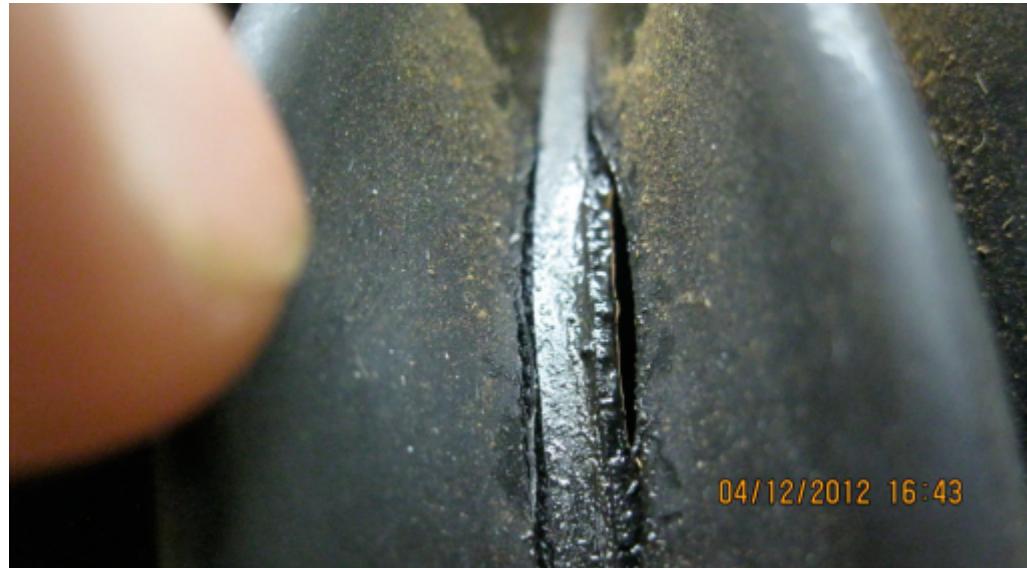
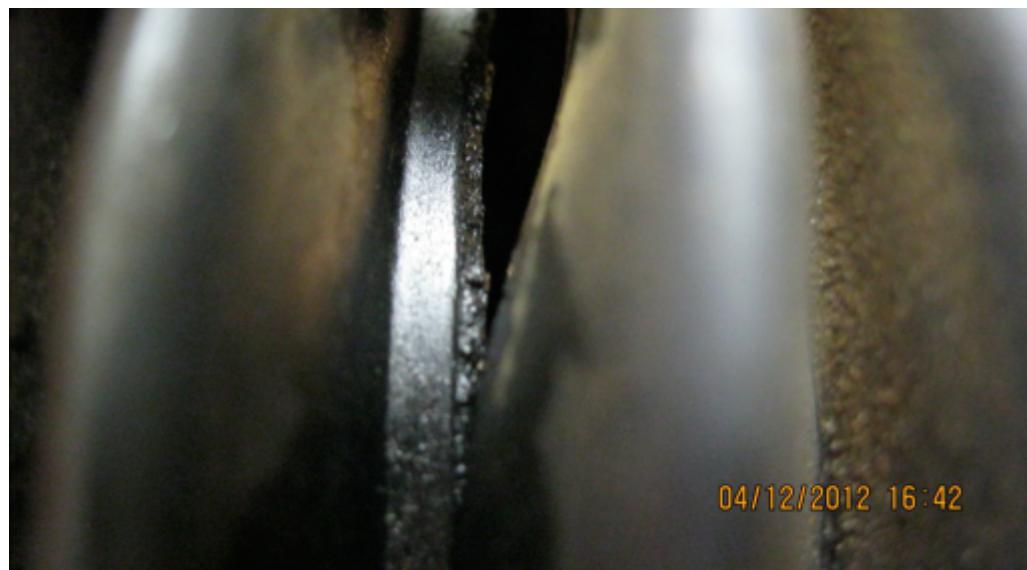
Figure 1a and 1b. Photomicroscopy showing crack in fold of bellows

Testing Undertaken	Photomicroscopy IR-Spec
Failure Analysis	The rubber bellows failed by cracking due to ingress of lithium ions into the nitrile rubber molecular structure.

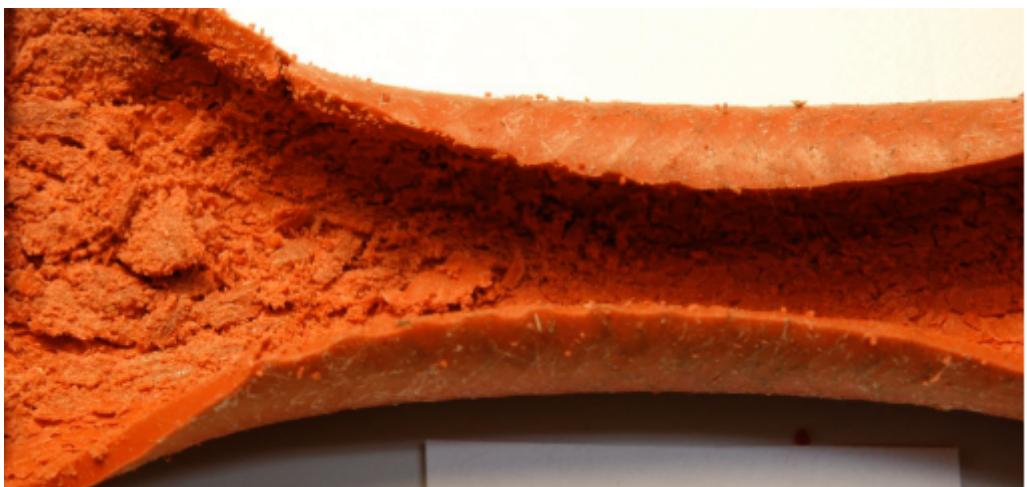
Figure 1. Faulty silicone sample

Testing Undertaken	<p>Ashing at 600°C Elemental Analysis by EDAX SEM Thermogravimetric analysis from RT to 700 °C</p>
Failure Mode	<p>Silicone insulation failed by embrittlement due to thermal degradation. The cable is apparently rated for 300 °C but turned brittle at lower temperatures ('good' silicone sample turned brittle after just 97 hours at 240 °C). The thermogravimetric scans showed that both silicone samples began to degrade at 250 °C, thus the silicone is not properly heat stable and was likely exposed to high conductor temperatures.</p>

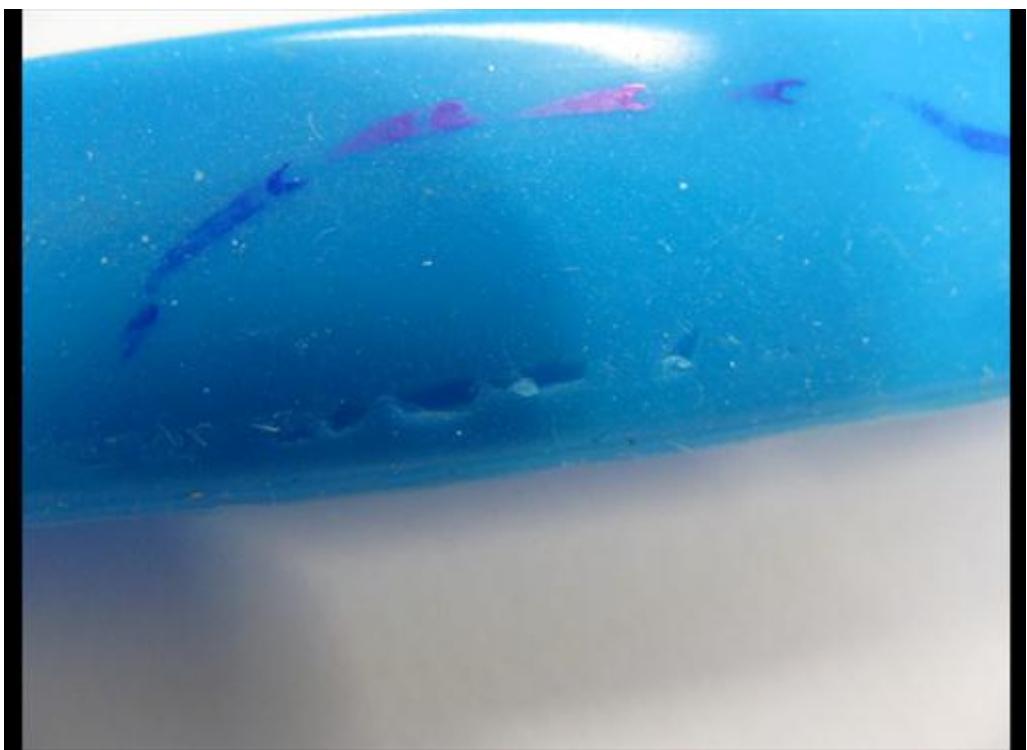
Figure 2. Seal showing areas of cohesive failure

Testing Undertaken	IR-Spec Microscopy
Failure Analysis	The glossy surface of the 'bad' silicone rubber has led to 'auto-adhesion' on the glass and this in turn has led to cohesive failure of the silicone. Use of a less glossy silicone, or one containing an anti-block additive (such as silica), or a grade of silicone with a higher tear strength value is recommended.

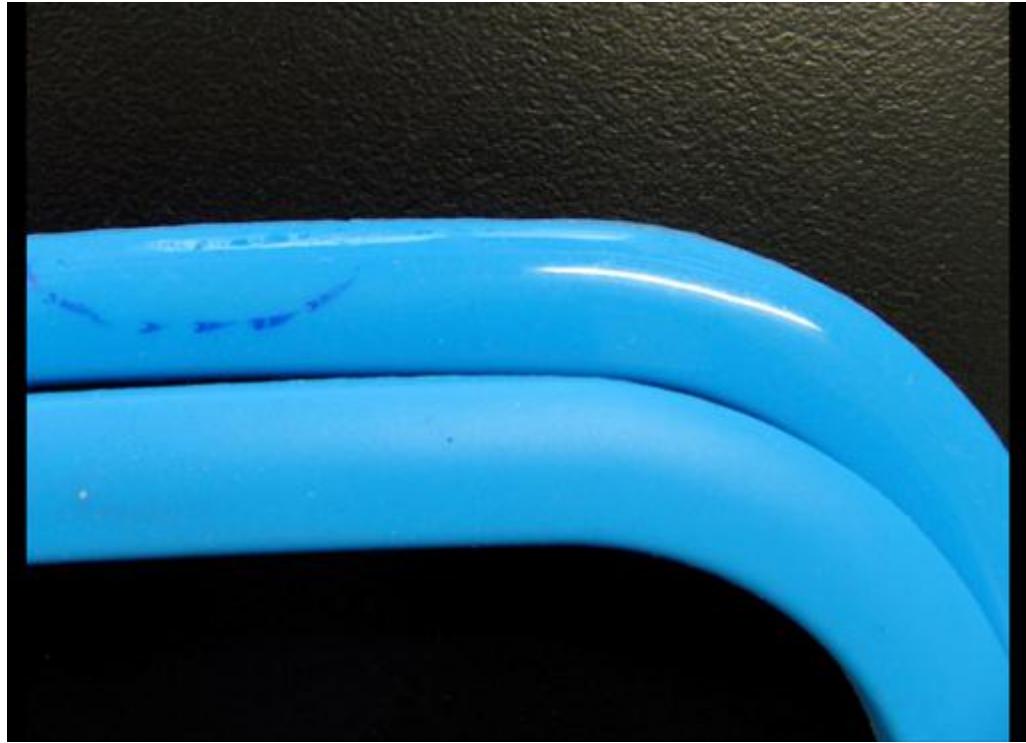
Figure 3. Difference in gloss levels between good (dull) and bad. (glossy) samples

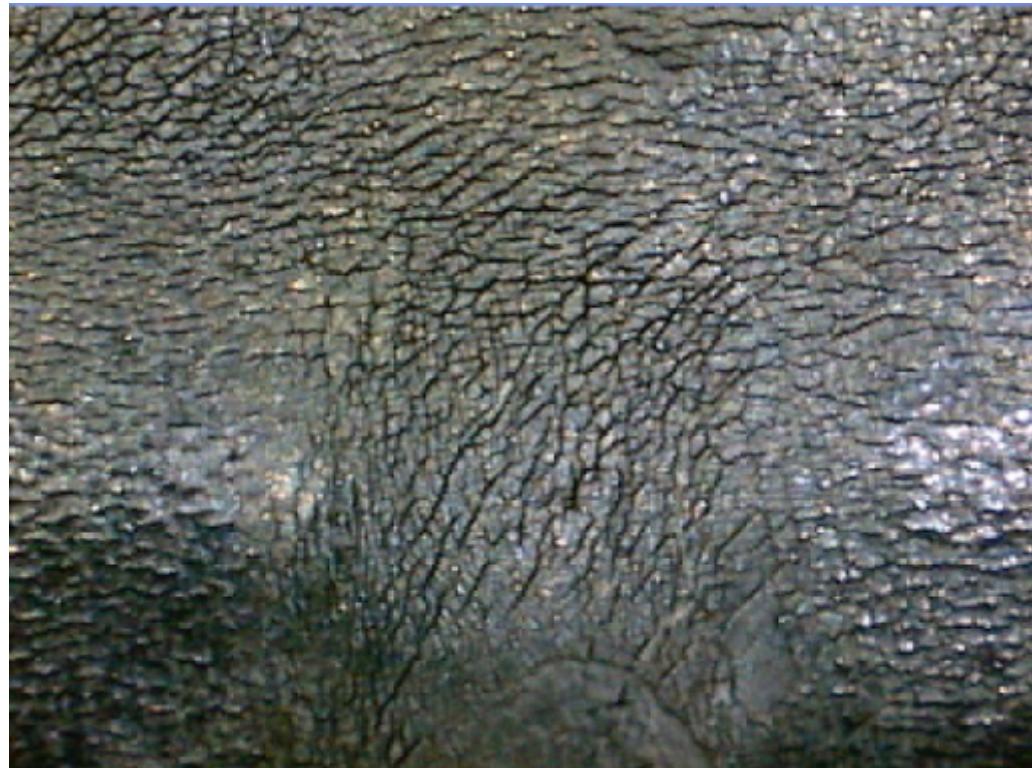
Figure 1. Used 1.0% free chlorine. Note extensive microcracking

Testing Undertaken	Chlorine Exposure Testing (under bending stress) Digital Microscopy (50x)
Failure Analysis	The hose failed due to oxidative stress cracking in part caused by chlorine exposure and in part by stress.

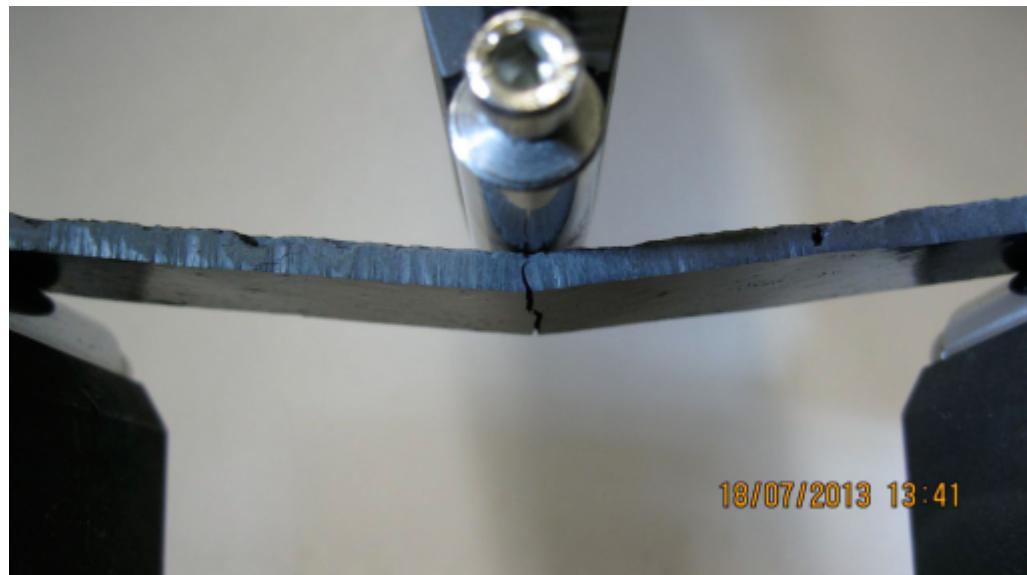
Figure 3. Flexural Testing of Compression Moulded Sample (4 mm displacement & break)

Testing Undertaken	Thermal Analysis by DSC Electron Microscopy Compression Moulding followed by flexural testing Re-emulsification testing
Conclusion	Good adhesion between toner phase and acrylic binder is evidence of mutual compatibility and miscibility. Mechanical testing indicated the toner is capable of moderate flexing, however it exhibits brittle behaviour. It is recommended a rubber modifier be added to reduce brittleness.
