Polymer Testing

Polymer Testing, Polymer Analysis, Plastic Testing, and Plastic Analysis by ExcelPlas

Acrylic – Panels

Title	CRACKED ACRYLIC PANELS
Date	2012
Objective	To investigate the root cause of cracking of acrylic panels used as decorative cladding panels on a foot bridge in NZ.
Photo

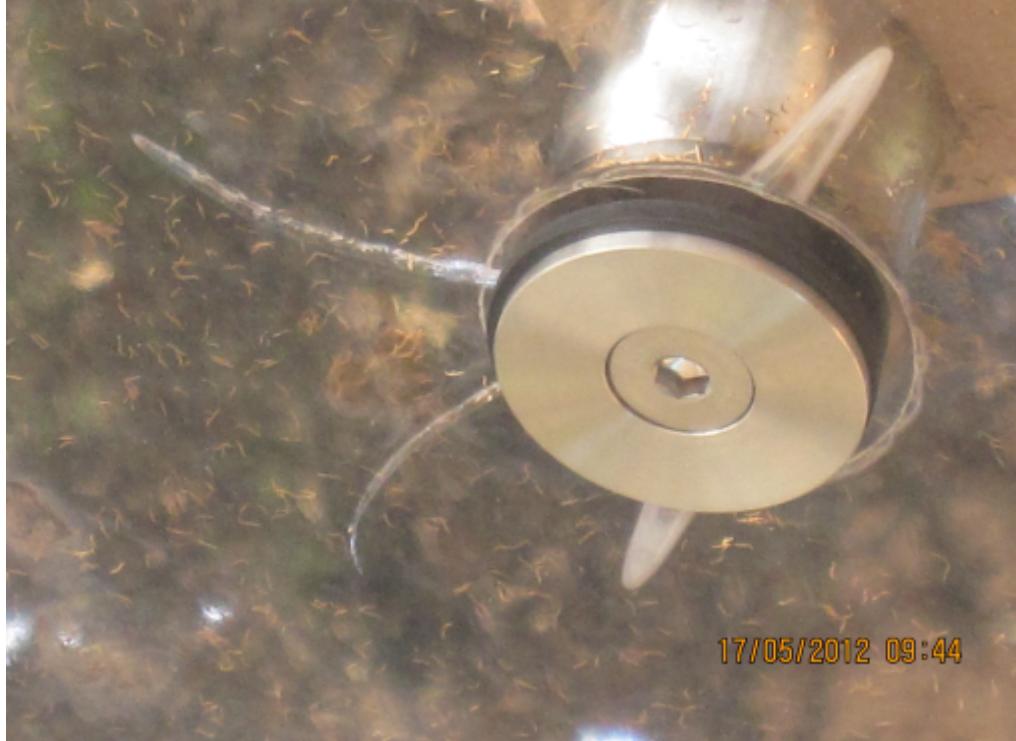
Figure 1. Cracking around mounting holes

<p>Failure Analysis Methodology (Scheirs 2000)</p> <p>Testing Undertaken</p> <p>Determination of Resistance to Environmental Stress Cracking (ESC) ISO 22088-3: 2006</p> <p>GC/MS</p>
Failure Analysis	<p>Cracking of the acrylic sheet was typical of ESC and Cyclic Stress Loading (CSL).</p> <p>Computer modelling showed that the panels were subjected to high strains concentrated around the mounting holes due to thermal stresses and wind gusting in service.</p> <p>The adhesive backed decorative film applied to the acrylic panels was the most likely root cause of the stress cracking owing to the various potent stress cracking chemicals detected in it.</p>

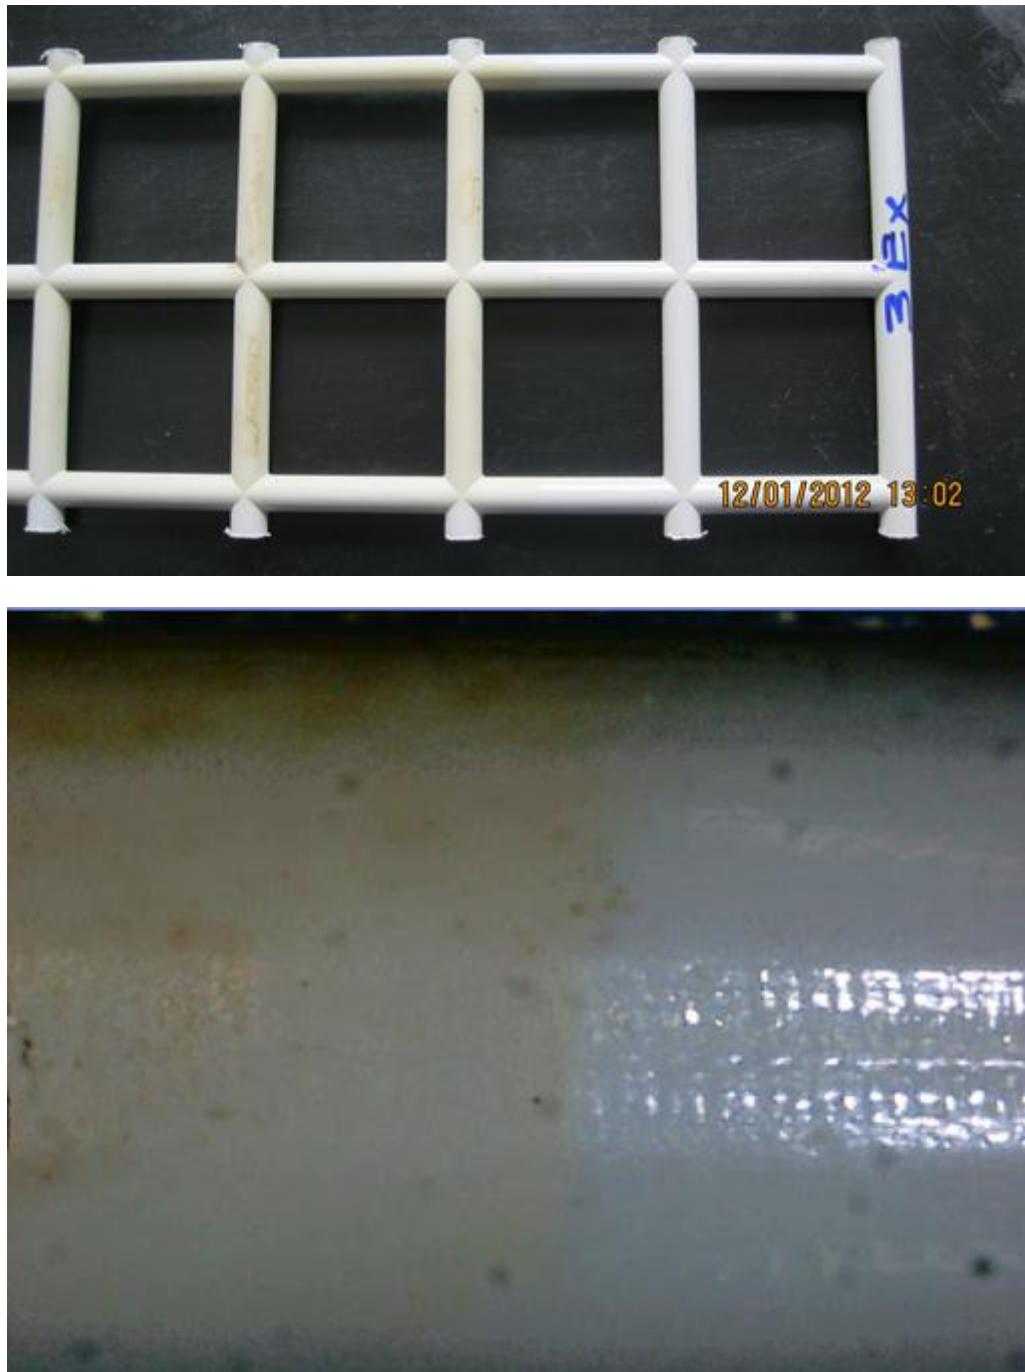
Figure 1a and 1b. Grey Mesh after UV exposure showing slight discolouration

Testing Undertaken	Strips of mesh that had previously undergone accelerated UV aging were re-loaded into a QLabs UV Weatherometer and exposed to a second period of accelerated UV aging. The samples were then visually inspected.
Failure Analysis	Visual inspection of both the grey and yellow mesh samples showed some dis-coloration but no evidence of substantial polymer degradation.

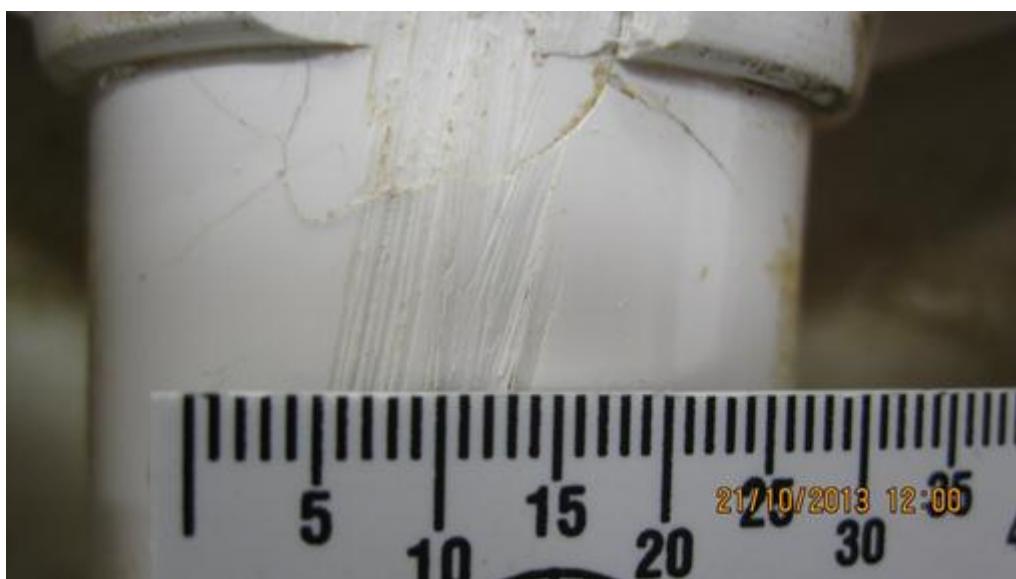
Figure 2. Sample showing cracks at side of moulding

Testing Undertaken	Infrared measurement to determine relative quantities of acrylonitrile in materials Visual assessment of nature of cracks using microscope at various magnification.
Failure Mode	The moulding cracked due to environmental stress cracking caused by cyclohexanone in the adhesive used during assembly.

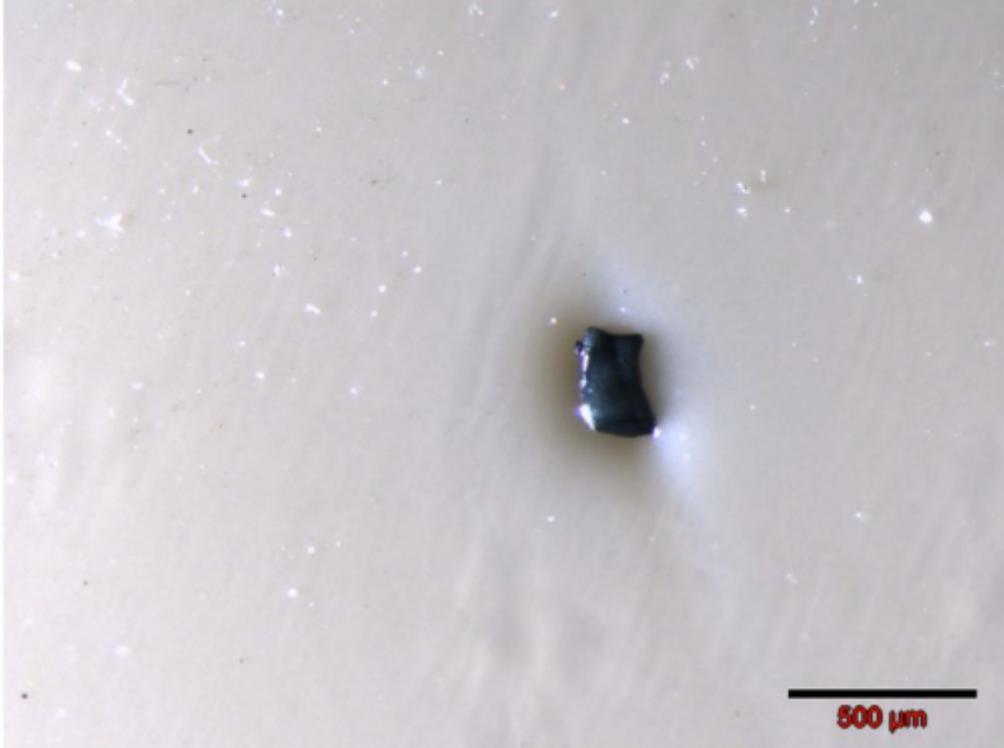
Figure 1. Sample 5
Testing Undertaken	Microtoming Grazing Angle Optical Microscopy (GAOM) SEM Microprobe Elemental X-ray Analysis (EDAX)
Failure Analysis	The defects in the ABS mouldings and plated ABS could be attributed to: carbonized black specks rich in bromine (poorly purged extruder), and blue pigment particles based on ultramarine blue (poorly purged extruder). The black specs may also be related to the use of recycled ABS which has additional heat histories

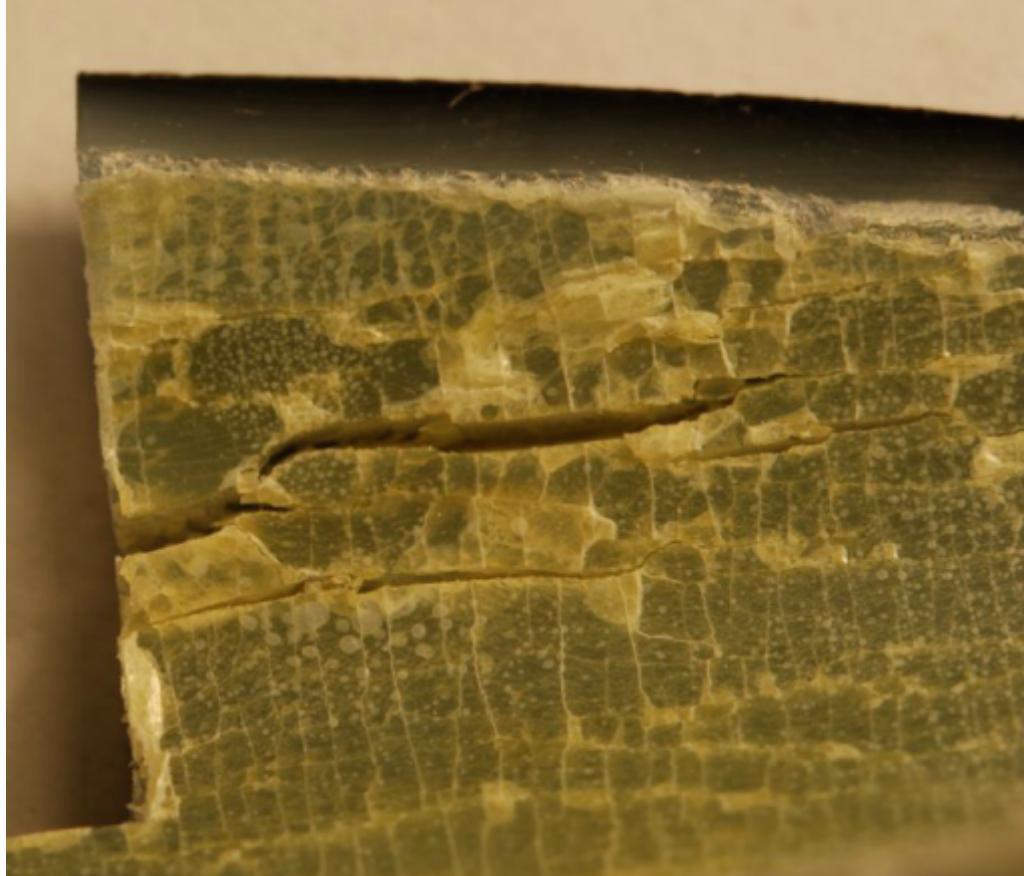
Figure 1. Sample internal surface (Low Mag.)

Figures 2. Internal cracks on sample (40x Mag.)

Testing Undertaken	Wall thickness measurements Photomicroscopy ATR-FTIR Carbonyl Index per ASTM F2102 OIT by DSC per ASTM D3895 Degree of crosslinking per AS2492
Failure Mode	The inner surface of the PEX pipe is totally degraded and embrittled down to ~ 2/3 rd total wall thickness. The PEX pipe has undergone a Stage III failure which is caused by depletion/extraction of its antioxidants.

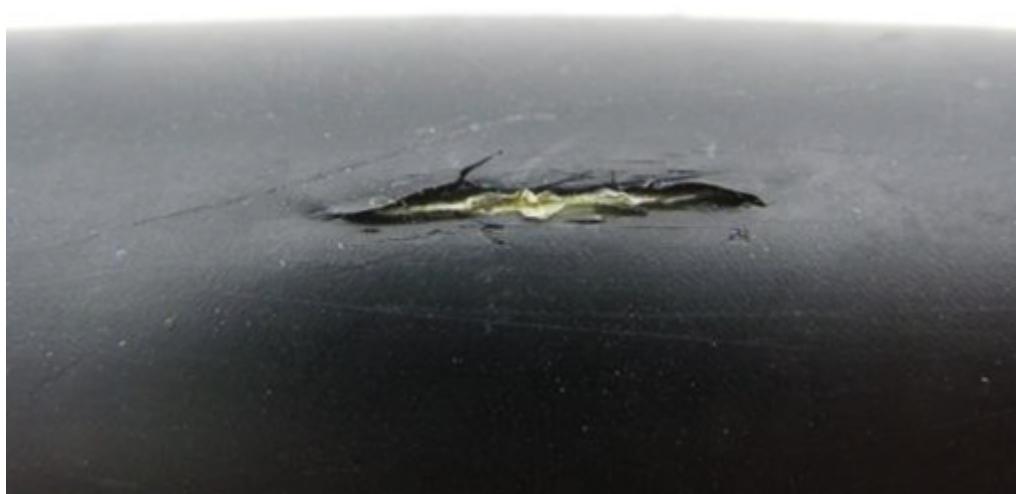
<p>Figure 1. Pipe showing brittle slit failure</p>

Testing Undertaken	SEM Fractographic analysis OIT (per ASTM D-3895)
Failure Analysis	The pipe failed prematurely by Fatigue Crack Propagation initiated at the inner surface.

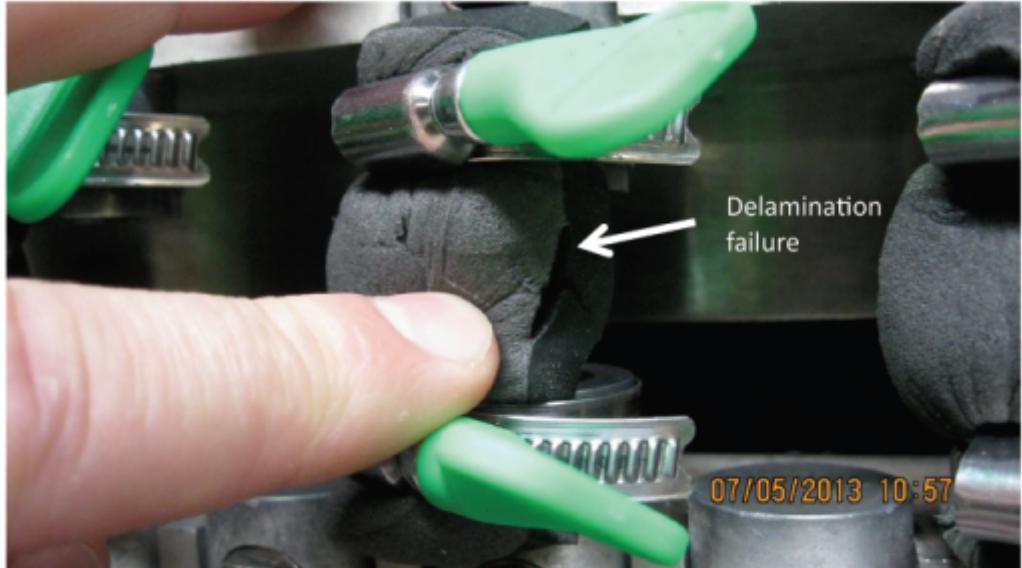
Figure 1. Failure after 1,000,000 flex cycles
Testing Undertaken	Flex cracking resistance of rubbers and elastomers by AS 4878.9-2001
Conclusion	Delamination failure was observed for the rectangular knee pad at the interface between the black rubber and the grey foam after 1,000,000 cycles.

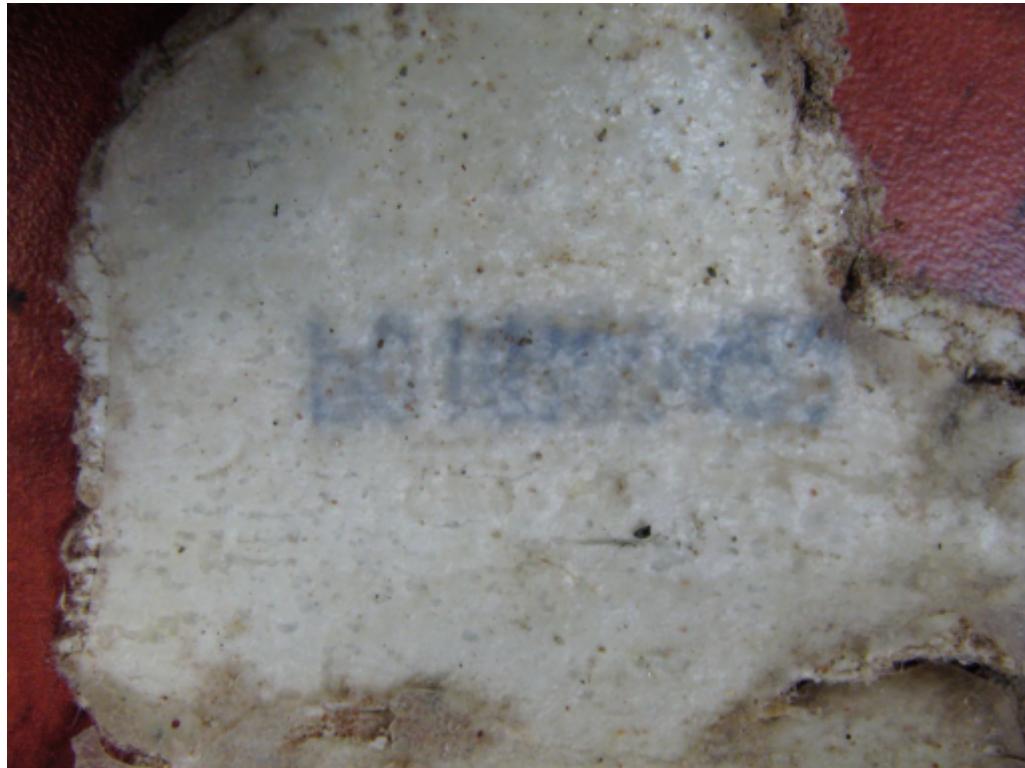
Figure 3. Photograph of recovered liner section

Testing Undertaken	DSC Thermal Analysis IR-Spec Durometer Shore D Hardness Measurements
Failure Analysis	There were some dry felt areas on the recovered liner, thus indicating resin poor zones suggesting the liner may not have been properly impregnated with epoxy resin. The cured liner has limited stress resistance and thus should not be in a load bearing service application as it lacks ring crush resistance and buckling resistance
