Polymer Testing

Plastic – Tap fittings

Polyacetal – Plastic nuts

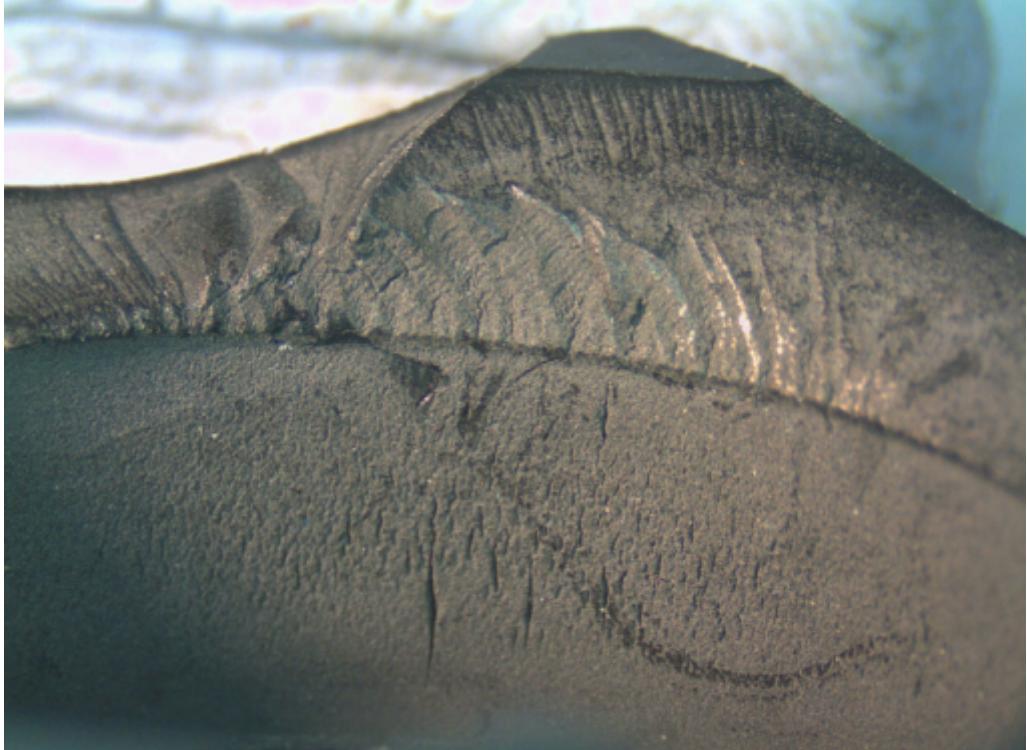
Figure 1. Fracture surface of plastic nut
Testing Undertaken	FTIR by horizontal attenuated total reflectance (HATR)
Failure Analysis	<p>The fractures samples were composed of Polyacetal (POM).</p> <p>Failure was possibly due to the parts undergoing oxidative stress cracking brought about by UV exposure. However, the parts were also exposed to hot water and it is very likely that the parts had degraded by hydrolysis which created formic acid and catalysed further hydrolysis, leading to degradation and embrittlement.</p>

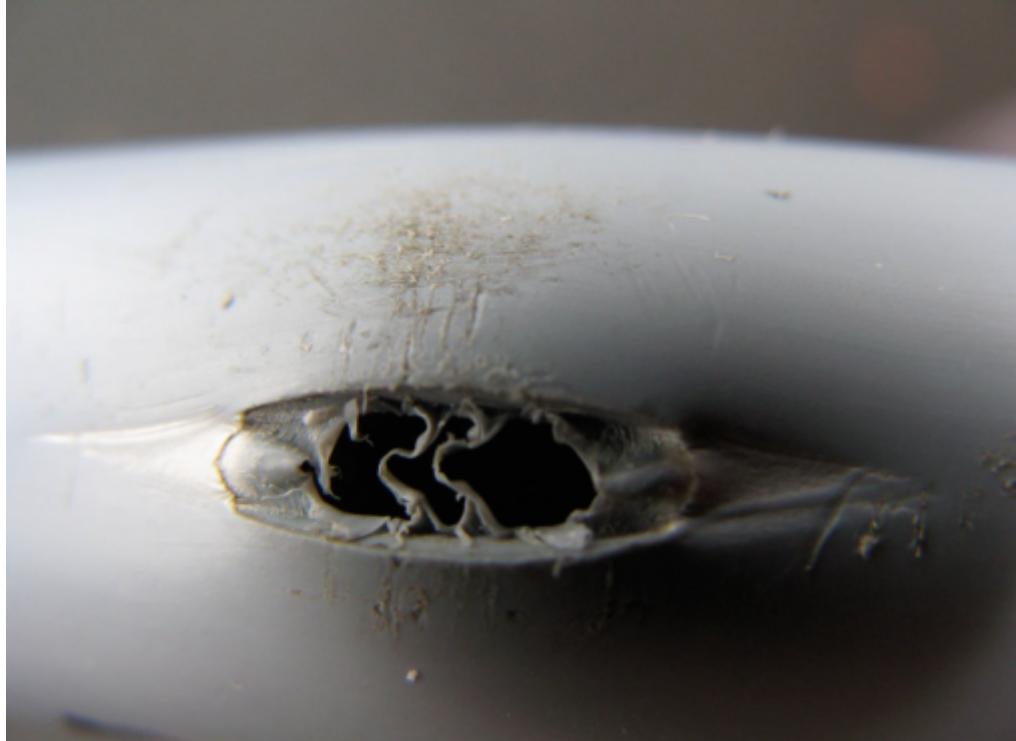
Figure 1. Failure site – ductile/brittle failure. Note scuff marks near failure
Testing Undertaken	Failure analysis Wall thickness analysis
Failure Analysis	The pipe failed prematurely by ductile failure (Stage 1 failure), most likely due to over pressurization by operating pressure excursion. There is also some evidence of brittle failure, thus the failure is best characterized as ductile-brittle hybrid failure

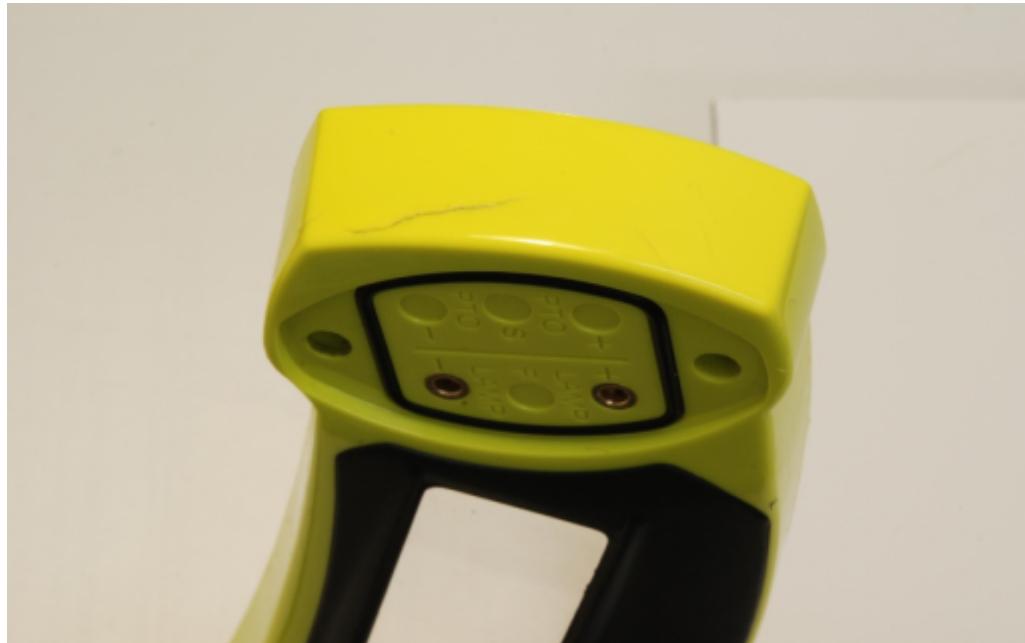
Figure 1. Crack in top cover

Testing Undertaken	Photomicroscopy Solvent Extraction IR spectroscopy
Failure Mode	Brittle nature of cracks and appearance of multiple crack junctions was indicative of environmental stress cracking. The cracking was traced back to the presence of the rubber insert. The rubber insert was chemically analysed and found to be made of an oil-extended styrene-co-isoprene synthetic rubber. The oil extender in the rubber appears to be a strong stress cracking agent for polycarbonate.

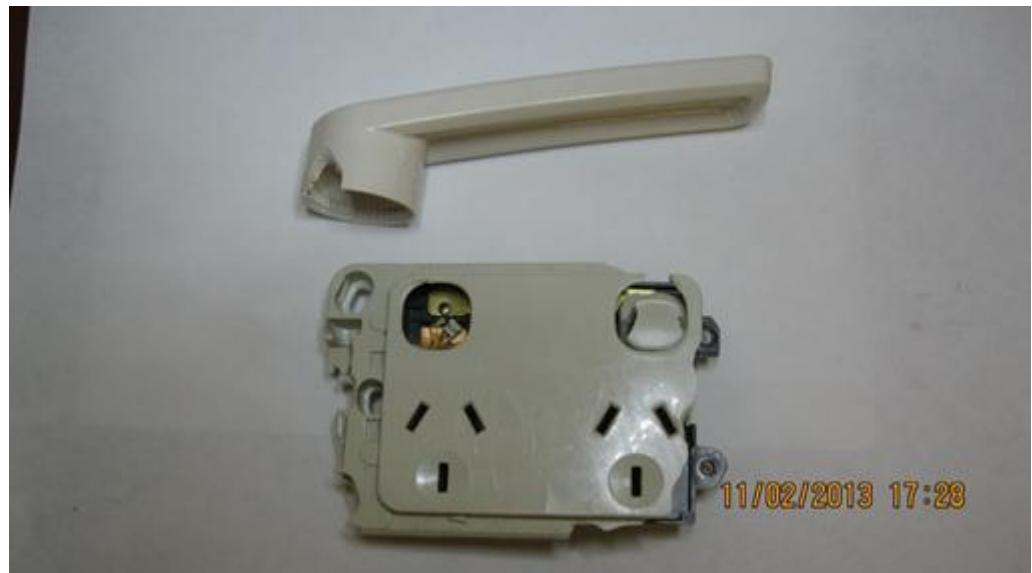
Figure 1. Photograph of handle and switch plate

Testing Undertaken	FT-IR (per ASTM E573) DSC (per ASTM D 3418)
Failure Analysis	<p>Handle: The handle material was Poly(ethersulfone) (PES). The nature of the cracking on the handle was highly suggestive of stress cracking as the material was locally embrittled and there were multiple crack fronts (see Figure 2). It was likely that the handle had been in contact with a disinfectant or cleaning chemical based on some organic chemicals (such as ketones, esters, DMSO, aromatic amines, nitrobenzene and some chlorinated hydrocarbons)</p> <p>Switch plate: The switch plate material was most likely polycarbonate (PC). The failure was also due to stress cracking and may have been due to the same type of chemicals that affected the PES handle.</p>

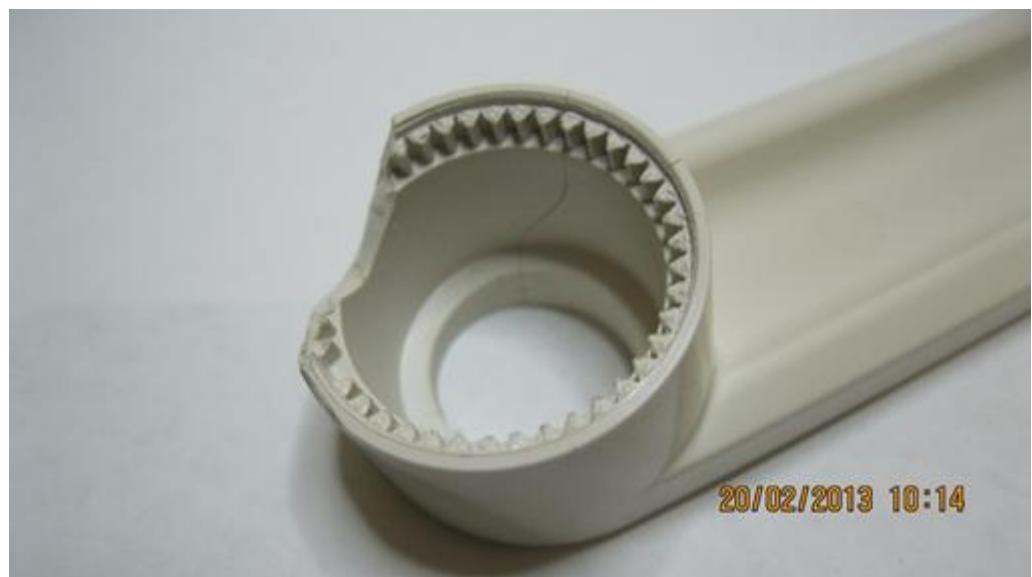
Figure 2. Photograph of handle showing multiple crack fronts initiated from a sharp moulded in notch at the point where the gripping teeth are present

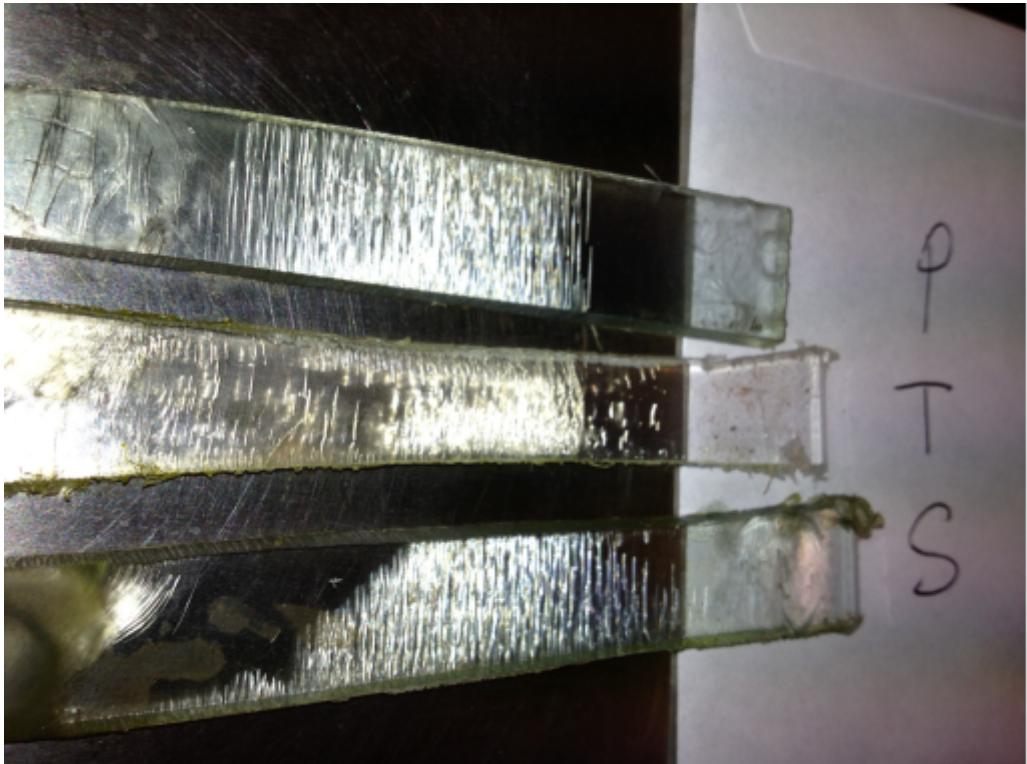
Figure 1. Results of Moderate Strain Test (dia. 400 mm). Note crazing on all three samples

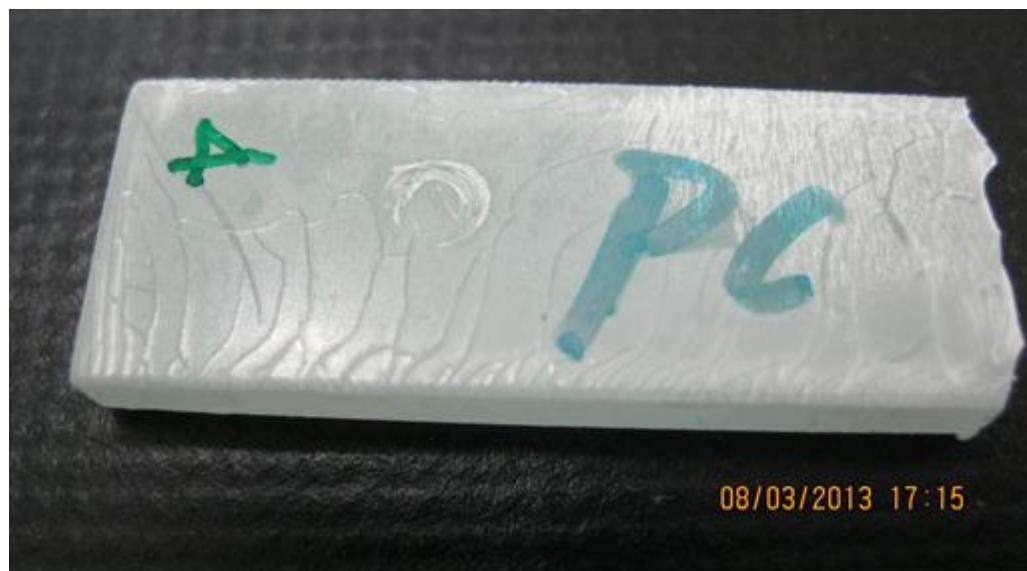
Figure 2. Polycarbonate specimen showing effect of immersion in d-limonene. Evidence of severe stress cracking at points where specimen held in notching apparatus.

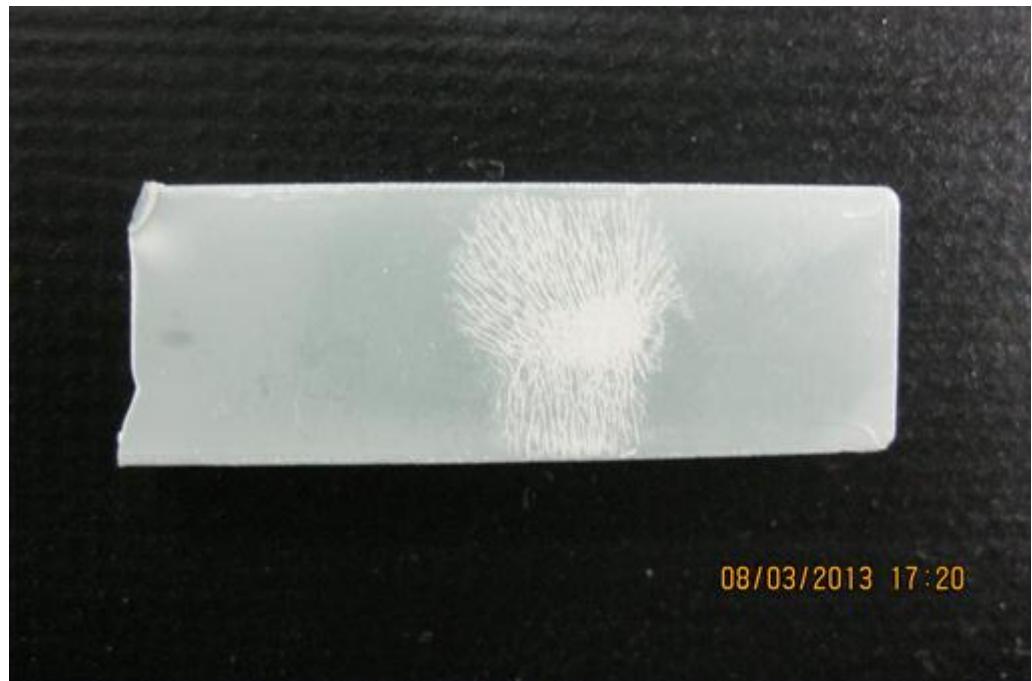
Figure 3. Stress cracking of Polycarbonate specimen after immersion in d limonene

Testing Undertaken	Izod Impact Strength measurement testing according to ASTM D 256 using Test Method A
Conclusion	D limonene can cause stress cracking of polycarbonate.
