## Quality Defect Report (v 2)

Howell south west

24A e12

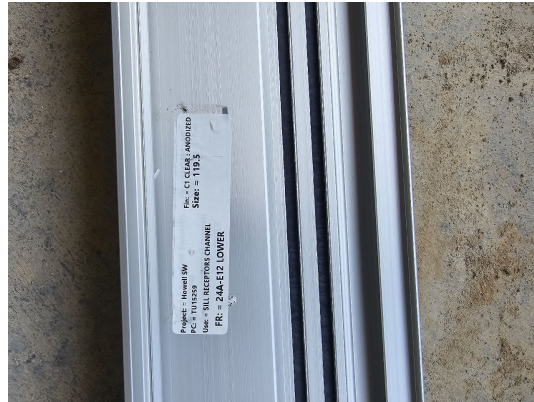
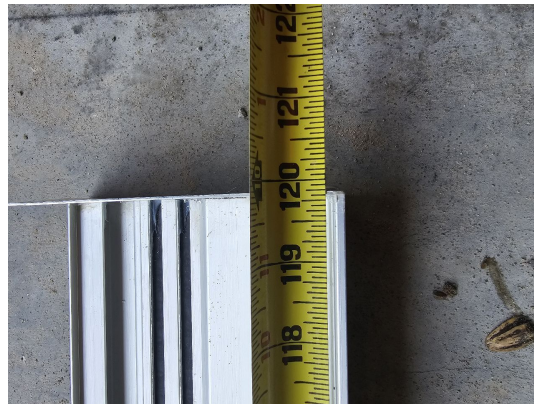
Labeled cut size 119½ actually 119⅞
