23/07/2025

## **DIVING SERVICE REPORT UNIT 2A UNDERWATER STOP LOG & SEAL PLATE INSPECTION.**

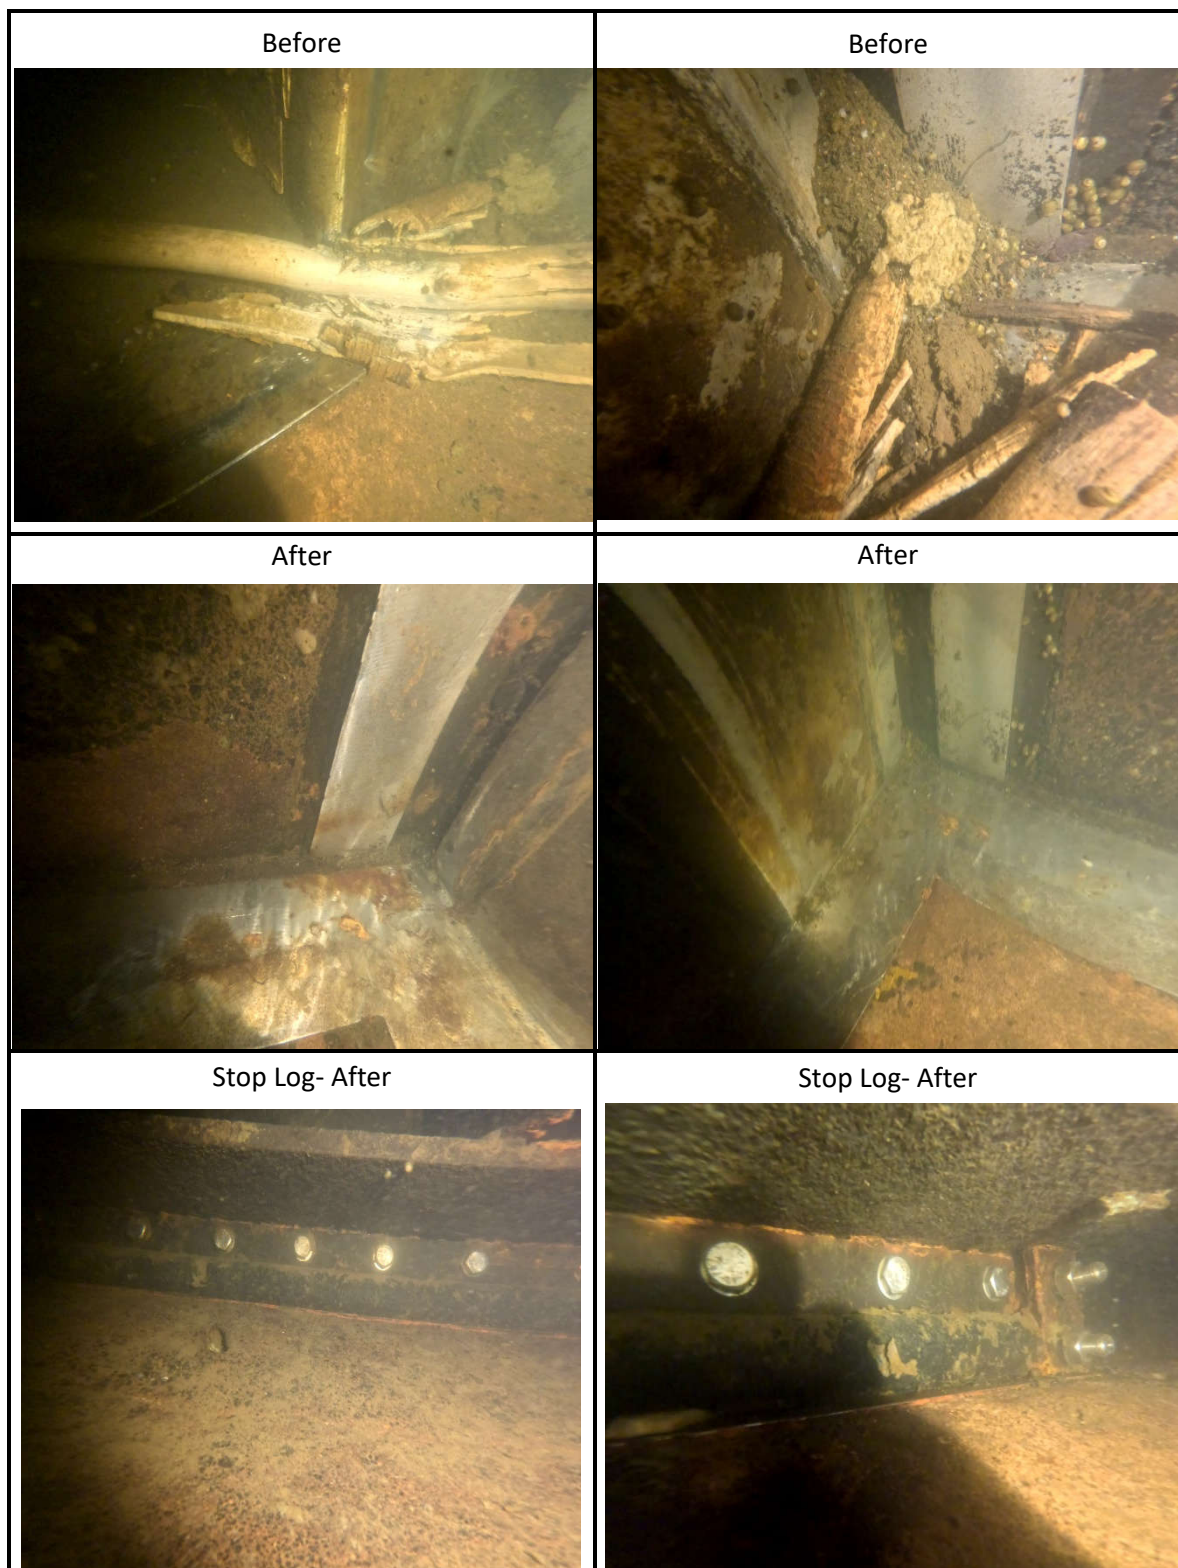
*Attach photos showing the debris removal process, final seating and indicating the cleaned areas.*

1. Multiple pieces of small wooden debris and a stone identified during the initial inspection were successfully removed.
2. The seating area was left clean, smooth, and free of obstructions.
3. After re-seating, no gaps were observed on the edges or along the length of the stop logs.
4. Water leakage previously noted (approximately 2 cm gap) is now completely eliminated.
5. The stop logs are in good structural condition and firmly sealed.

- Continue routine underwater inspections before and after stop log installation to ensure a clean seating surface.
- Once the dive is completed, first initiate the lowering of the bottom stop logs on both sections.
