17/07/2025

# **BUJAGALI HYDROPOWER PLANT. UNIT 2 DOWNSTREAM LIFTING BEAM INSPECTION AND LIFTING REPORT.**

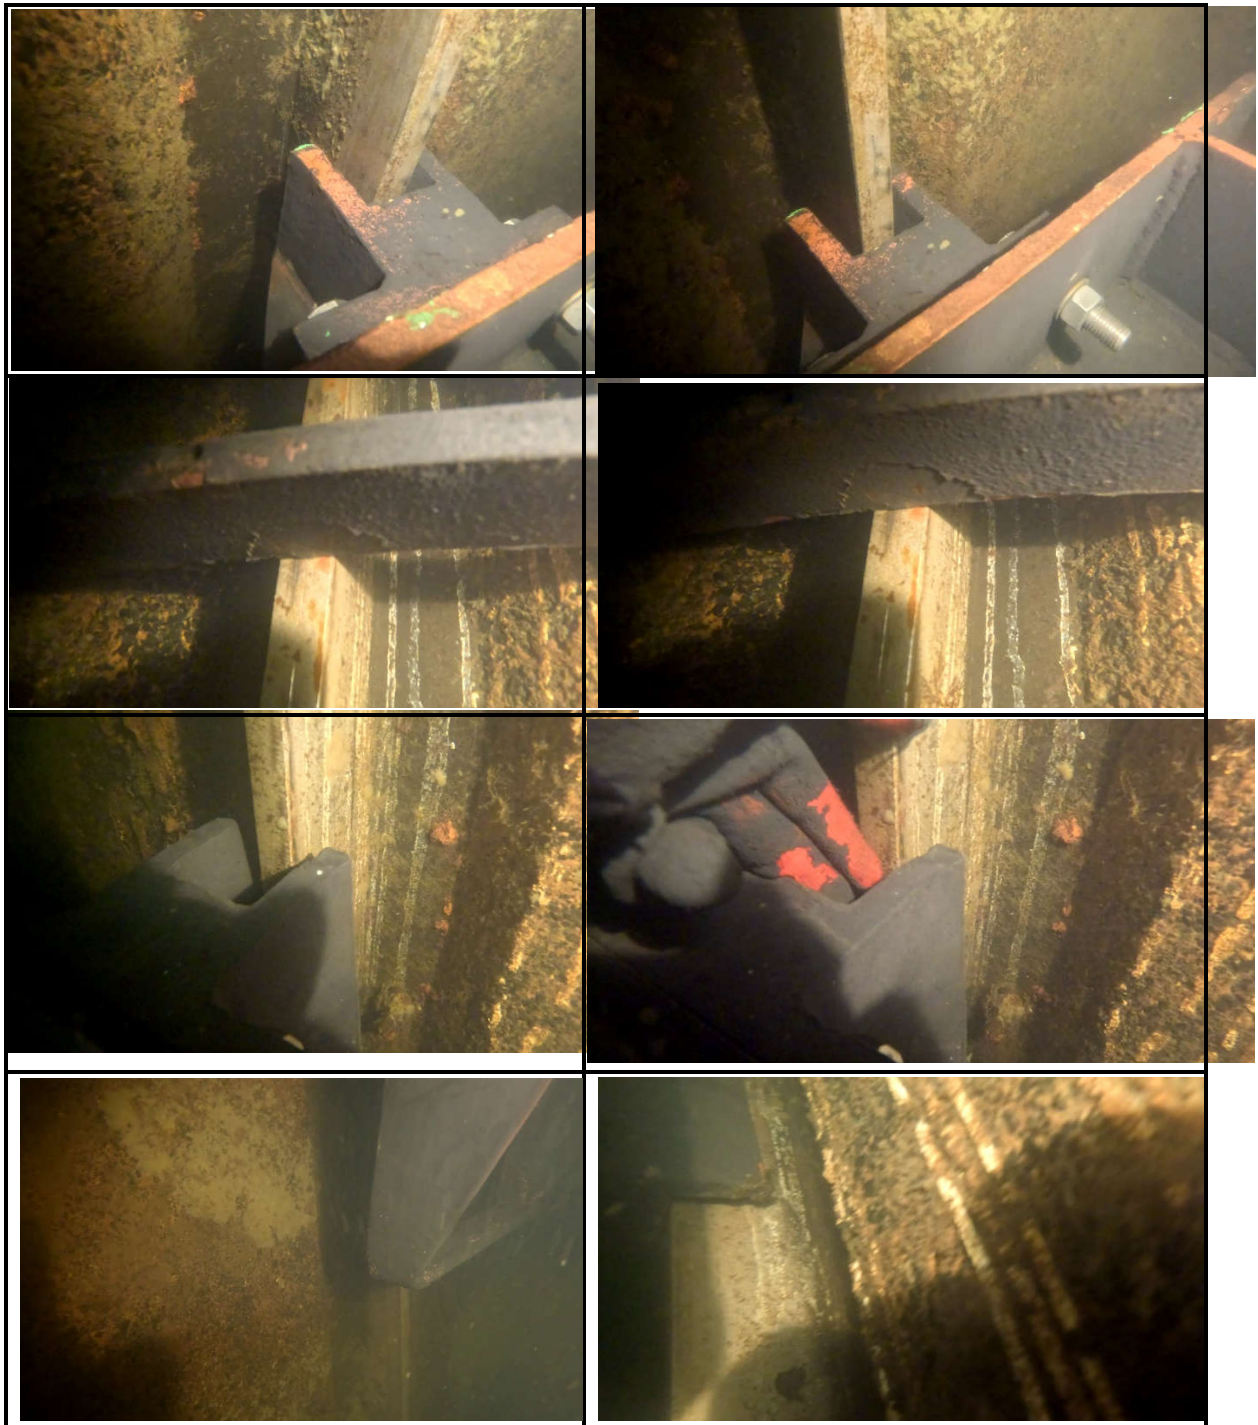
Table 1: Showing how the lifting beam edges were in contact with the guide rails.

The diving team mobilized on 19th July 2025 at 11:30. After a safety briefing and equipment checks, the divers entered the water to locate and inspect the lifting beam. The beam was confirmed to be stuck and not properly balanced on the tail race/ guide rails at around 11 meters. The upper side of the lifting beam edge was stuck at 11.6 meters deep, leaving a gap of about 5 centimeters towards the guide rail, while the lower side was stuck at 11.2 meters deep, leaving no gap between the lifting beam edge and the guide rails. This resulted in an inclination of approximately 0.4 meters. Divers installed slings and chain block of 2 tons on the available lifting points, and inflatable lifting bag/ balloon of 1 ton was positioned strategically. A controlled lift was executed in stages to realign the beam before final lifting up.

The lifting beam was successfully recovered and aligned without damage. No injuries or incidents were reported. Minor scratches were noted on the guide railings on both walls/ sides.

1. Conduct underwater inspection on the guide rails to check its alignment especially where the lifting beam was stuck.
2. Schedule such operations during low-flow periods/ no surface currents.
