Vibration Analysis Report

August 2025 / 408 Section Vibration Report

Report Number: 408 Sec-VA-190825

Mogalakwena North Concentrator/MNC Wet Section/VIB-Section-408/408 Off Line/408 Conveyors/408 Conveyor Drives

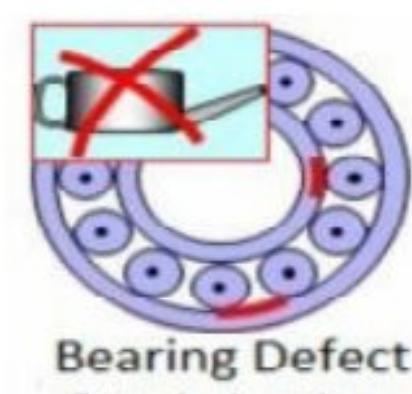
408-PP-002 / Motor

Date: 2025/08/18
Fault Type: **Bearing Defect & Lubrication**
Findings: The vibration recorded indicates raised noise floor in the high frequency range with low amplitude defect frequency present. This typically relates to a lubrication starvation and or early bearing defect developing.
The 10-1KHz band trend has been increasing, bearing defect visible in the acceleration spectrum in 10-1KHz frequency range.
Action: Ensure both bearings have optimal lubrication.

**Bearing Defect
& Lubrication**

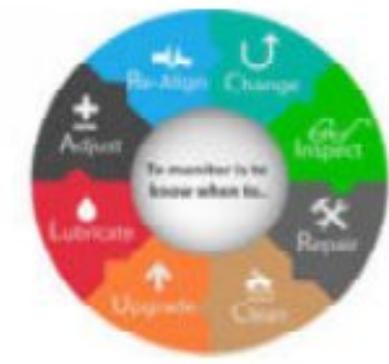
Machine: 408-PP-037

Fault Type: Monitor Condition

Findings: The vibration recorded indicates a possible lubrication starvation and or early bearing defect developing in the enveloping spectrum. impacting at low amplitudes is also present in the time domain.

Action: Continue to monitor the condition for any change.

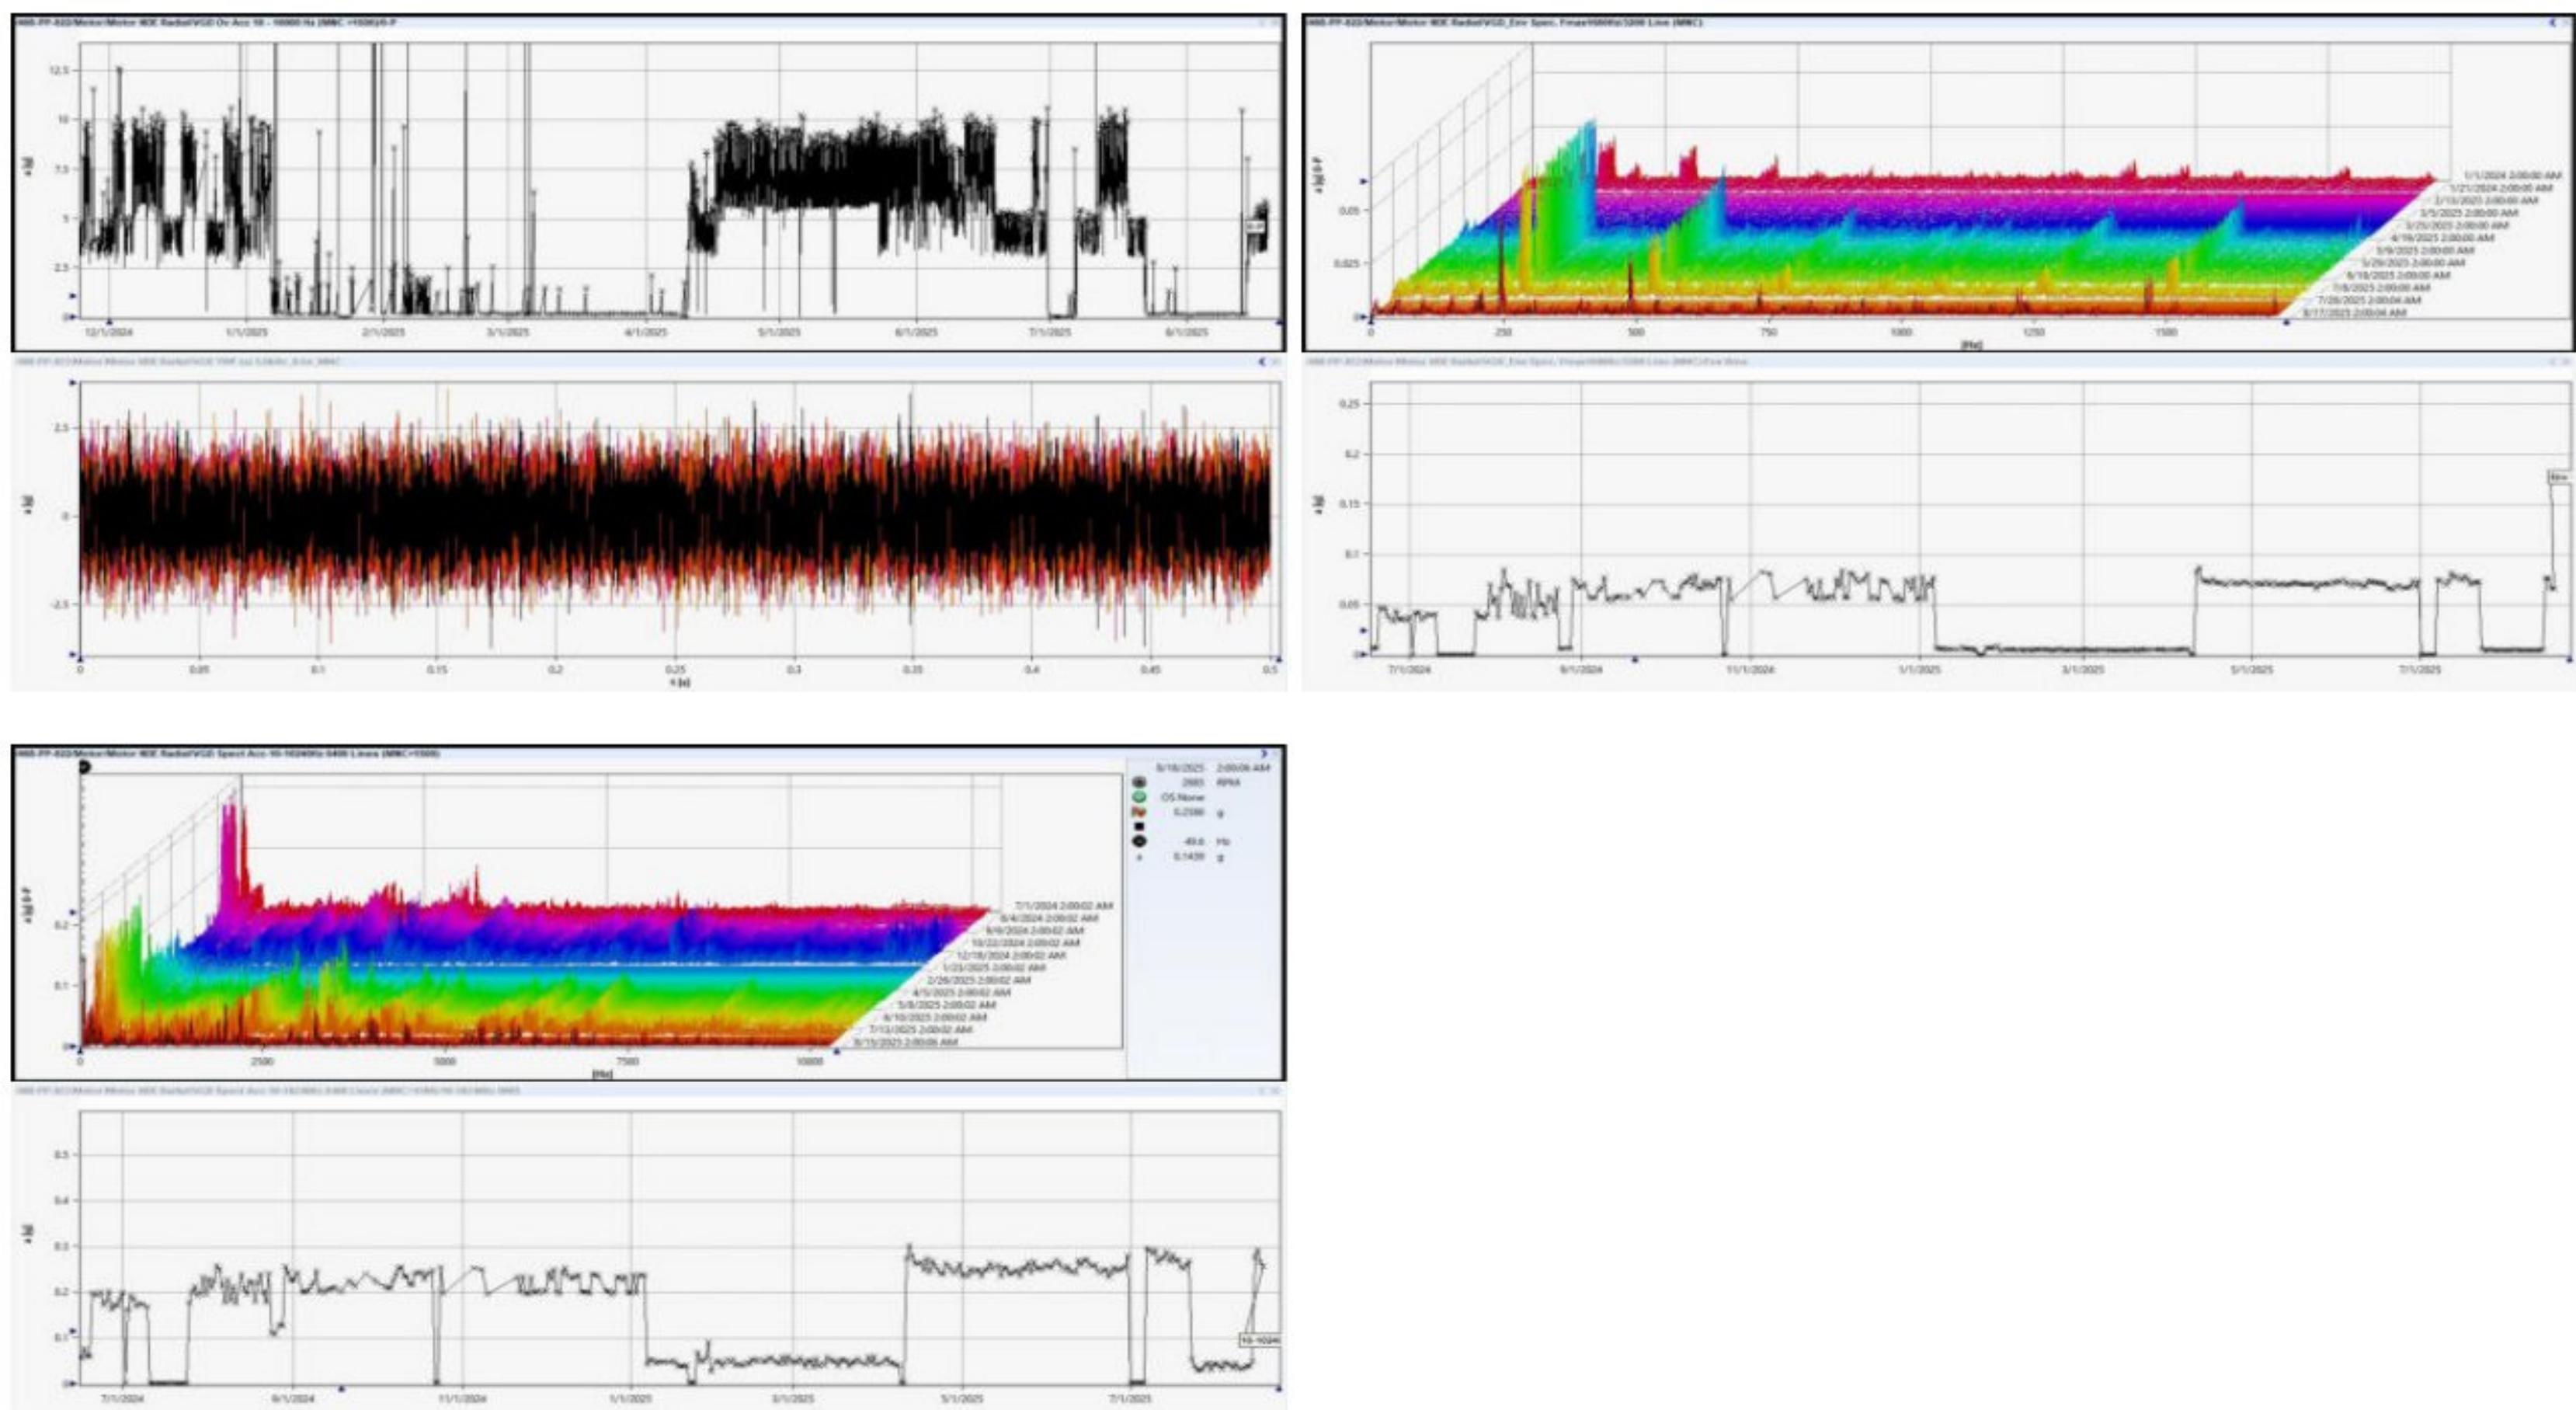
Machine: 408-PP-022

Fault Type: Bearing Defect

Findings: The vibration recorded indicates no further deterioration of previously recorded bearing defect. Low amplitude impacts in the time domain, enveloping RMS band trend and overall acceleration trends are stable.

Bearing Defect

Action: Continue to monitor the condition for any further deterioration.
