## NANOSPECT AI — RESIDENTIAL HOUSING INSPECTION REPORT

100 E University  
04/20/2026

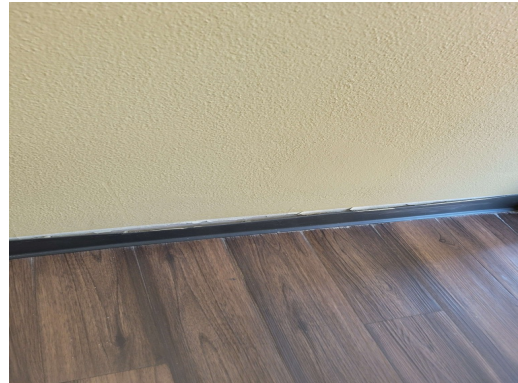
### Finding 1: INTERIOR BASEBOARD SEPARATION

Minor Defect / FYI

A continuous gap is observed between the top edge of the baseboard trim and the adjacent wall surface. This separation appears to be a result of material shrinkage over time, minor structural settling, or the failure of the original adhesive or fasteners. The condition is currently cosmetic but presents a potential entry point for insects and allows for the accumulation of dust and debris. If left unaddressed, the gap may widen due to normal temperature and humidity fluctuations. Furthermore, this condition compromises the finished aesthetic of the interior space and can make cleaning more difficult.

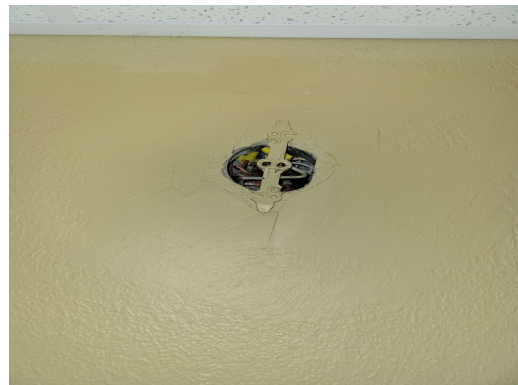
### Finding 2: EXPOSED ELECTRICAL WIRING

Significant Defect

Hallway Wall

An open electrical junction box was observed in the wall, leaving energized wires and connection points exposed. This condition typically occurs when a light fixture or cover plate has been removed and not properly replaced. The absence of a protective cover presents a significant electrical shock hazard to occupants, especially if the wires are inadvertently touched. Additionally, the open box is susceptible to accumulating dust and combustible materials, which increases the risk of an electrical fire. This is a serious safety violation that requires immediate attention to prevent potential injury or property damage.

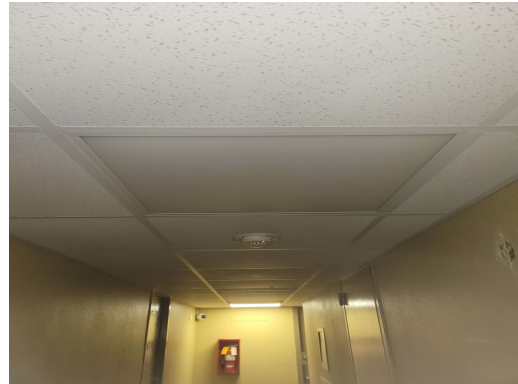
### Finding 3: INOPERABLE CEILING LIGHT

**Marginal Defect**

#### Hallway Ceiling

The central recessed troffer light fixture located in the hallway ceiling was found to be non-functional at the time of the inspection. The probable cause for this condition could range from a simple burnt-out bulb or a failed ballast to a more complex issue with the electrical wiring or the controlling switch. This lack of illumination results in a significant reduction in ambient light within a primary thoroughfare of the property. The resulting dim conditions create a potential safety hazard by increasing the risk of trips and falls over unseen obstacles. Continued use of the hallway in this state compromises the safety and functionality of the space.

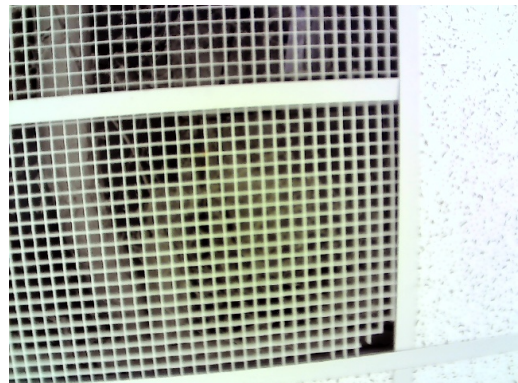
### Finding 4: DAMAGED HVAC REGISTER

**Minor Defect / FYI**

#### Hallway Ceiling

The ceiling air return vent cover exhibits physical damage and a significant buildup of dust and particulate matter on its grille. The breakage could be the result of accidental impact or simple degradation of the material over time, while the dust is an accumulation from normal HVAC system operation without periodic cleaning. This condition can negatively impact indoor air quality by circulating dust, allergens, and other contaminants. Furthermore, the damaged components of the grille could potentially detach and fall into the space below. The overall efficiency of the HVAC system may also be marginally reduced due to restricted airflow.

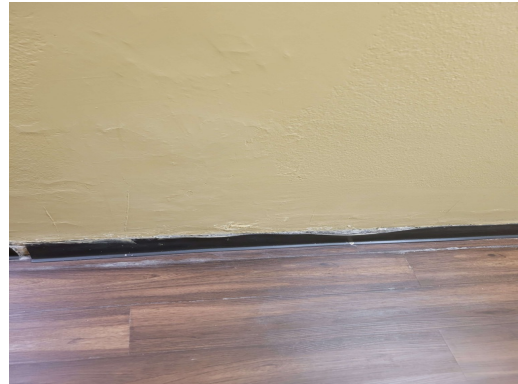
**Finding 5: WARPED AND SEPARATED BASEBOARD**

Minor Defect / FYI

## Hallway

A noticeable gap and signs of warping were observed along the top edge of the baseboard where it meets the wall. This condition is prevalent in multiple areas and is likely caused by a combination of factors, including the natural expansion and contraction of building materials and failure of the original caulk and adhesive. The separation creates an unfinished appearance and provides a space where dust, moisture, and pests can accumulate. If moisture intrusion were to occur in this area, it could be concealed behind the baseboard, leading to potential hidden damage. This is a recurring maintenance item noted in the property.

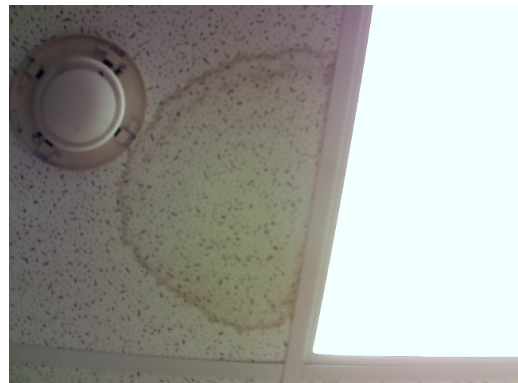
**Finding 6: EVIDENCE OF MOISTURE STAIN**

Significant Defect

## Hallway Ceiling

A distinct, circular water stain is present on an acoustic ceiling tile. This type of staining is clear evidence of moisture intrusion from an area above the ceiling, such as a roof leak, plumbing failure, or a malfunctioning HVAC condensation line. While the stain may be from a past and repaired leak, its presence warrants further investigation to determine if an active moisture source exists. If the leak is ongoing, it can lead to significant secondary damage, including decay of structural components, ceiling collapse, and the development of microbial growth. The integrity of the ceiling tile itself has also been compromised by the moisture saturation.

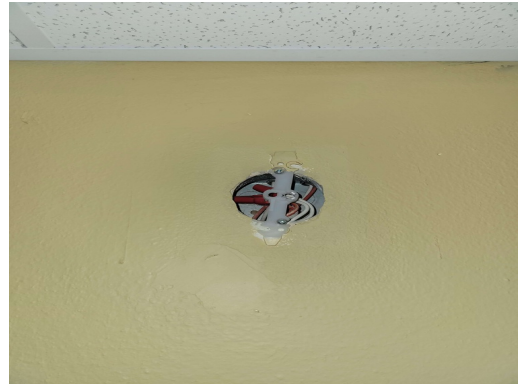
## Finding 7: EXPOSED ELECTRICAL WIRING

**Significant Defect**

Hallway Wall

A second instance of an uncovered electrical junction box was identified in the hallway wall, exposing internal wiring and connectors. The cover plate for this box is missing, which is a direct violation of standard safety codes for electrical installations. This condition presents an immediate and serious risk of accidental electric shock to anyone who might come into contact with the energized components. Furthermore, the absence of a cover allows for the potential intrusion of foreign objects or dust, creating a notable fire hazard. This unsafe condition requires prompt remediation to ensure the safety of the building's occupants.

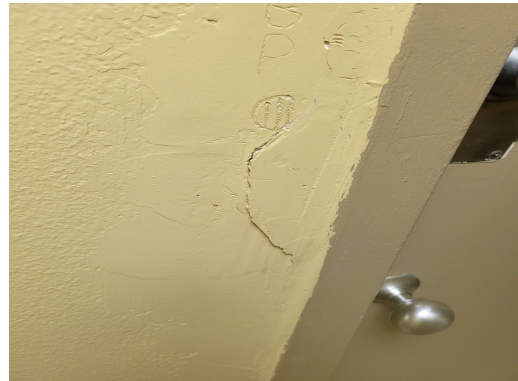
## Finding 8: DAMAGED INTERIOR DRYWALL

**Marginal Defect**

Hallway Wall by Door

A vertical crack was observed in the drywall surface adjacent to a door frame, accompanied by additional superficial damage. This type of cracking is commonly associated with stress points in the structure, often resulting from normal building settlement or repeated vibrations from door usage. Although the immediate issue appears cosmetic, such cracks can propagate over time and may indicate underlying movement of the wall framing. The breach in the finished surface also creates a potential pathway for moisture ingress and can flake or chip further. This compromises the integrity of the wall's finished surface.

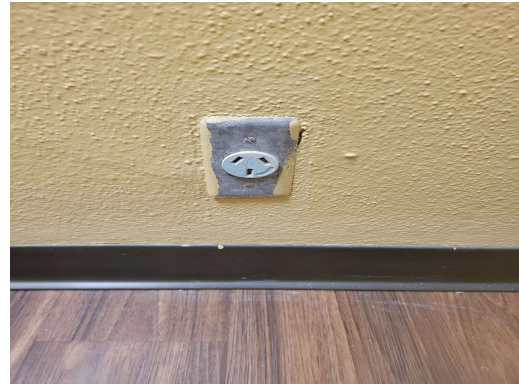
**Finding 9: NON-STANDARD ELECTRICAL RECEPTACLE****Marginal Defect**

## Hallway Wall

An electrical outlet with a non-standard configuration was observed installed near the floor. The receptacle appears to be a high-voltage or specific-use type, such as a twist-lock connector, rather than a standard 120-volt duplex outlet. This type of installation is typically intended for dedicated commercial or industrial equipment and is incompatible with common residential or office appliances. As a result, this outlet is non-functional for general purpose use within the space. Its presence does not contribute to the utility of the room for standard equipment and may have been left over from a previous building configuration.

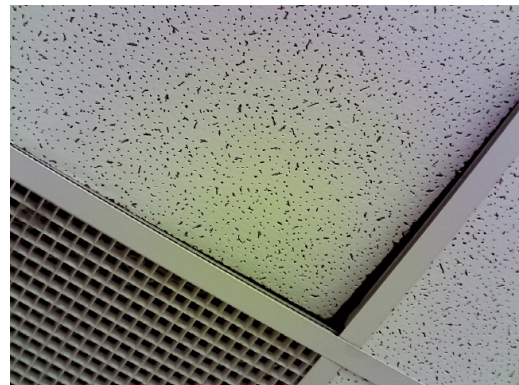
**Finding 10: DISPLACED CEILING TILE****Minor Defect / FYI**

## Hallway Ceiling

An acoustic ceiling tile was observed to be out of alignment and not properly seated within its suspended grid frame. This misalignment is often the result of recent maintenance or inspection activities within the ceiling plenum, but can also be caused by vibrations or air pressure changes. The condition is primarily cosmetic, detracting from the uniform appearance of the ceiling. However, the resulting gap can permit unconditioned air, dust, and debris from the plenum space to enter the occupied area below. In certain commercial ceiling systems, proper seating of all tiles is necessary to maintain the assembly's intended fire-resistance rating.
