## NANOSPECT AI — DORMITORY INSPECTION REPORT

100 E University  
04/17/2026

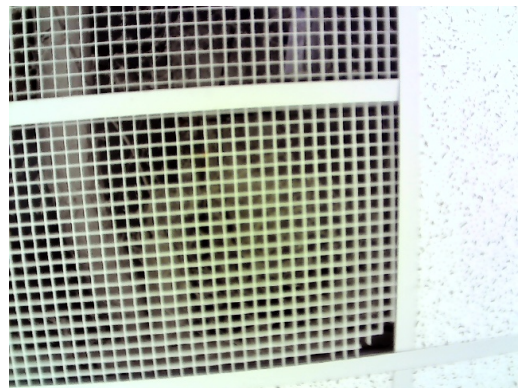
### Finding 4: DAMAGED HVAC VENT COVER

**Minor Defect / FYI**

#### Hallway Ceiling

The HVAC return air vent cover installed in the ceiling grid was observed to be damaged. A section of the plastic grille is broken and not seated correctly within its supporting frame. An accumulation of dust was also noted on the grille and within the visible ductwork. Damage to such components can result from accidental impact or material degradation over time. A broken grille can potentially impede airflow, which may slightly reduce the efficiency of the HVAC system. The dust buildup can negatively impact indoor air quality as particles are circulated by the system.
