## INSPECTION FINDINGS

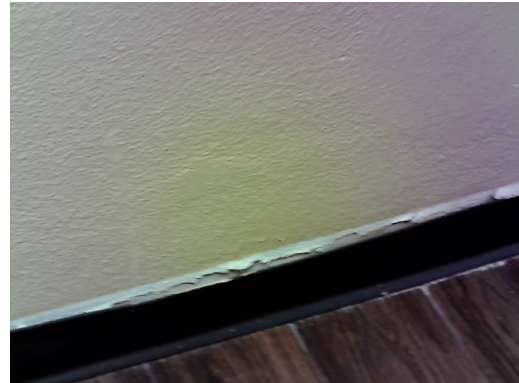
### Finding 1: BASEBOARD SEPARATION FROM WALL

Minor Defect / FYI

A visible gap was observed between the baseboard and the adjacent wall surface. The sealant applied to this joint has failed, exhibiting cracking and peeling along the upper edge of the trim. This condition is commonly caused by the natural expansion and contraction of building materials due to temperature and humidity changes, or minor building settlement. While primarily a cosmetic issue, the gap can collect dust and debris. If left unaddressed, the paint and caulk will continue to deteriorate, further detracting from the interior finish. The opening could also create a pathway for insects into the wall cavity.

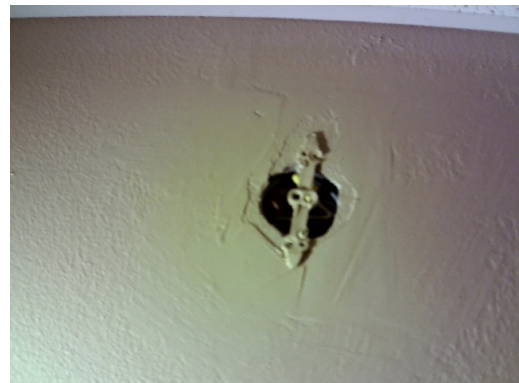
### Finding 2: EXPOSED ELECTRICAL WIRING

Significant Defect

Left side of the hallway

An uncovered opening in the wall reveals an electrical box with exposed wiring. No fixture or protective cover plate was installed over the box at the time of the inspection. This condition typically occurs when a fixture is removed and not properly terminated with a blank cover. Exposed, potentially live electrical conductors present a serious risk of accidental contact, which can lead to severe electrical shock or electrocution. Furthermore, the open box allows combustible materials like dust to accumulate near the wiring, creating a significant fire hazard. This is a major safety deficiency requiring immediate attention.

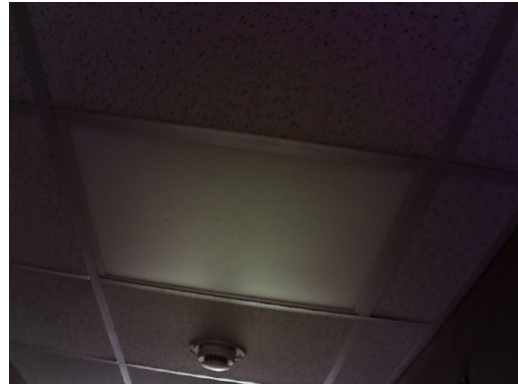
### Finding 3: INOPERABLE CEILING LIGHT

**Marginal Defect**

#### Hallway Ceiling

The overhead light fixture located in the middle of the hallway was not operational during the inspection. The lamp failed to illuminate when the corresponding wall switch was activated. The cause for this functional failure is unknown but could range from a simple burnt-out bulb to a more complex issue like a faulty ballast, defective switch, or wiring problem. This lack of illumination results in inadequate lighting for the area, creating a potential trip-and-fall hazard for occupants navigating the hallway. The condition represents a loss of intended function for the installed fixture.

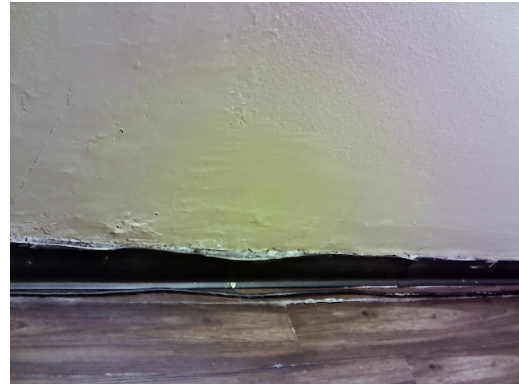
**Finding 5: BASEBOARD GAP WITH EXPOSED CABLE****Marginal Defect**

End of hallway

A significant gap is present where the baseboard has pulled away from the wall surface. Visible within this opening is an electrical cable that has been routed outside of the protected wall cavity. This condition likely stems from improper fastening of the trim combined with the improper installation of the low-voltage cabling. The exposed cable is vulnerable to physical damage from cleaning equipment, furniture, or pests. Damage to the cable's insulation could create a short circuit or a potential shock hazard. This represents a deficiency in workmanship and a potential safety concern.

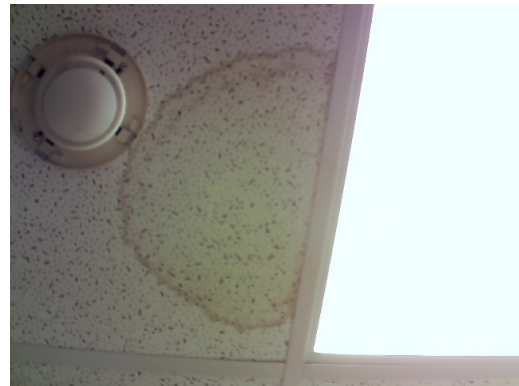
**Finding 6: EVIDENCE OF MOISTURE INTRUSION****Significant Defect**

Hallway Ceiling

A prominent, discolored stain was observed on an acoustic ceiling tile, which is characteristic of water damage. The tile was dry to the touch at the time of the inspection, suggesting the leak may be intermittent or has been resolved without replacing the tile. Such stains are evidence of a leak from a plumbing pipe, HVAC condensate line, or roof component located above the ceiling. If the source of moisture has not been corrected, recurring leaks can lead to significant damage to structural components, deterioration of ceiling materials, and the potential for microbial growth. The integrity of the stained tile is compromised.

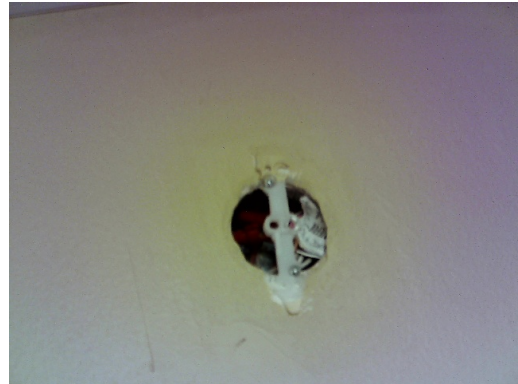
### Finding 7: UNCOVERED JUNCTION BOX

**Significant Defect**

Right side of the hallway

An electrical junction box recessed in the wall was found to be open and uncovered. The wiring inside the box is exposed, lacking the protection of a fixture or a blank cover plate. This hazardous condition is typically the result of an incomplete electrical project or the improper removal of a wall-mounted device. Exposed electrical components create a severe risk of electric shock from accidental contact. The opening also allows dust and other combustible materials to enter the box, which can accumulate and create a substantial fire hazard. This is a serious safety violation that needs to be addressed.

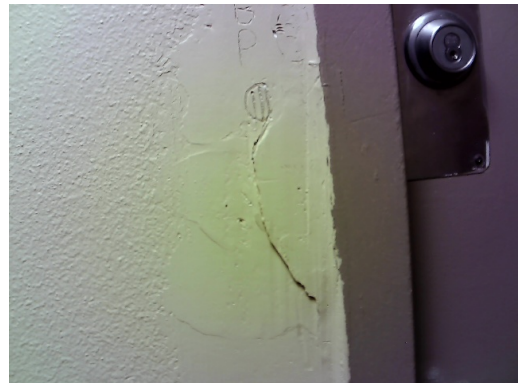
### Finding 8: WALL SURFACE DAMAGE AT DOOR

**Marginal Defect**

Wall at door frame

A vertical crack was noted in the wall finish immediately adjacent to a door frame. The area appears to have been subject to a previous, poorly finished repair, and is further marred by cosmetic damage from inscriptions. Cracks in this location can be caused by the repeated impact of the door closing, or from minor building settlement causing stress at the opening. While currently a cosmetic defect, the crack could worsen over time with continued vibration and movement. It may also be an early indicator of ongoing settlement that could affect the door's operation in the future.

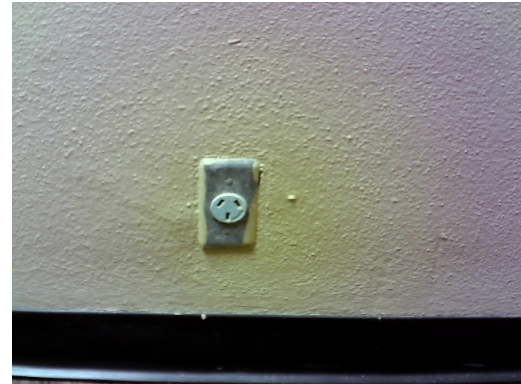
**Finding 9: NON-STANDARD ELECTRICAL RECEPTACLE****Marginal Defect**

An electrical receptacle installed in the wall has a non-standard configuration that is not compatible with common North American (NEMA) plugs. This outlet may have been installed for a specific piece of foreign or specialized equipment that is no longer present. As a result, this outlet is non-functional for general use, limiting the electrical access in the area. It is unknown if the voltage and wiring connected to this outlet are standard for the building. Using an adapter without confirming the circuit's specifications could result in damage to connected equipment.

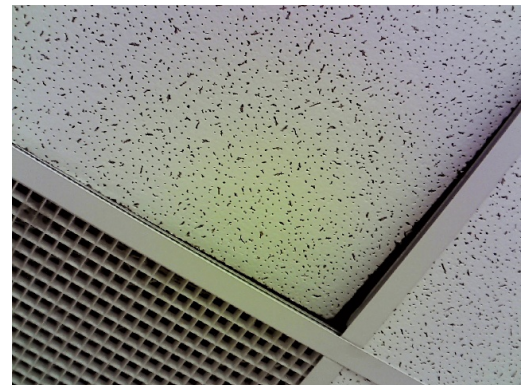
**Finding 10: DISPLACED SUSPENDED CEILING TILE****Minor Defect / FYI****Hallway Ceiling**

A tile within the suspended ceiling grid system was observed to be misaligned and not properly seated in its frame. This condition creates a visible gap between the tile and the supporting metal grid. Such displacement often occurs after maintenance work is performed in the ceiling plenum and the tile is not reinstalled correctly. It can also be caused by building vibrations. Although primarily a cosmetic issue, a loose tile could become fully dislodged and pose a minor falling hazard. The gap also compromises the finished appearance of the ceiling.
