# LAPORAN REPAIR KOMATSU INDONESIA

| Assy No | 21T-06-44661-01 dan 14X06J1150-00 |
| Methode Repair | Repair salah setting dan Buzzer ulang |

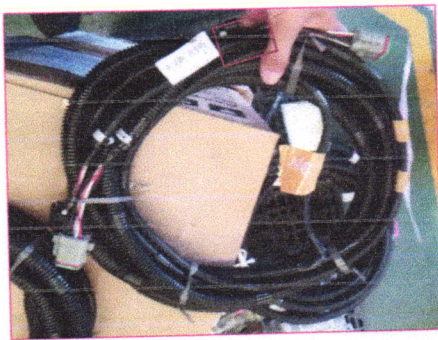
Before :

1. Buzzer ulang, pasang name plate dan tape OK assy 21T-06-44661-01

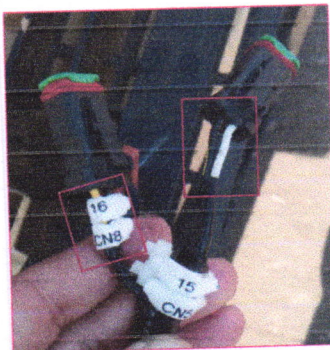
Before :

2. Repair assy 14X06J1150-00 pada posisi CN5 dan CN8 NG salah setting

CN5 : Std : B , Y  
Act : W , B - Y

CN8 : Std : W , B - Y  
Act : B , Y

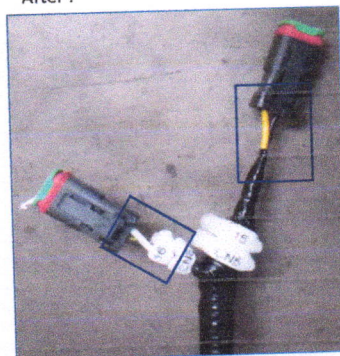
After :

CONFIRM "OK"
