# LAPORAN REPAIR KOMATSU INDONESIA

| Assy No | 14X0625321 |
| Type Unit | D 65 E |
| Methode Repair | Penambahan circuit dan ganti lampu |

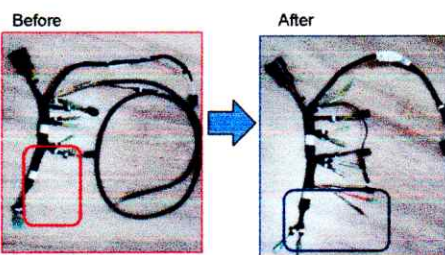
1. Modif harness GAUGE dari assy 14X0625321 ke assy 14X-06-J4510 sebanyak 11 pcs

2. Melakukan Repair Lampu Bulb diganti ke LED sebanyak 10 pcs
