# LAPORAN REPAIR KOMATSU INDONESIA

| Assy No | 14X0625321 |
| Type Unit | D 65 E |
| Methode Repair | Penambahan circuit dan ganti lampu |

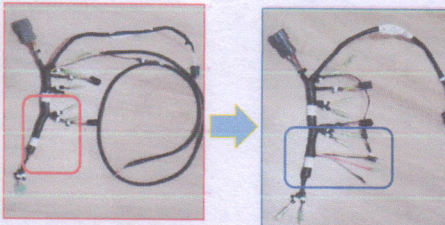
1. Modif harness GAUGE dari assy 14X0625321 ke assy 14X-06-J4510 sebanyak 4 pcs
