# LAPORAN REPAIR KOMATSU INDONESIA

| Assy No | 14X0625321 |
| Type Unit | D 65 P |

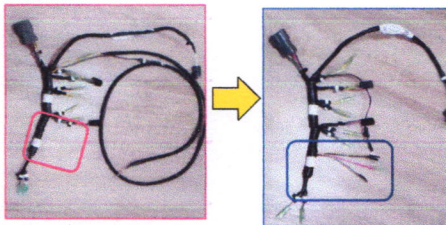
1.Modif harness GAUGE dari assy 14X0625321  
ke assy 14X-06-J4510 sebanyak 11 pcs  
Before After
