# LAPORAN REPAIR KOMATSU INDONESIA

| Assy No | 14X0625321 |
| Type Unit | D 65 P |
| Methode Repair | Penambahan circuit dan ganti lampu |

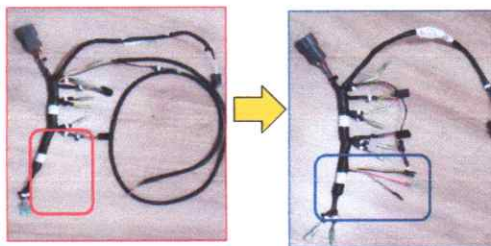
1. Modif harness GAUGE dari assy 14X0625321 ke assy 14X-06-J4510 sebanyak 11 pcs  
Before After
