## LAPORAN REPAIR KOMATSU INDONESIA

| Assy No | 21T0645230-00 |
| Type Unit | PC2000-11 |

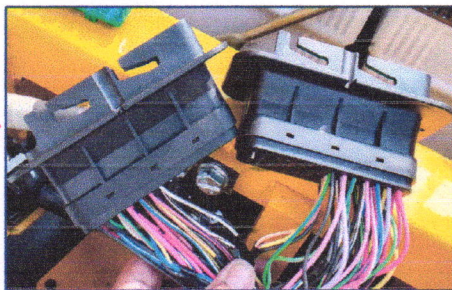
1. Terminal push out pada wire colour Yellow

1. Observasi problem terminal lepas yang terjadi main harness untuk unit PC2000-11 pada posisi CN-A06 connector 937928400 colour Yellow pada pin connector A6.
2. Proses repair ganti connector 937928400 dikarenakan lock terminal dalam connector patah
3. Setelah repair selesai, connector di pasang ke unitnya

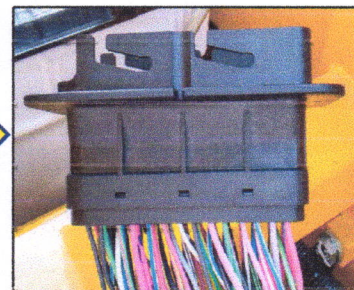
2. Repair ganti connector
