# LAPORAN REPAIR KOMATSU INDONESIA

| Assy No | 22150615-00 |
| Type Unit | PC135F-10M0 |

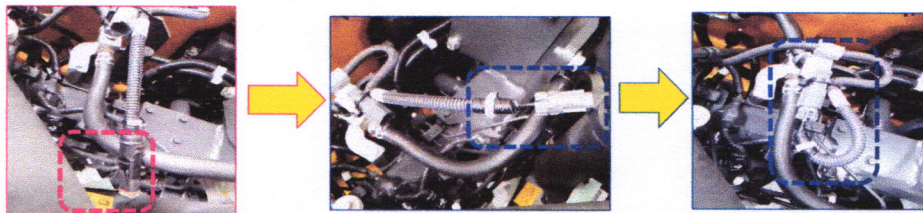
1. Modif harness PC135F pada posisi AC03 dari connector DT ke connector 7123-6214-40 sebanyak 24 pcs

Before :

After :

| Methode Repair | Potong Wire ganti terminal dan pasang connector |
