# LAPORAN REPAIR KOMATSU INDONESIA

| Assy No | 561-95-82614-02 |
| Type Unit | HD785 |
| Methode Repair | Check tegangan resistor dan menukar resistor |

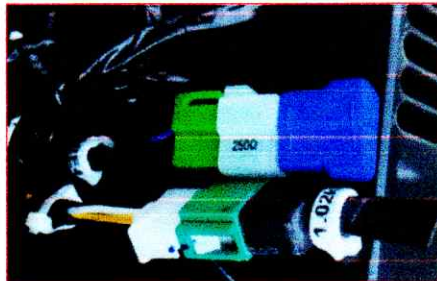
Before :

1.Repair resistor pada posisi RE3 dan RE4 di assy 561-65-82614-02 sebanyak 1 pcs

Marker RE3 : 250  $\Omega$

Marker RE4 : 1.02  $\Omega$

Marker RE3 : 1.020  $\Omega$

Marker RE4 : 250  $\Omega$

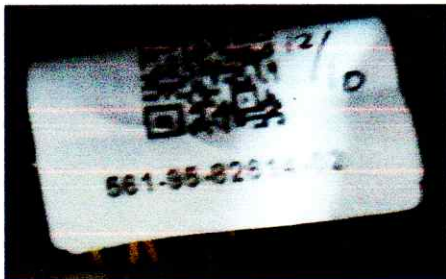
2.Assy No

CONFIRM "OK"
