CLIFTON PARK CONSERVATION AREA APPRAISAL

A Report for Metropolitan Borough of Wirral by Donald Insall Associates Ltd

June 2004

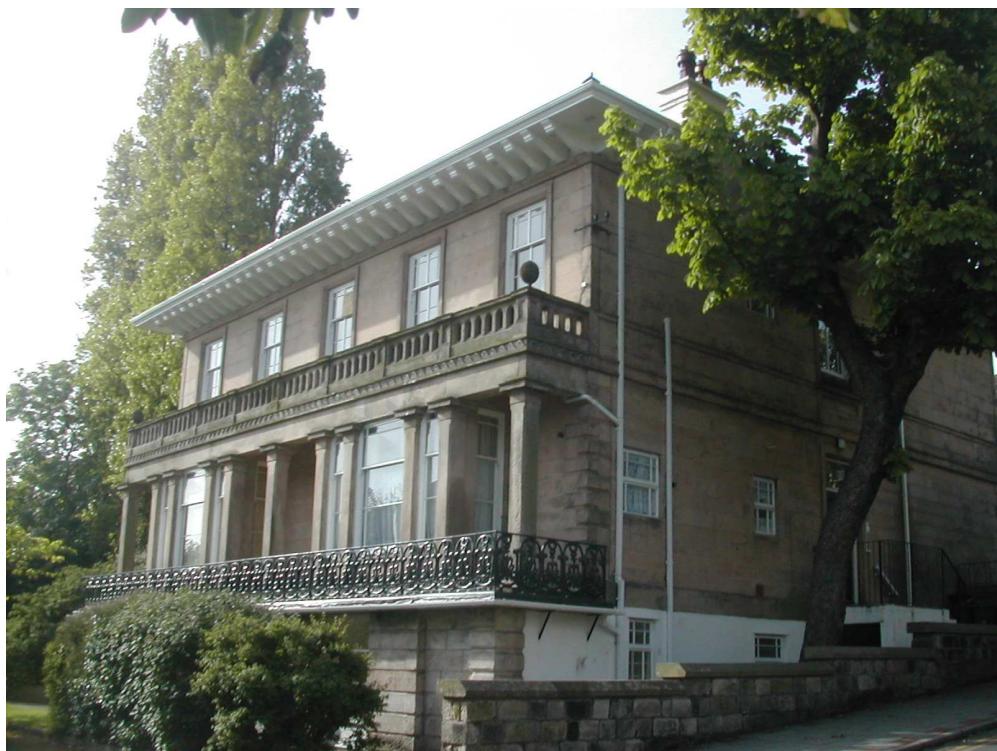
Number 47, Clifton Road, an original house in the development, by Walter Scott

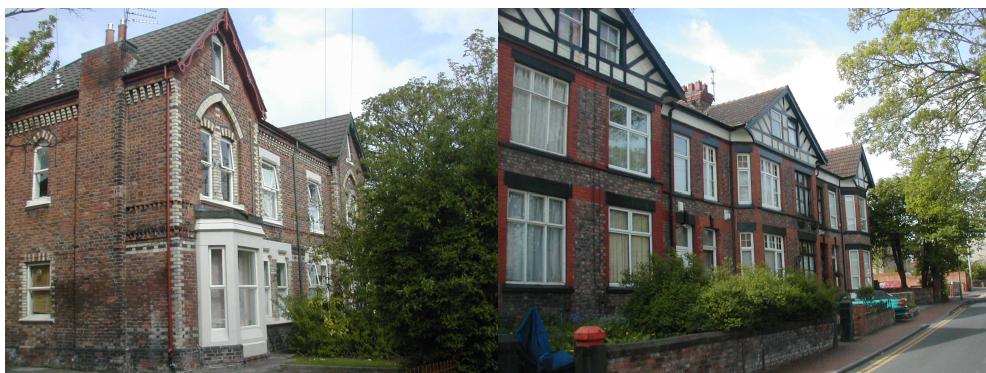
Number 11 Circular Road (c 1880) and 46-50 Woodlands (c. 1890)

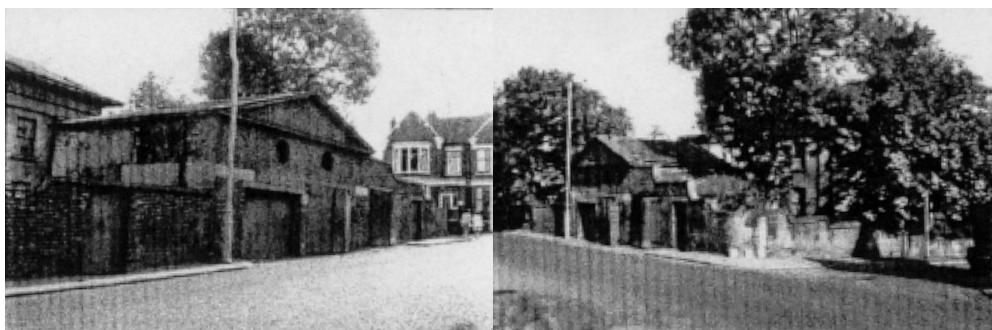
Photographs of coach house on Whetstone Lane, prior to demolition.

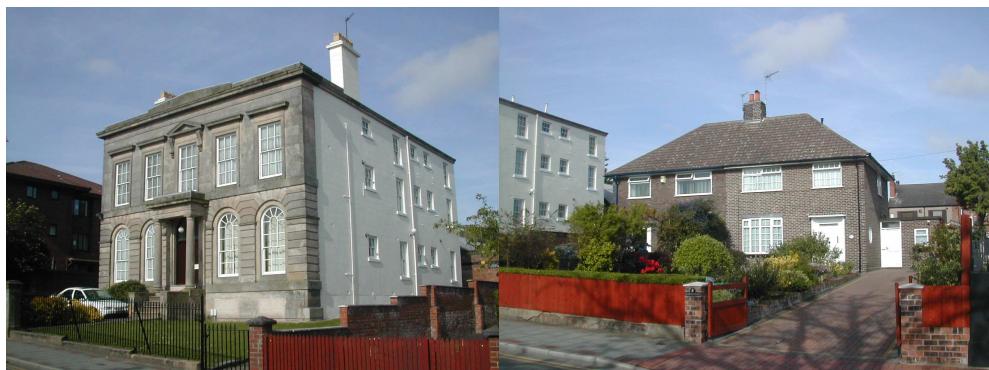
An example of the variety of scale and character, seen particularly towards the lower end of Clifton Road. Adjacent house, numbers 20,22 and 24 Clifton Road.

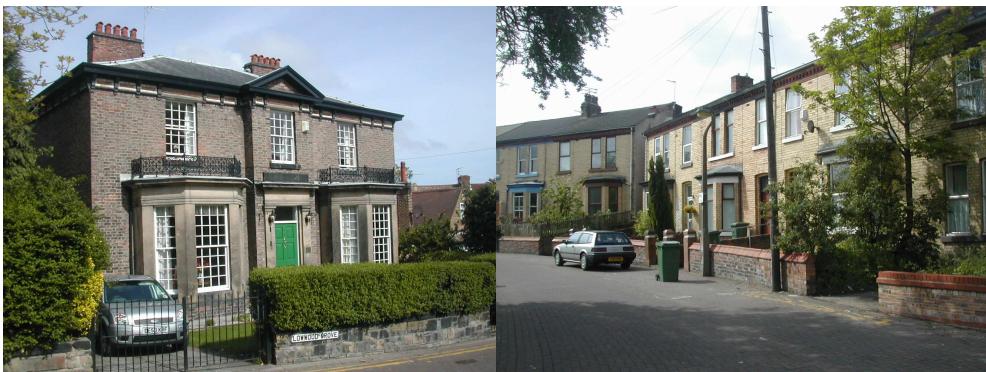
Villa c. 1850 (number 8 Lowwood Grove) and terrace on Circular Road (c.1890)

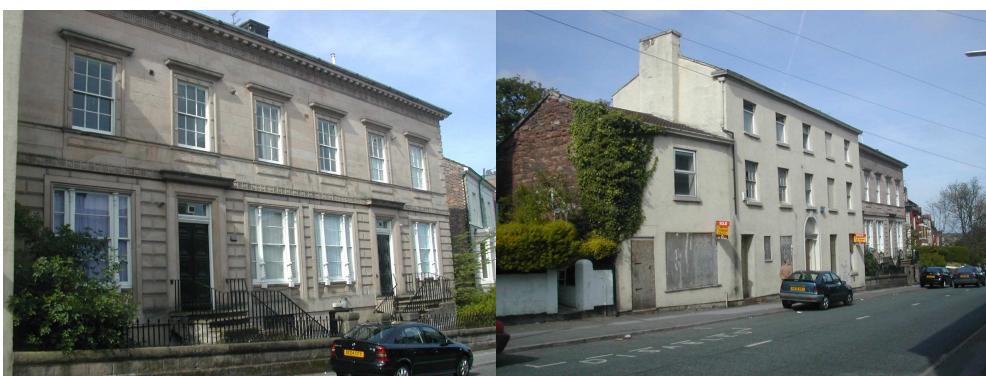
Although there are a few architecturally interesting buildings, there is a lack of any overriding character or style to the road. Many of the buildings themselves are worthy of protection (as suggested by their listed status) but there is little of interest to their setting. Numbers 140 and 142 are a positive asset to the road, whereas the current derelict state of number 144, although of a similar age, leaves that area of the road looking shabby and run-down.

Numbers 140/142 and 144 Whetstone Lane. Although of a similar date and both listed, they are of stark contrast in terms of condition.

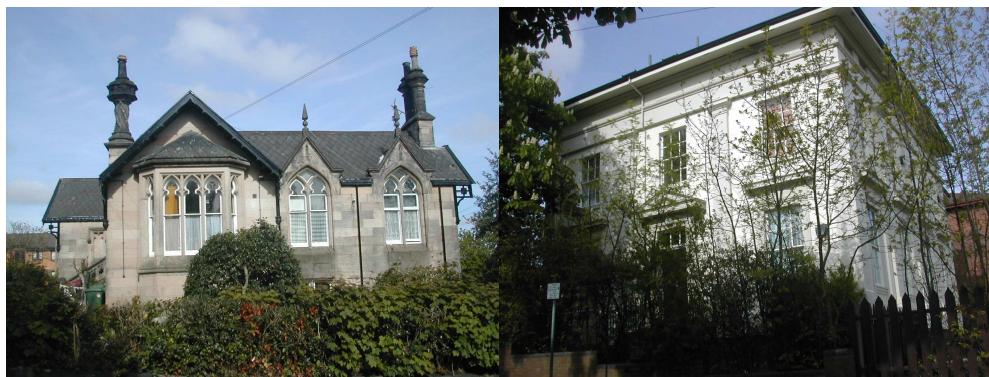
Number 42 and 44 Clifton, both designed by Scott and built between 1840 and 1850, are contrasting in style.

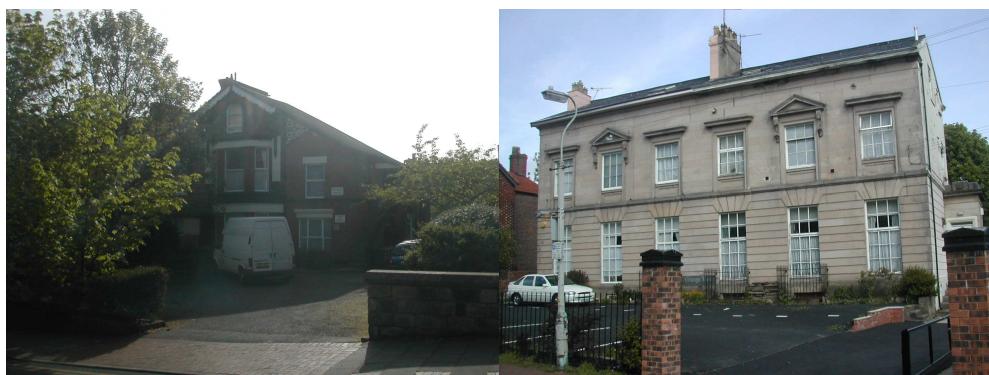
Number 45 Clifton Road (left) and 53 / 55 Woodlands (right). Both examples of larger properties being subdivided into flats. 45 Clifton Road is dominated by parking in front of the building, ugly signage and an external fire escape. 53 / 55 Woodlands has a tarmacaded parking area taking up virtually all the front area. Its stonework is dotted with extract vents and its roof littered with television aerials.

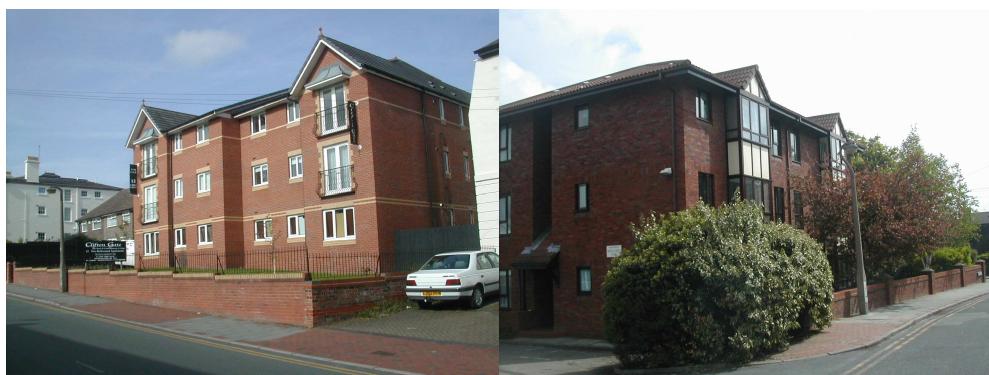
Clifton Gate (left) and Field House (right). Both recent developments on Clifton Road, of a similar size and quality. Neither building makes a positive architectural contribution to the area nor is sufficiently set back

from the road to be unobtrusive. It should be noted, however, that a good landscaping scheme can have a considerable impact on the site. Field House is well screened behind mature and semi-mature trees and hedges. Clifton Gate, on the other hand, has only a small area of lawn, a few small shrubs and a couple of scrawny, barely distinguishable trees. Although only newly planted, this scheme will never mature into an attractive garden. The building is further blighted by a large area of tarmac, without even a border of planting, on the left hand side for car parking.

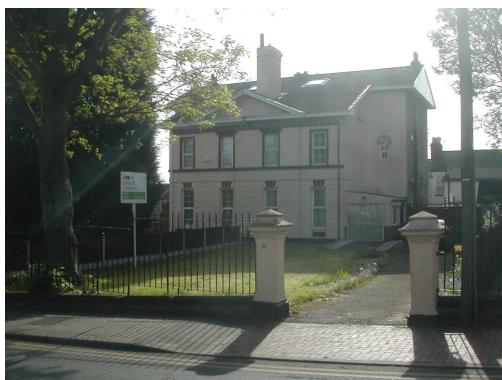
No. 31 & 33 Clifton Road. Although small in scale, an unsympathetic porch with large patio doors is stylistically out of keeping with the rest of the building and upsets the symmetry of the building as a whole.

The materials, form and positioning of any extension must also be carefully considered if the building's character is not to be lost. Materials should be of a quality that matches the existing building and should not detract from it. Traditional materials would generally be preferable to man-made ones, however, there may be instances where a 'sleeker' more modern alternative (e.g. lightweight materials such as glass) may actually detract less. The form of any extension should consider the scale, proportion and massing of the original as well as roof pitch. A new extension should generally be positioned in an unobtrusive position as possible, with the rear elevation being preferred to the front and sides.

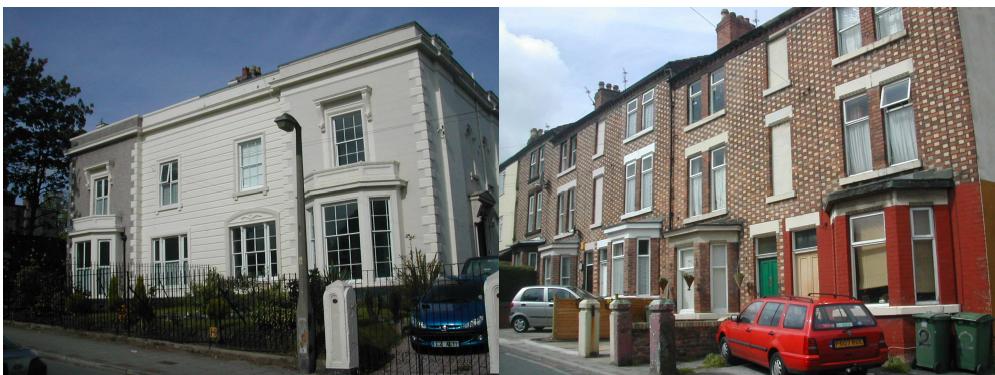
(Left) Grade II listed 34 & 36 Clifton Road. Although generally in a good state of repair, the symmetry of the pair is partly lost due to the unmatching render types and the insertion of top UPVC casement windows into the openings of the left hand house. (Right) Terrace on Brookland Road. The attractiveness of the polychromatic brick is marred by the muddle of different windows, painted brick and cars parked in gardens.
