BROMBOROUGH VILLAGE CONSERVATION AREA APPRAISAL AND MANAGEMENT PLAN

PART 1 – CONSERVATION AREA APPRAISAL

Prepared for Wirral Council by Donald Insall Associates Ltd, 2007 – Wirral Council 2009

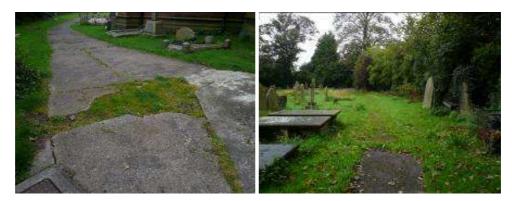
(left) The concrete pathways within the churchyard are in need of repair or replacement and do not enhance the setting of the church. The pathways turn to grass towards the northern end of the churchyard, making them uninviting and potentially dangerous in wet weather (right).

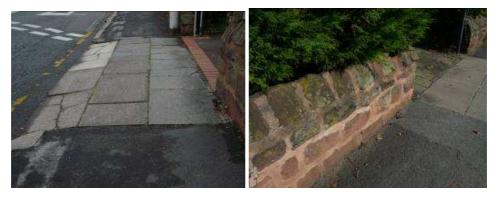
Poor quality surface treatments do little to enhance the setting of the conservation area

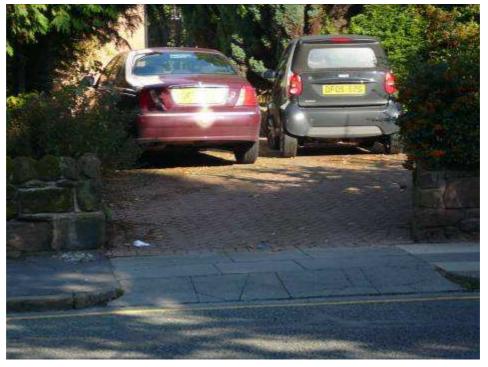
The block paved drive within the conservation area boundary contrasts with the broken flags at its entrance; to the left the pavement is surfaced with tarmacadam, to the right there are mixed paving slabs.

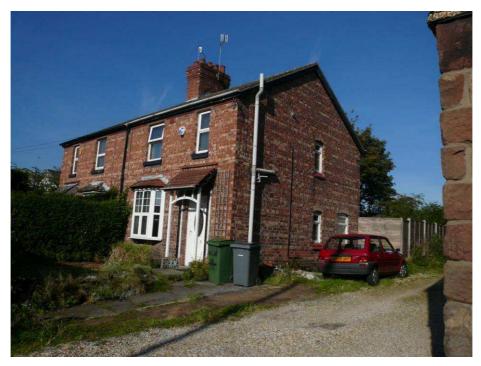
An early C20th inserted access lane between Nos 10 and 12 is surfaced with loose gravel but the border treatment does not enhance the setting of the adjacent dwellings

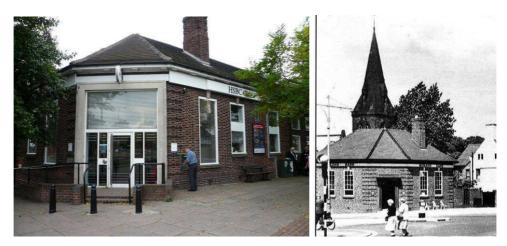
6.3.5 The enlargement of door and window openings, and its detrimental effect on the character of a building, can be seen particularly at the HSBC bank at 58 Bromborough Village Road. It was constructed in the 1940s to replace an earlier temporary wooden structure and it made a positive contribution to the street scape around the market cross. The subsequent insertion of plate glass doors and windows has significantly altered its character.

58 Bromborough Village Road: unsympathetic alterations are illustrated by comparison with a photograph from the 1950s

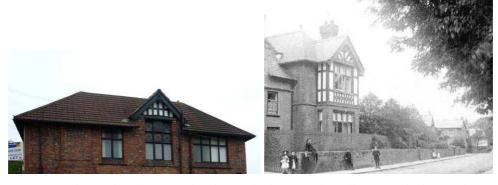
No 52 Bromborough Village Road: The north elevation (left) illustrates the loss of the east and west projecting gables and chimney shown in a 1920s photograph (right). (Note the open space beyond the building is the site of 36-46 Bromborough Village Road)

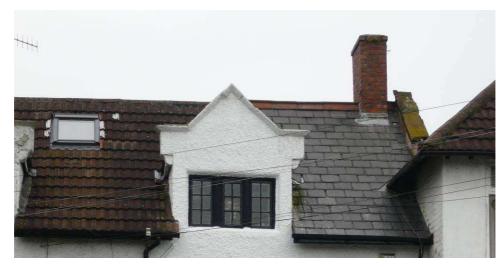
- 6.3.7 Within the conservation area, roof replacement has generally been carried out sympathetically using traditional slates and ridge tiles. However, notable exceptions to this include the 17th-century former Tellet's Farm at Nos 54-56 Bromborough Village Road. Now in shared ownership, this building has been partially reroofed with profiled interlocking tiles, which do not preserve or enhance its character and emphasise the splitting of the former farmhouse into two properties. Similarly, the roof to No 52 has been much altered; the building has lost its projecting gable ends and the profiled interlocking tile roof is alien to its original character.

Nos 54/54a Bromborough Village Road demonstrates the difference in appearance between a slate roof (right) and modern interlocking profiled tiles (left)

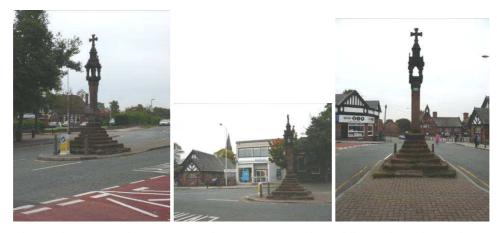
6.6.1 Although the construction of the by-pass has undoubtedly alleviated traffic pressures on the village, there is still a relatively high volume of traffic using Bromborough Village Road and The Rake. The associated public realm including traffic signage, road markings and pedestrian amenities, notably around the market cross, does little to preserve or enhance the setting of the conservation area or the buildings within it. The exclusion of the listed market cross from the conservation area may have had an adverse effect on subsequent public realm works; the siting of the cross on what is effectively a pedestrian refuge detracts from its importance visually and historically.

The Market Cross today sits on a pedestrian refuge in the middle of a busy thoroughfare

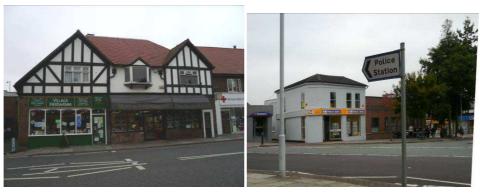
- 6.6.4 Signage on some buildings within the conservation area is inappropriate and detracts from its character. This is most noticeable along Bromborough Village Road.
- 6.6.5 The setting of the conservation area, particularly around the market cross, is also affected by signage on nearby shops particularly where it is illuminated. A notable example is the illuminated signage to the former Royal Oak public house, now housing an estate agent, near the Market Cross.

Subtle signage can enhance the setting of the conservation area. Along Allport Road, Nos 3 to 5 (left) for example have pleasantly designed shop fronts and appropriate signage, whereas the illuminated signage to the former Royal Oak (No 60 Bromborough Village Road, (right) is insistently bright and overly conspicuous.
