# WOOD DESTROYING PESTS AND ORGANISMS INSPECTION REPORT

| Building No.<br>1634 | Street<br>Benedict Canyon Dr. | City<br>Beverly Hills | Zip<br>90210 | Date of Inspection<br>03/16/21 | Number of Pages<br>6 |
| GENERAL DESCRIPTION: <b>1-Story Family Dwelling, Stucco Construction, Attached Garage, Detached Pool House and Gazebo with Roll Composition Roof.</b> | | | | Inspection Tag Posted:<br><b>Attic</b><br>Other Tags Posted: | |

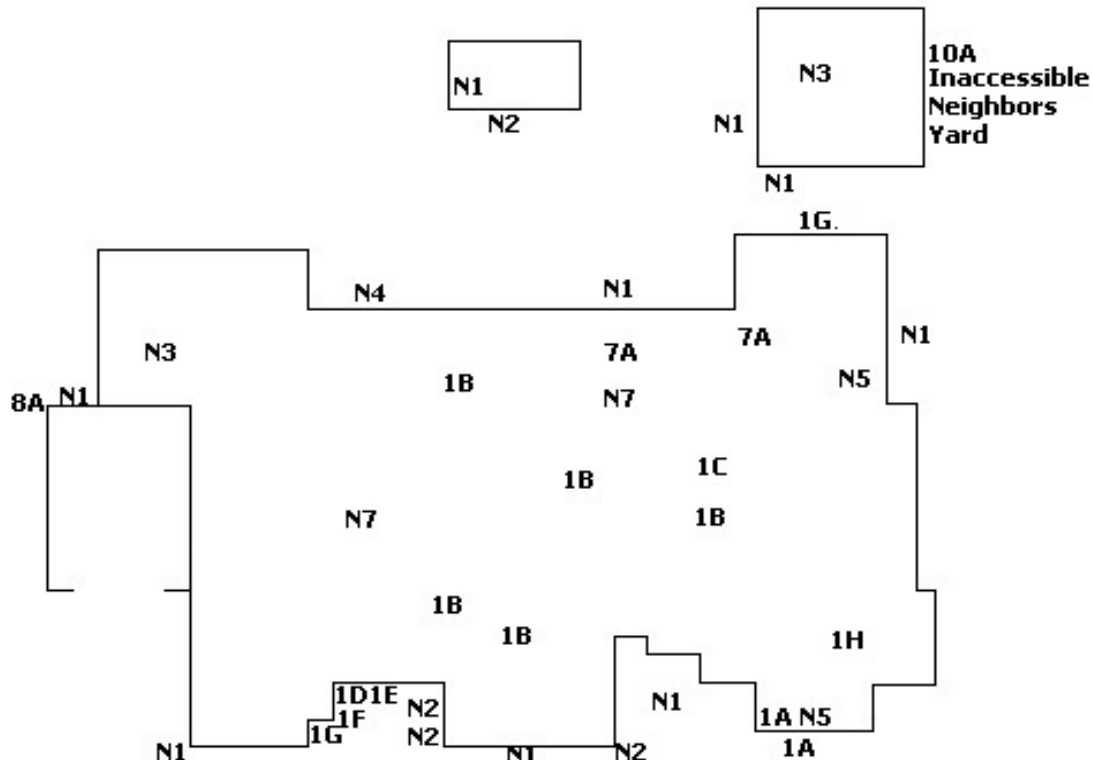
**Diagram Not To Scale**

01A - FINDING - Faulty planter and water damage found at front right same wall on interior. 1A on diagram.

01B - FINDING - Cellulose debris found in sub area. 1B on diagram.

01C - FINDING - Plumbing leak found at drain line. 1C on diagram.

01D - FINDING - Evidence of drywood termites found in jams. 1D on diagram.

01E - FINDING - Drywood termite damage found in jams. 1E on diagram.

01F - FINDING - Dryrot found at jams. 1F on diagram.

01G - FINDING - Faulty planter in rear and left of property. 1G on diagram,

01H - FINDING - Inaccessible area of substructure due to grading. 1H on diagram.

07A - FINDING - Soft spots found on roof, unable to tell if loose roof or warped wood. 7A on diagram.

08A - FINDING - Water appears to be seeping through roof. 8A on diagram.

10A - FINDING - Pool house appears to be faulty grade. 10A on diagram,

NOTE - Cracks found in stucco. N1 on diagram.

NOTE - Water staining found in stucco. N2 on diagram.

NOTE - Areas of ceiling appear to have been patched prior to inspection. N3 on diagram.

RECOMMENDATION - Tradesman to repair as necessary. SECTION 1

RECOMMENDATION - Remove cellulose debris as necessary. SECTION 2

RECOMMENDATION - Tradesman to repair as necessary. SECTION 2

RECOMMENDATION - Chemically treat with TERMIDOR SC. Cover or remove pellets. SECTION 1

RECOMMENDATION - Repair as necessary. SECTION 1

RECOMMENDATION - Tradesman to lower dirt (make accessible) to allow inspection to be performed and a supplemental report to be issued as to findings and cost, if any.

RECOMMENDATION - Roofer to inspect and repair as necessary.

RECOMMENDATION - Roofer to inspect and repair as necessary. SECTION 2
