# Home Inspection Experts Report

LOCATED AT:  
1634 Benedict Canyon Drive  
Beverly Hills, California 90210

INSPECTED ON:  
Friday, February 6, 2026

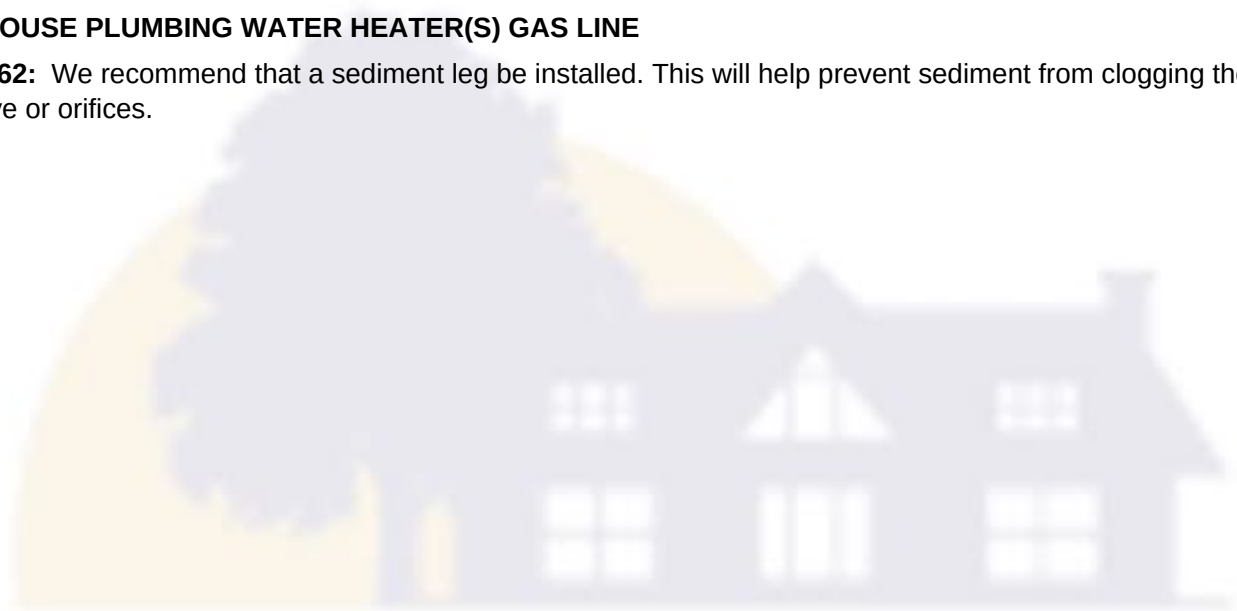
### MAIN HOUSE PLUMBING WATER HEATER(S) GAS LINE

**WARN s-162:** We recommend that a sediment leg be installed. This will help prevent sediment from clogging the gas valve or orifices.
