## Confidential Inspection Report

LOCATED AT:  
139 S. Edinburg Ave.  
Los Angeles, California 90048

INSPECTED ON:  
Tuesday, May 13, 2025

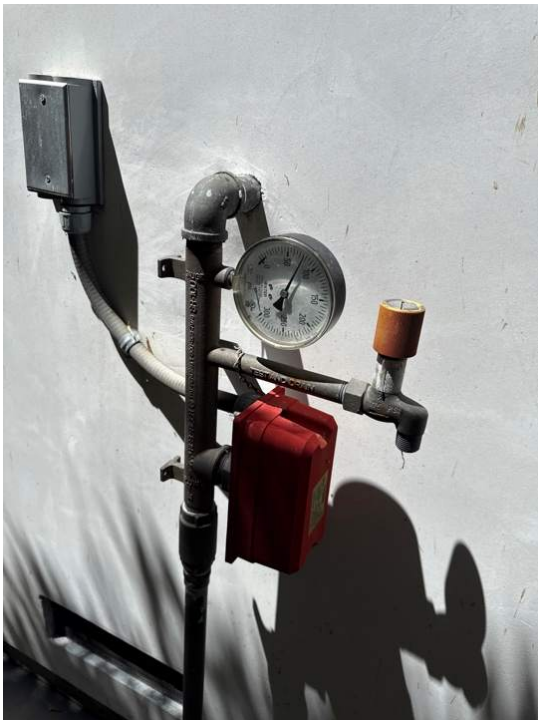
**s-54:** Yes - There is a fire sprinkler system installed. It is recommended that it be checked by a professional with appropriate experience.

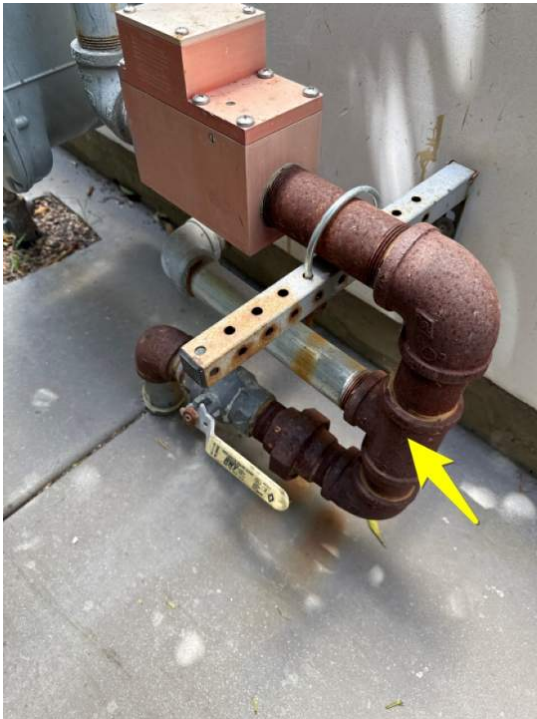
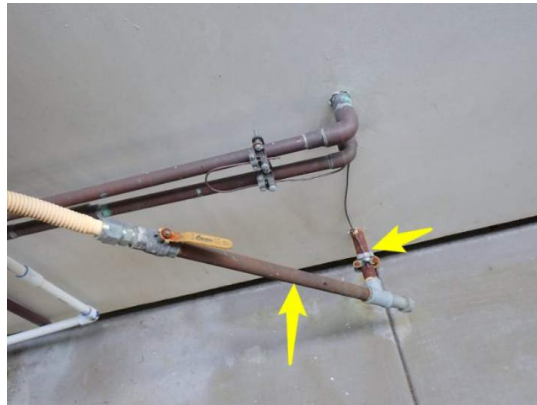
**s-72:** Excessive rust and corrosion noted to portions of the gas line piping. Recommend that rust be cleaned off and gas pipe be painted. Gas lines should be protected from any form of damage or corrosion.

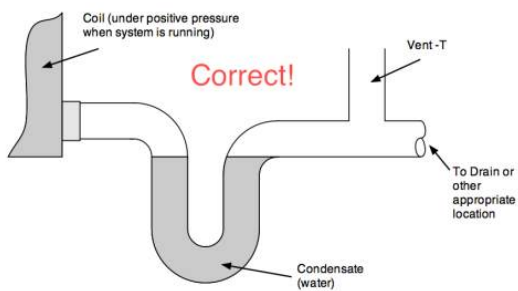
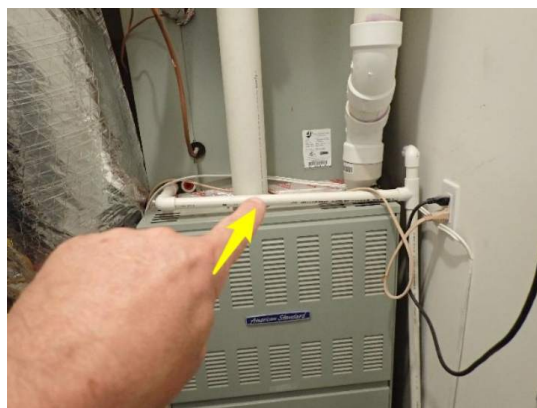
**s-115:** Attention needed: Unit lacks a properly installed P trap and vent. Have technician conduct corrections.

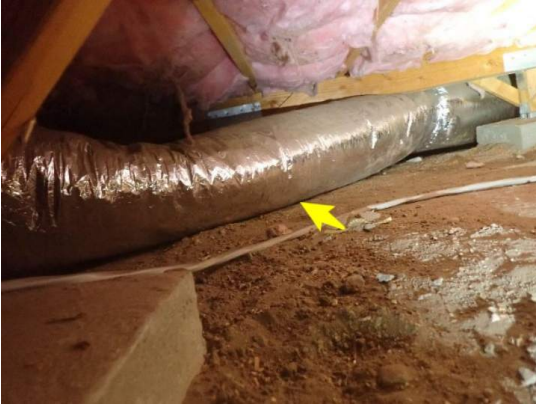
**s-116:** Duct work in the crawl area is resting onto the soil. Duct work should be elevated at least 4 inches above dirt to prevent corrosion.

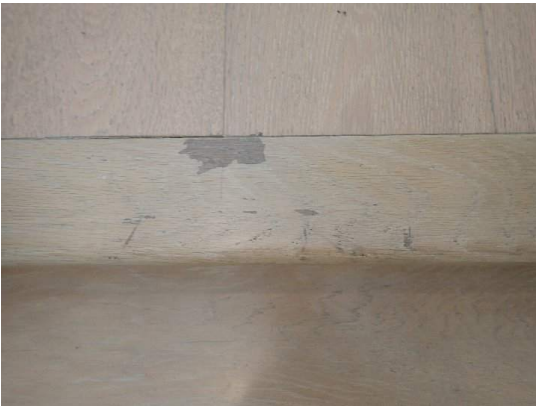
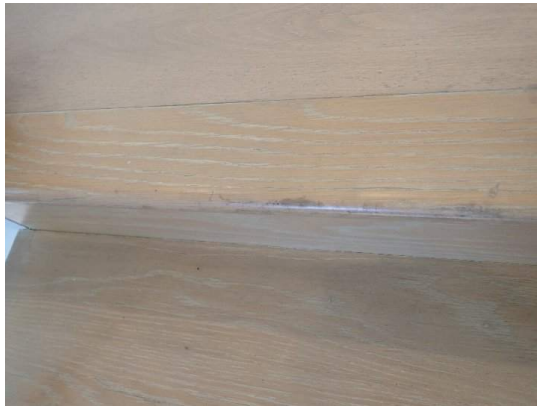
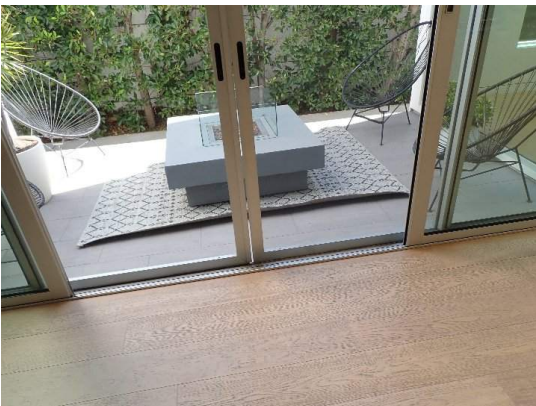
**s-169:** Attention needed: There are notable scratch marks and wear seen throughout areas of wood flooring. Refinishing may be needed

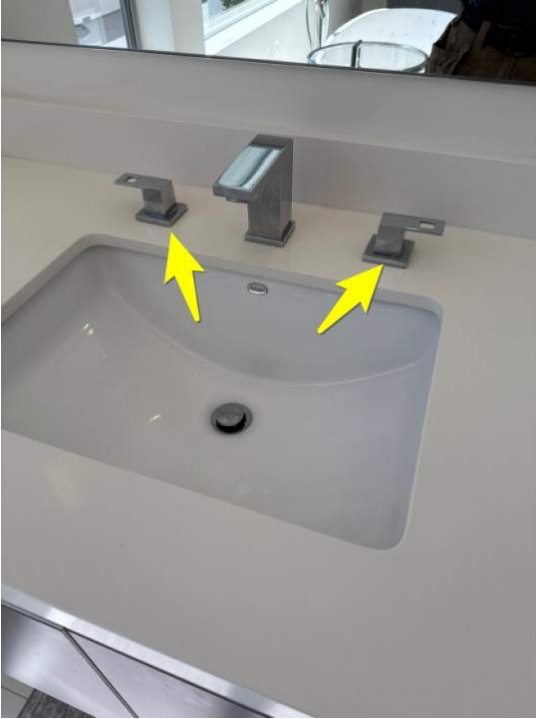
**s-264:** Attention needed: Sink fixtures hard to operate.  
Adjustments needed.

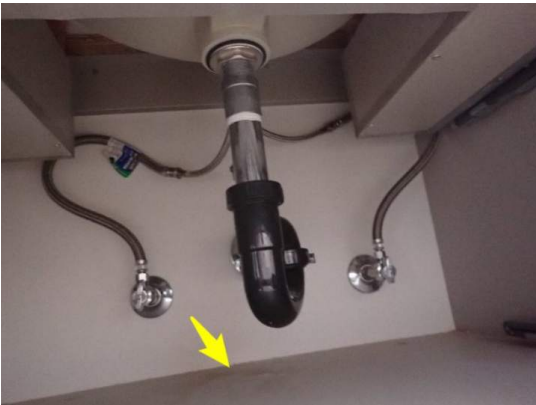
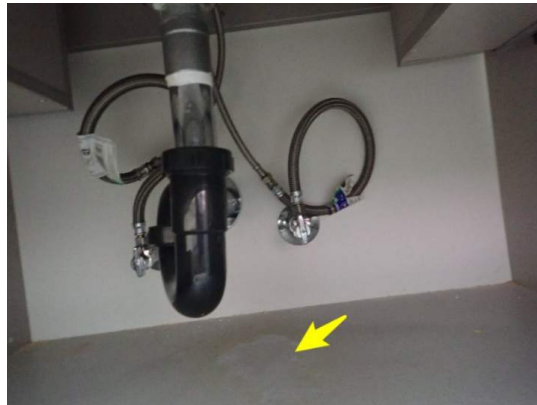
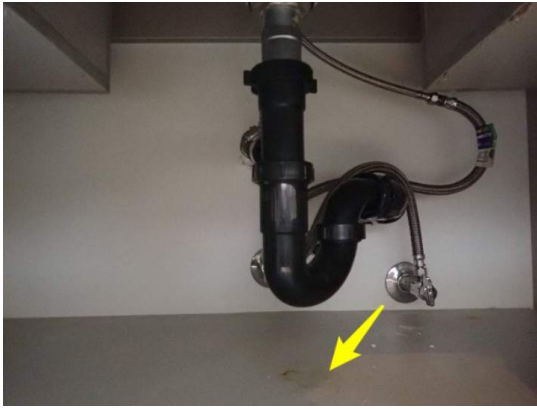
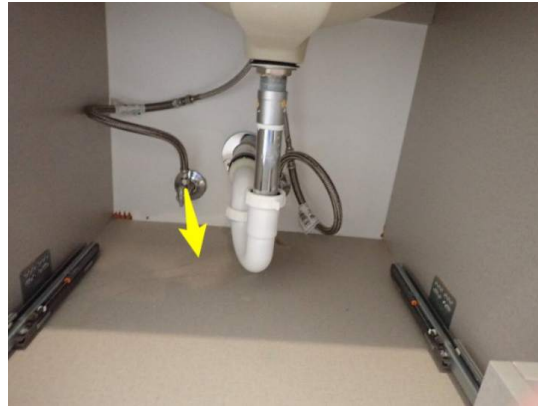
**s-277:** Attention needed: Some water staining noted under a few of the bathroom sink cabinets. Maintenance needed to insure plumbing drain lines are tightened and free from leaks to prevent possible water damage to cabinets.

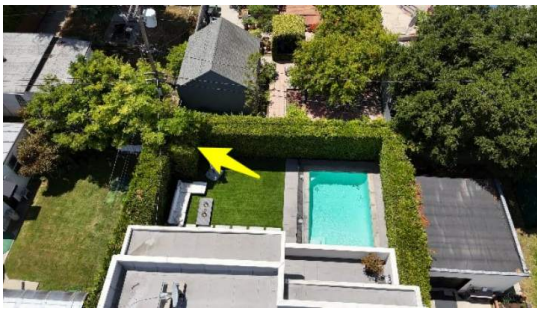
**s-295:** Some trees and/or shrubs on the site need to be trimmed.

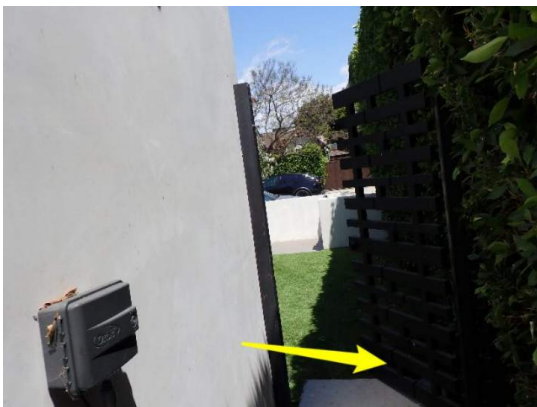
**s-306:** Attention Needed - The gate or latch hardware needs repair to function as intended.

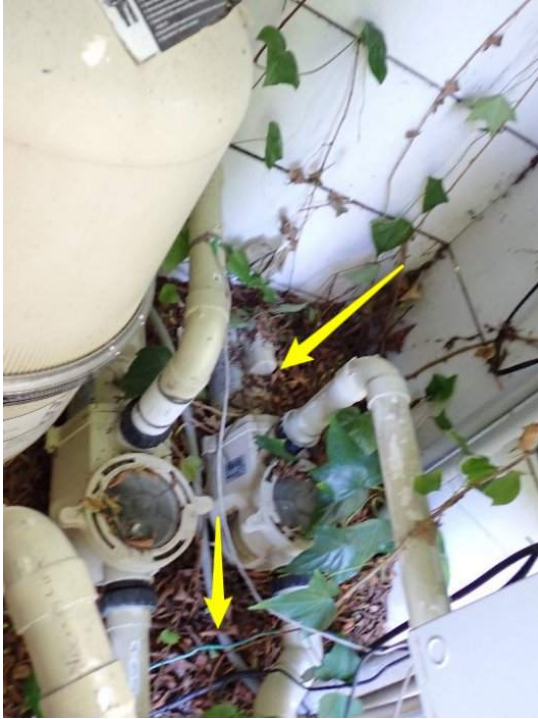
**s-313:** Satisfactory however vegetation and debris removal around equipment needed

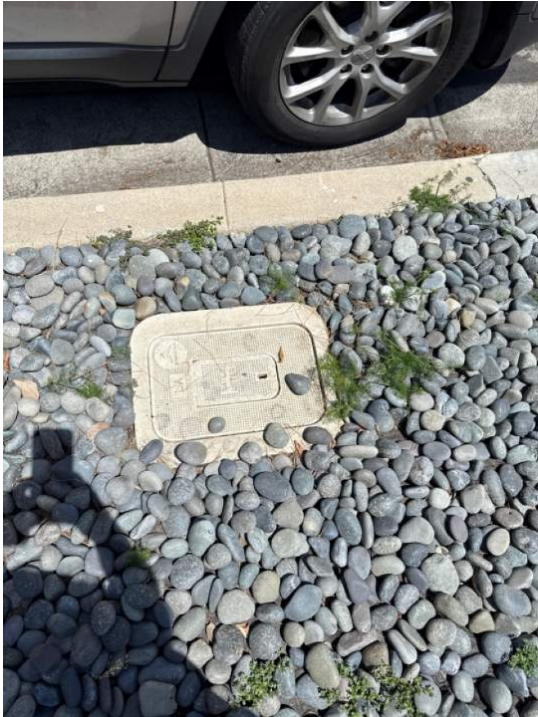
**39:** Meter is located at Front parkway

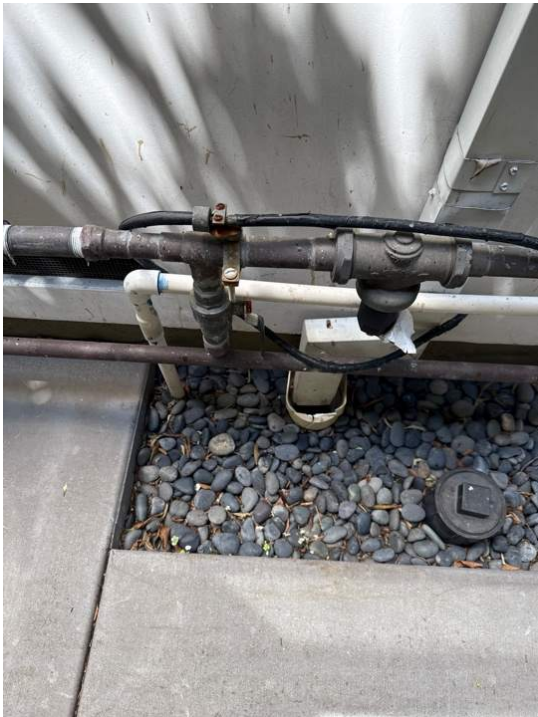
**40:** Shut off valve is located at left side of building

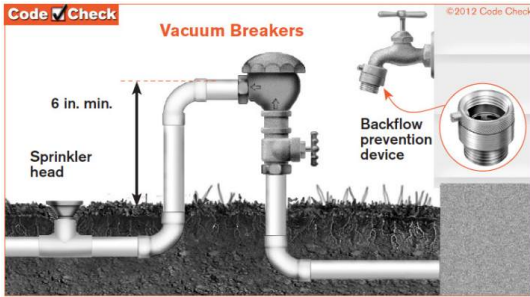
**49:** There are no backflow preventer valves installed. Under current standards, backflow preventer valves are required. It would be a good investment to have them installed.

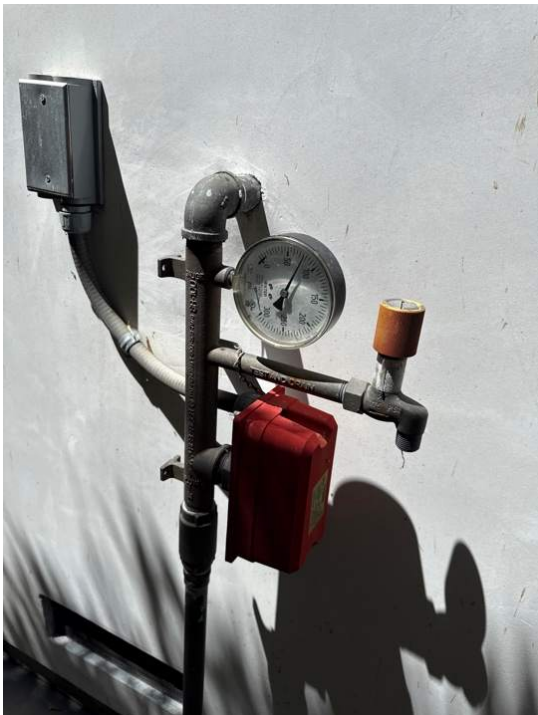
**54:** Yes - There is a fire sprinkler system installed. It is recommended that it be checked by a professional with appropriate experience.

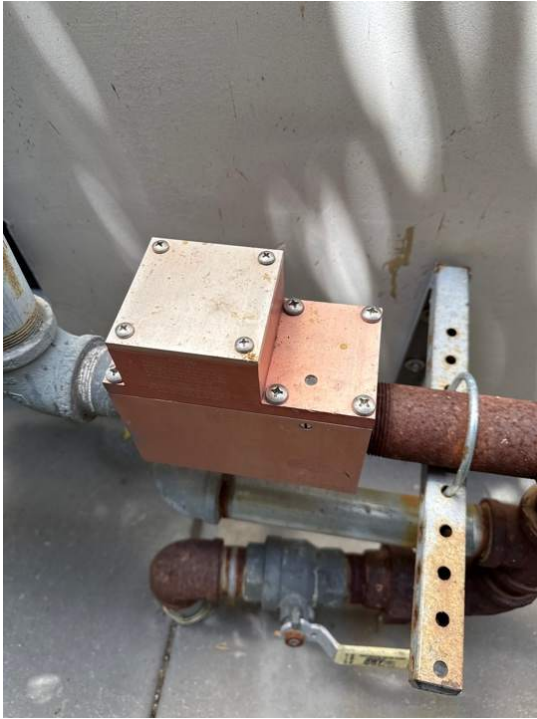
**69:** An automatic seismic gas shut off valve is installed

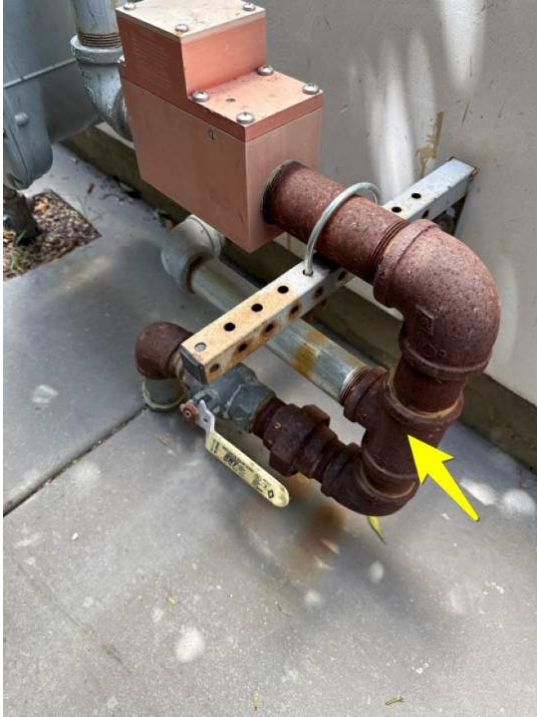
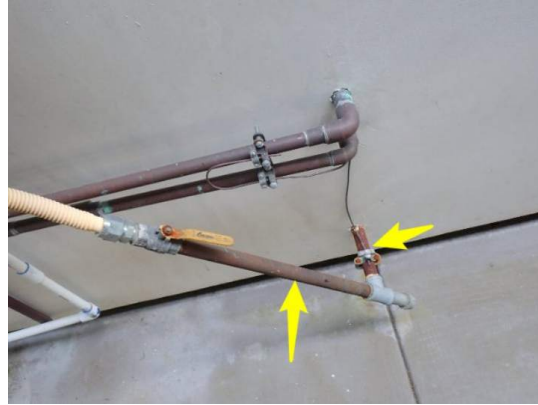
**72:** Excessive rust and corrosion noted to portions of the gas line piping. Recommend that rust be cleaned off and gas pipe be painted. Gas lines should be protected from any form of damage or corrosion.

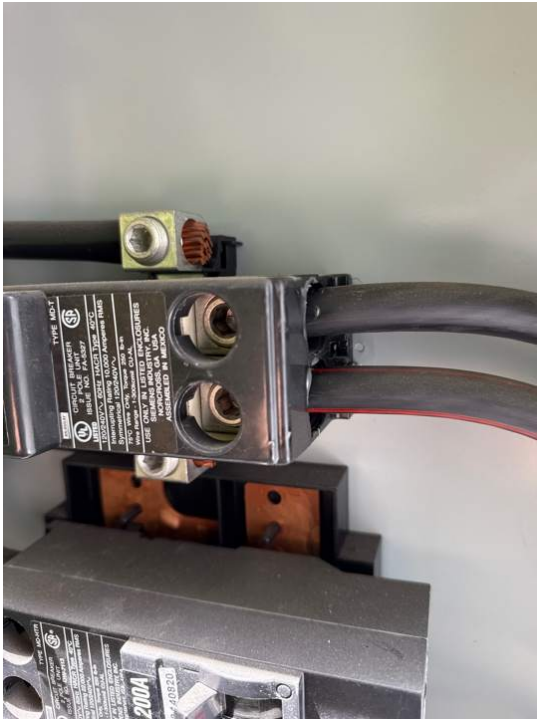
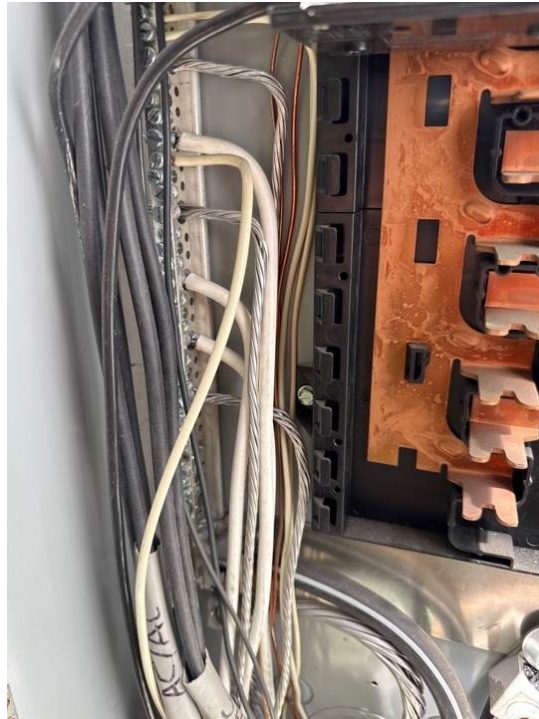
77: A combination of copper cables and aluminum ground wire cables were used.

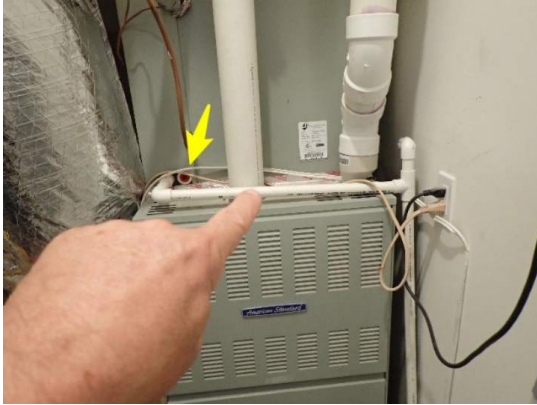
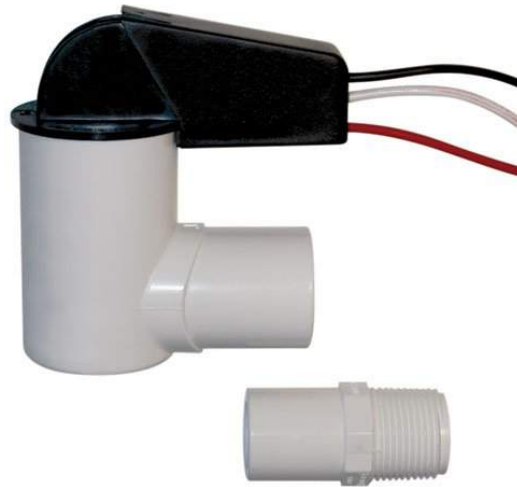
**114:** Interior fan coils lack a secondary condensation drain or safety shut off. The purpose of a secondary drain or safety shut off is to prevent any potential water damage to the ceiling or interiors in the event that the primary condensation drain is clogged.

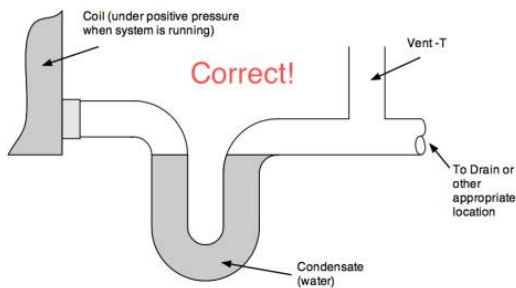
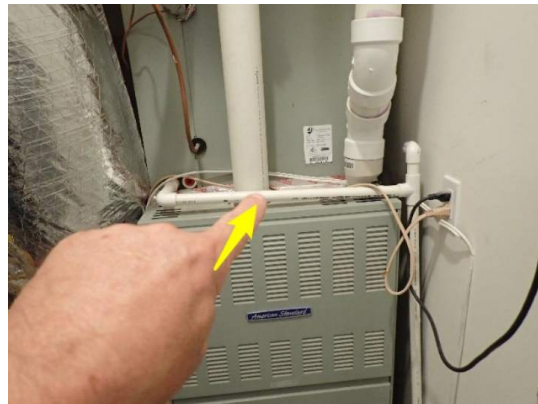
**115:** Attention needed: Unit lacks a properly installed P trap and vent. Have technician conduct corrections.

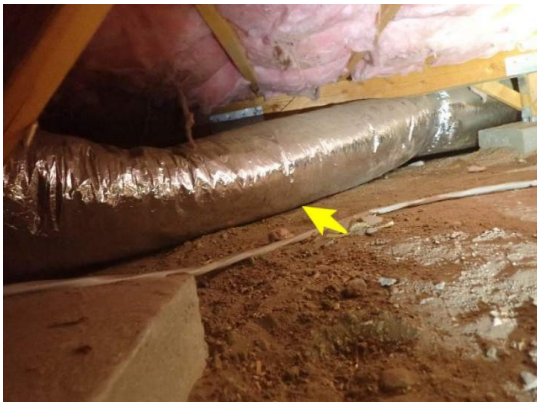
**116:** Duct work in the crawl area is resting onto the soil. Duct work should be elevated at least 4 inches above dirt to prevent corrosion.

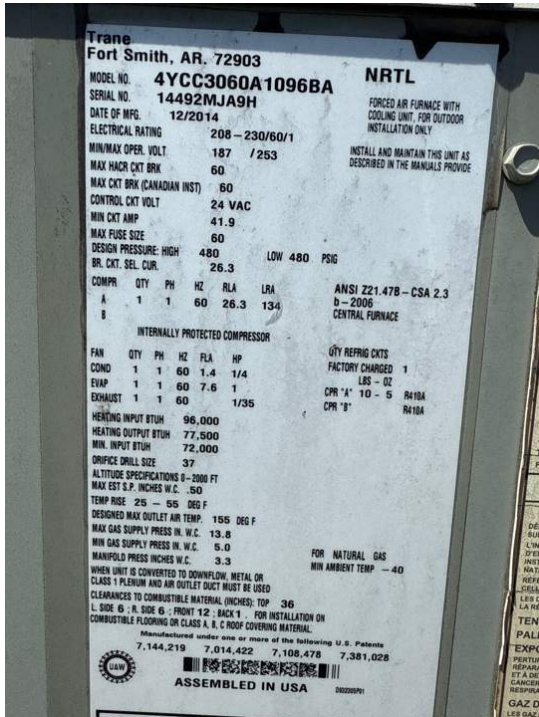
**119:** 11 years old 96,000btu natural gas fired. The typical service life for a forced air natural gas furnace is 18 - 20 years.

**120:** Although operational at the time of the inspection, the age and/or condition of this unit is such that you may need to replace it in the near future.

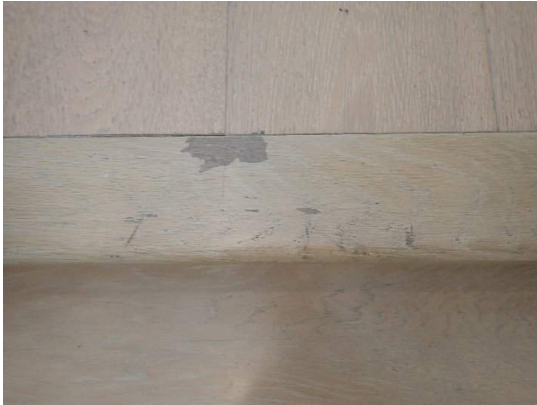
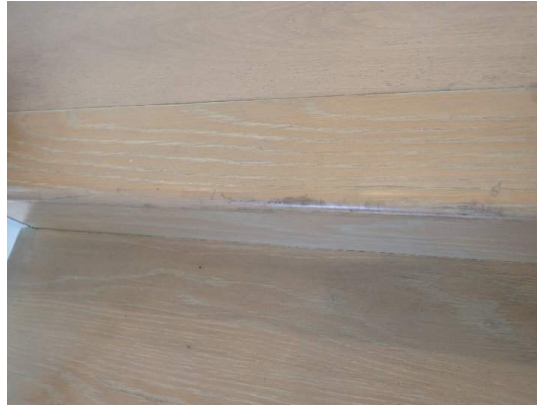
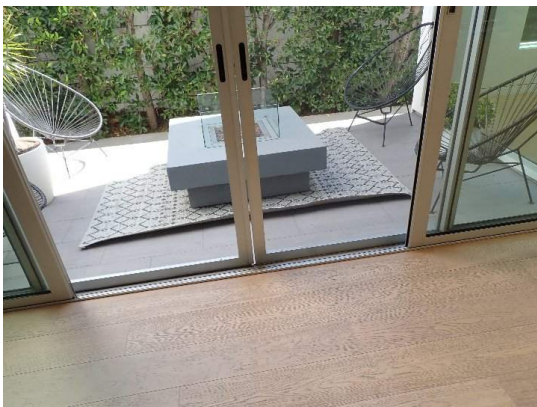
**169:** Attention needed: There are notable scratch marks and wear seen throughout areas of wood flooring. Refinishing may be needed

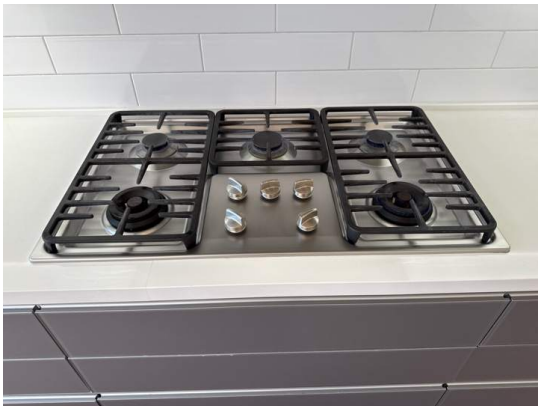
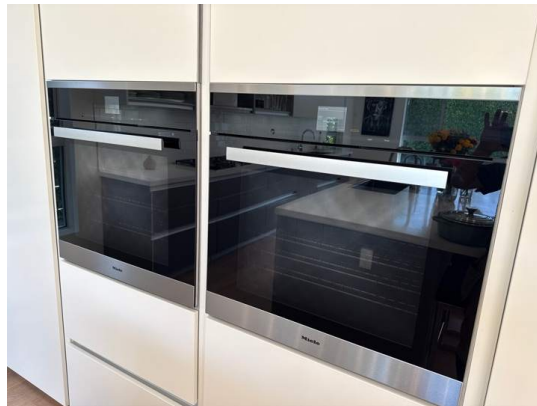
**187:** Built-in - There is a built-in gas range top and electric oven. They appeared to function correctly at the time of the inspection. The timers and temperature settings were not tested and are not a part of this inspection.

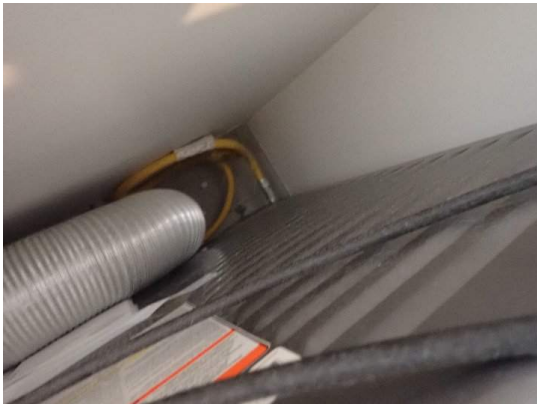
**191:** Satisfactory - The dryer ventilation as installed appears adequate. The vent hood outside is clean, and the flapper is functional.

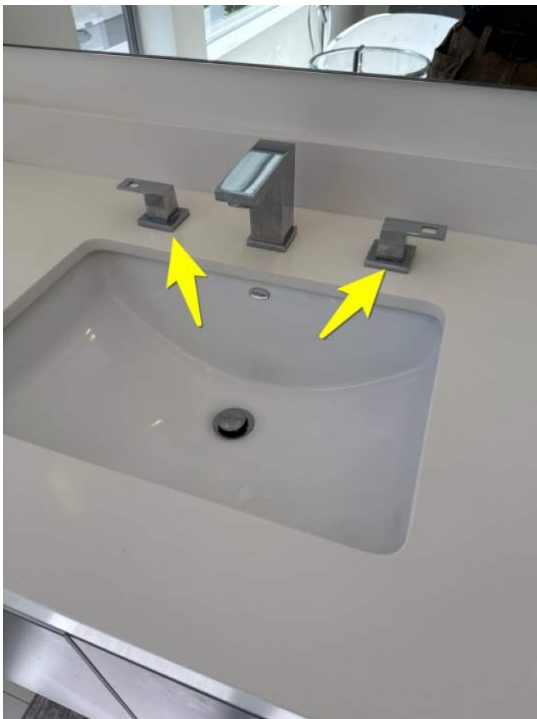
**264:** Attention needed: Sink fixtures hard to operate.  
Adjustments needed.

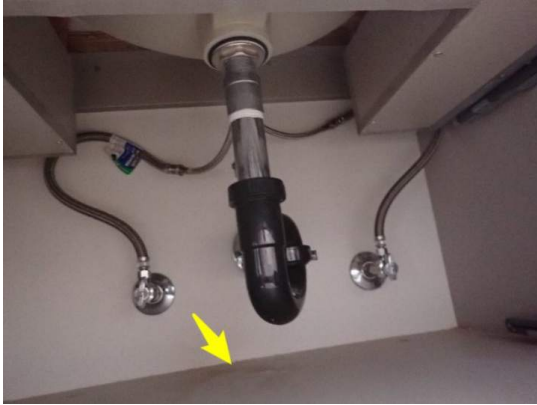
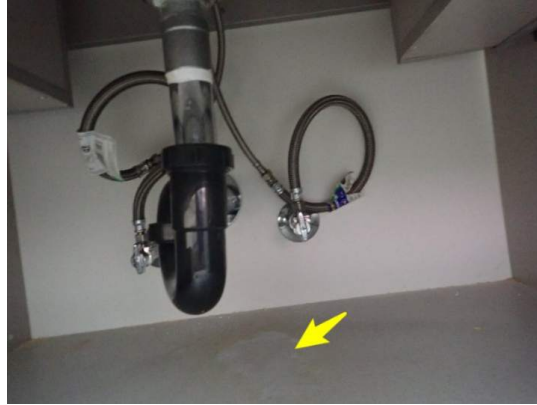
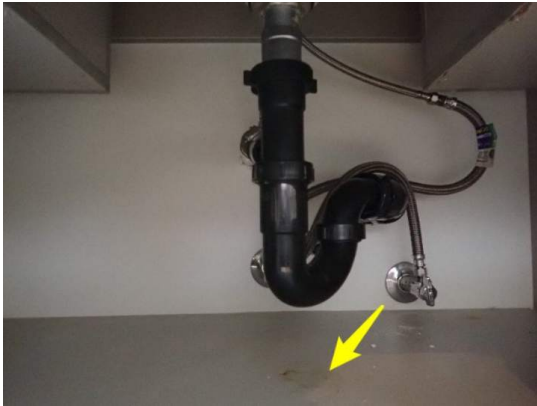
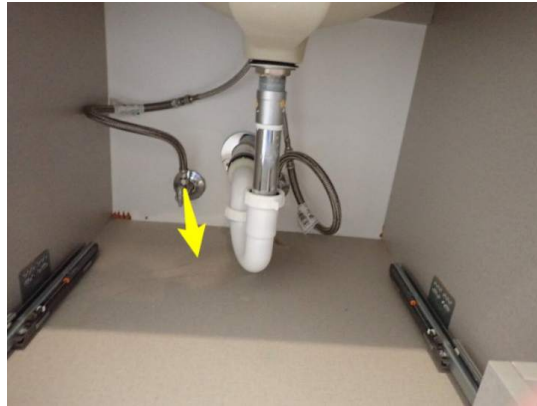
**277:** Attention needed: Some water staining noted under a few of the bathroom sink cabinets. Maintenance needed to insure plumbing drain lines are tightened and free from leaks to prevent possible water damage to cabinets.

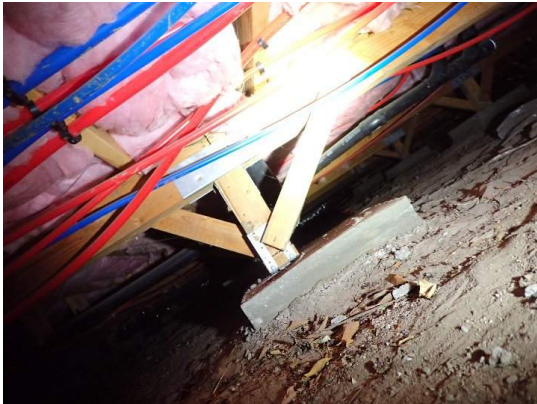
**290:** Satisfactory

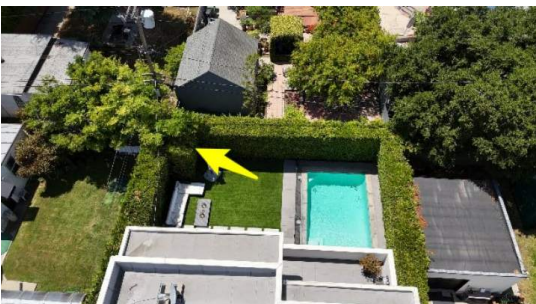
**295:** Some trees and/or shrubs on the site need to be trimmed.

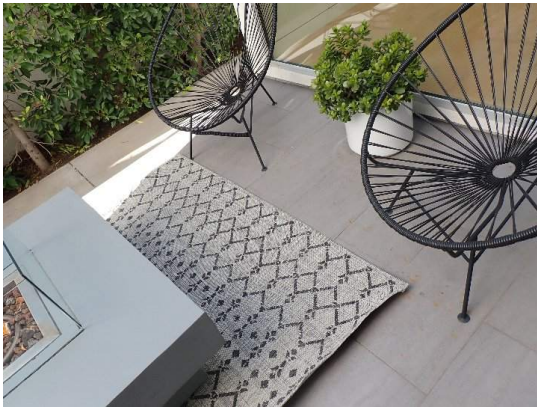
**301:** Tile.

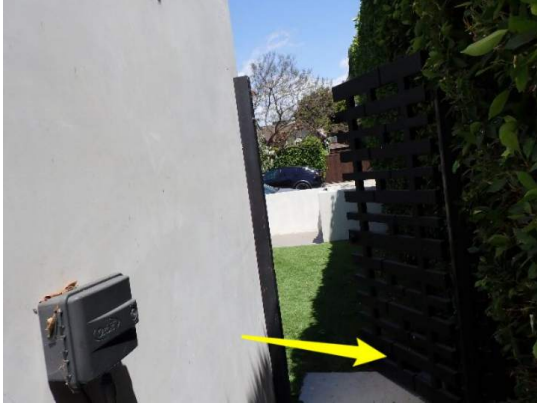
**306:** Attention Needed - The gate or latch hardware needs repair to function as intended.

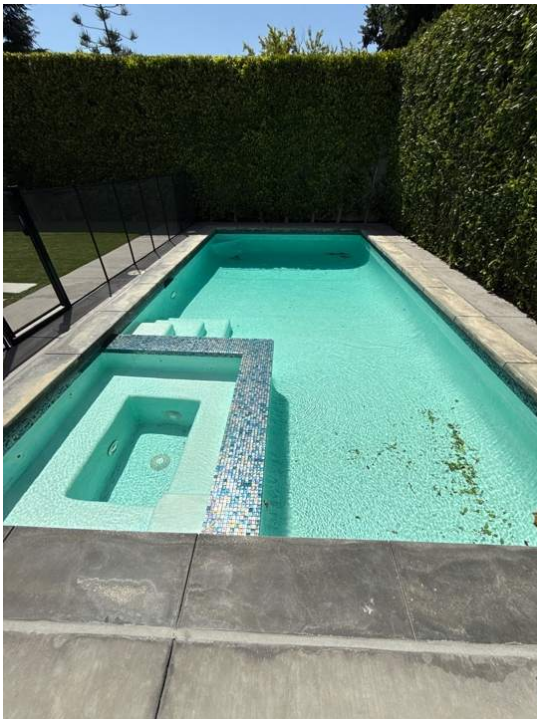
**307:** Cement Plaster

**308:** Pool surface is only fair in appearance due to age and wear. Expect replastering in the not to distant future.

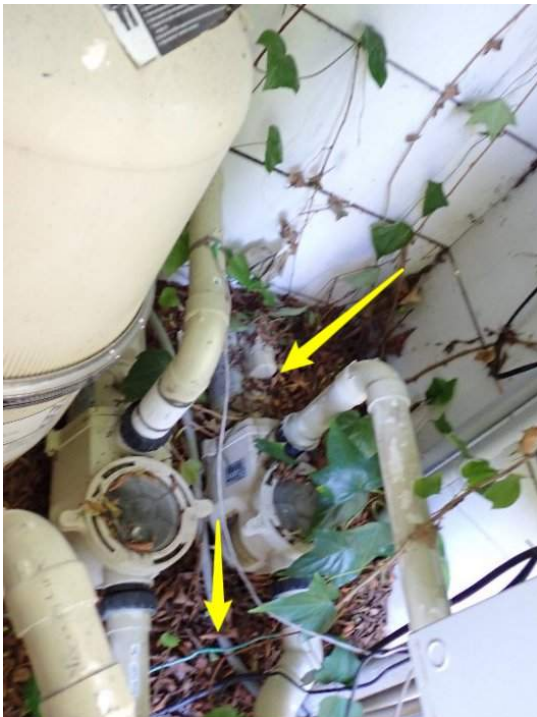
**313:** Satisfactory however vegetation and debris removal around equipment needed

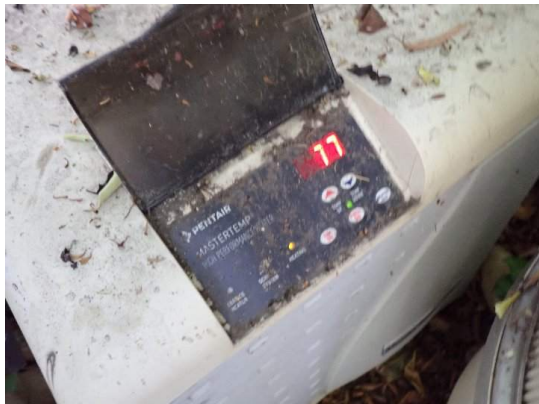
**318:** Satisfactory

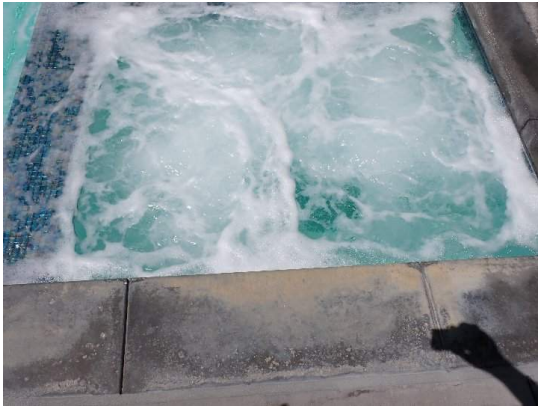
**325:** Operational using normal operating controls

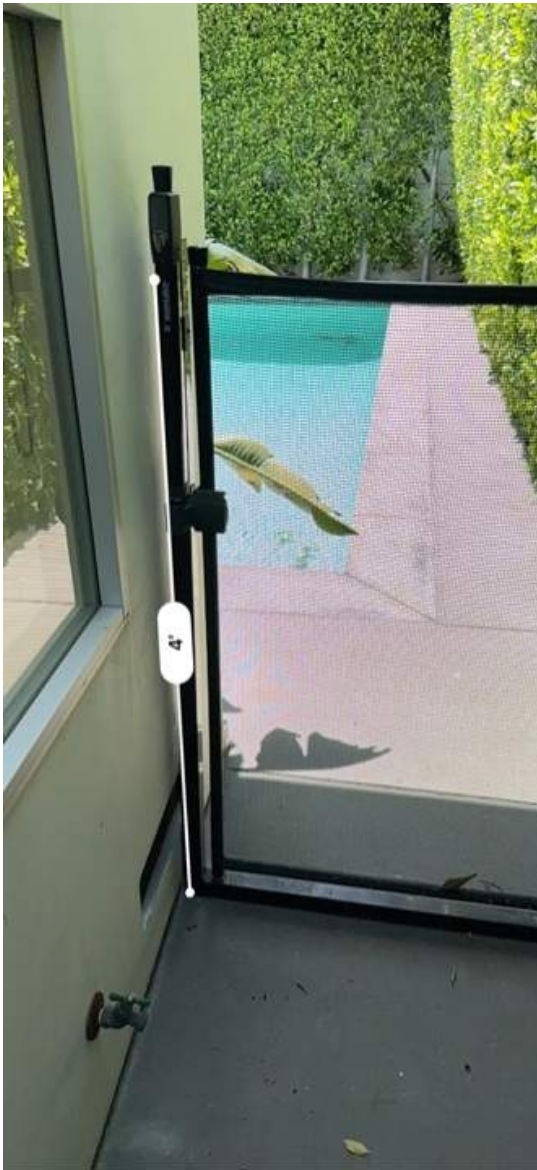
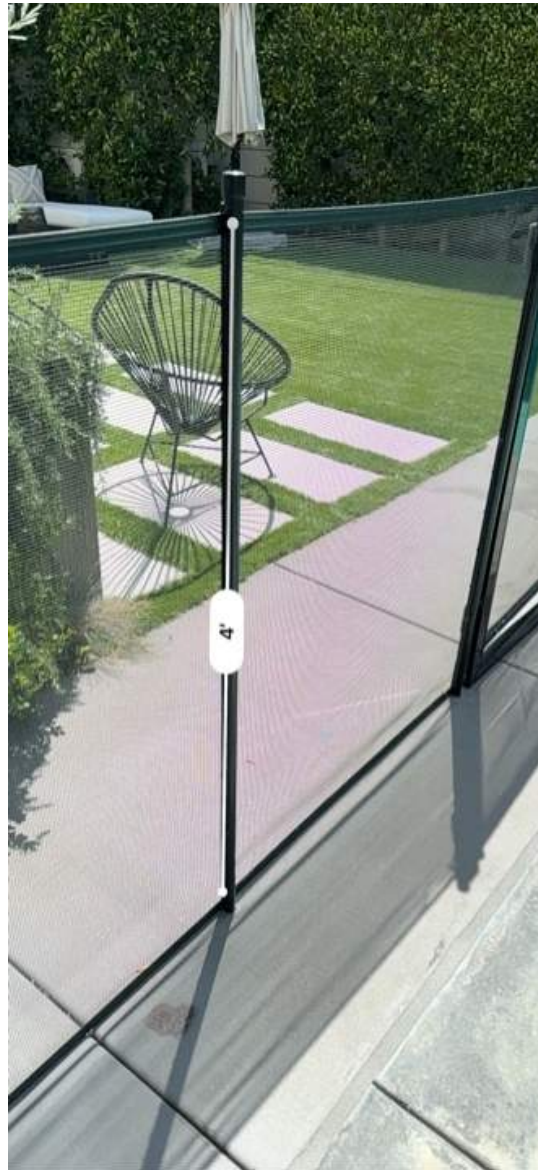
**328: INFORMATION BULLETIN / PUBLIC -**  
**BUILDING CODE REFERENCE NO.: LABC Section 3109,**  
**Effective: 1/1/2023**  
**Ch. 31B**  
**DOCUMENT NO.: P/BC 2023-014**  
**Previously Issued As: P/BC 2020-014**

**329:** Conditions noted: Enclosure does not meet the 5 feet high rule. Exit doors do not have alarms informing entry to pool area. Please see city requirements listed in above comments.
