# WOOD DESTROYING PESTS AND ORGANISMS INSPECTION REPORT

| Building No.<br>139 | Street<br>S. Edinburgh Ave. | City<br>Los Angeles | ZIP<br>90048 | Date of Inspection<br>05/13/2025 | Number of Pages<br>5 |
| GENERAL DESCRIPTION:<br>Two-story single family residence, frame & stucco, flat roof, furnished & occupied, attached garage, header construction | | | | Inspection Tag Posted:<br>Subarea<br>Other Tags Posted:<br>N/A | |

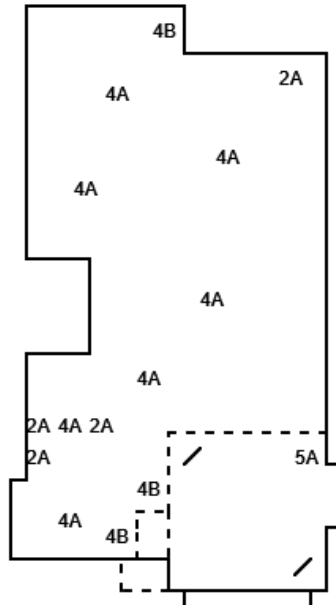
**Diagram Not To Scale**

**FINDING:** Evidence of drywood termites extending to inaccessible areas was noted in the subarea, 2A on the diagram..

**FINDING:** Cellulose debris (wood, paper products) was noted in the subarea, 4A on the diagram.

**FINDING:** Form boards/stakes were noted embedded in the subarea soil, 4B on the diagram.

**FINDING:** The garage is partially inaccessible for inspection due to occupant's storage where indicated on diagram.

**PRIMARY RECOMMENDATION:** Fumigate the structure with a state approved and registered fumigant to control drywood termites. Owner or agent to prepare the structure for fumigation as per list of instructions to be furnished by this company. The structure must be vacated until released for re-entry by the licensed fumigator. Cover evidence as necessary. (2 year guarantee)

**RECOMMENDATION:** Owner/agent should engage the services of a licensed contractor to remove all cellulose debris of a size that can be raked (or larger)

**RECOMMENDATION:** Owner/agent should engage the services of a licensed contractor to remove and dispose of the form boards/stakes from the subarea.

**RECOMMENDATION:** The owner should remove the storage where indicated and call for further inspection. For an additional charge (not to exceed the cost of the original inspection) the garage will be inspected and any findings will be listed on a supplemental report along with estimates for repair and/or treatment, if within the scope of this company's operations.
