# PROPERTY INSPECTION REPORT

Date: 1/19/2026

4232 Maplehurst Rd, Virginia Beach

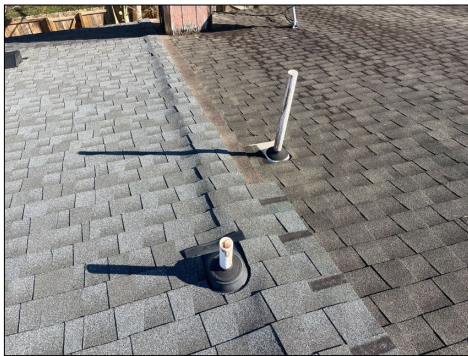
2.2. There were shingles that were not installed in a manner consistent with standard building practices. We recommend consulting with a qualified roofing contractor to determine the potential performance and warranty implications with this manner of installation. Our locations are just an example, we did not inspect every row of shingle, a qualified roofer should determine the extent of improper installation. Location: rear right

Improper installation

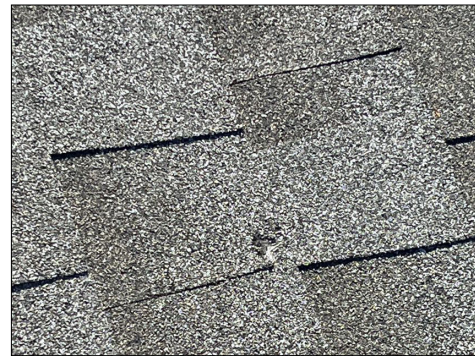
2.1. FYI: Minor damage was observed which appeared to be typical wear and tear and should be repaired as needed to prevent moisture intrusion.

Shingle damage

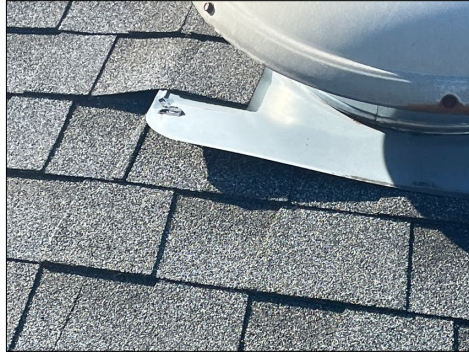
4.1. Loose **flashing**(s) should be secured and sealed to prevent moisture intrusion. Location: power ventilator

Secure and seal loose flashing

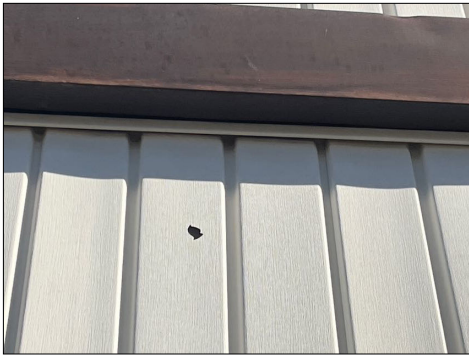
1.4. Damage to the vinyl siding which can allow moisture intrusion and should be repaired. Location:front middle

Siding damage

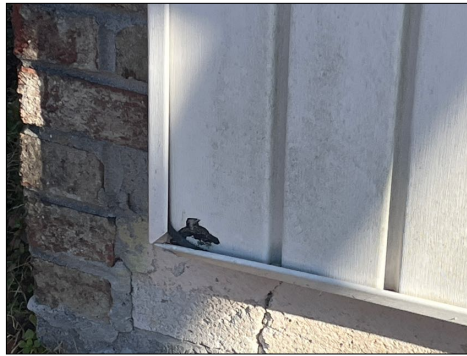
Minor siding damage

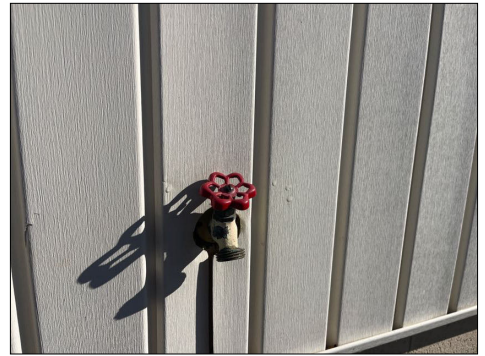
Recommend sealing all penetrations

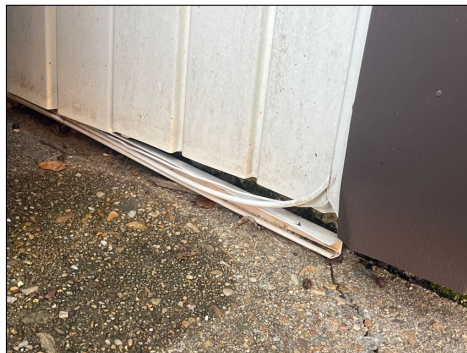
1.3. All loose vinyl siding trim should be secured. Location:by shed

Loose siding trim

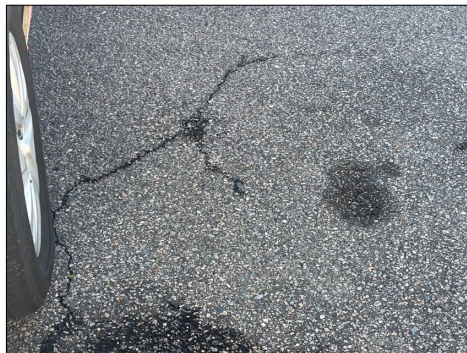
2.1. You should consider repairing cracking at the driveway to prevent further damage and the development of trip hazards.

Seal cracks to prevent damage

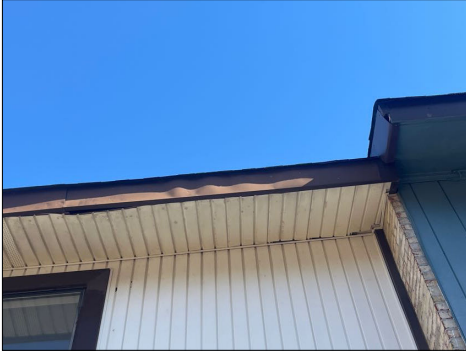
- 3.1. Loose soffit wrap should be properly installed or adjusted to prevent openings to the attic. Location:front right, rear  
3.2. Secure and seal all loose trim to prevent moisture intrusion and possible damage. Location:middle left, shed  
3.3. Missing soffit wrap should be properly installed or adjusted to prevent openings to the attic. Location:rear right

Soffits need repair

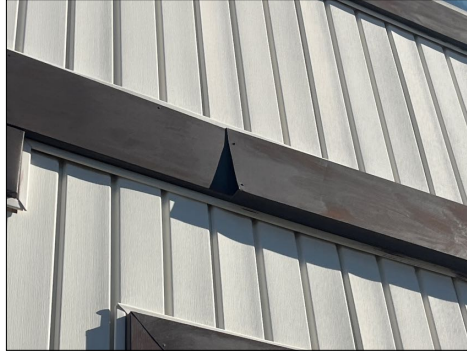
Loose trim wrap

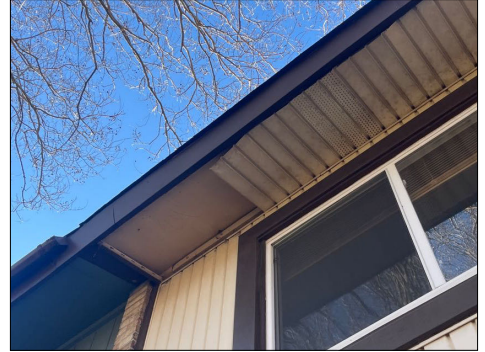
Soffits need repair

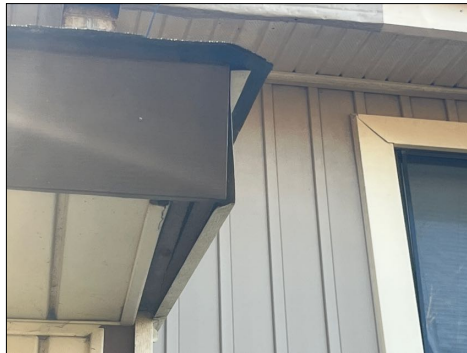
Loose trim wrap

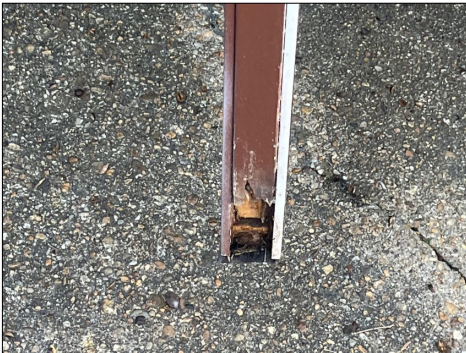
- 4.1. Damage to an exterior door should be repaired or replaced as needed. Location:shed

Damaged

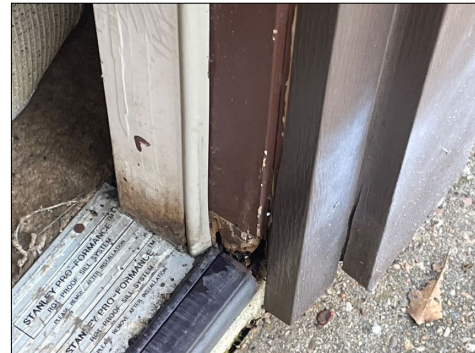
Damaged

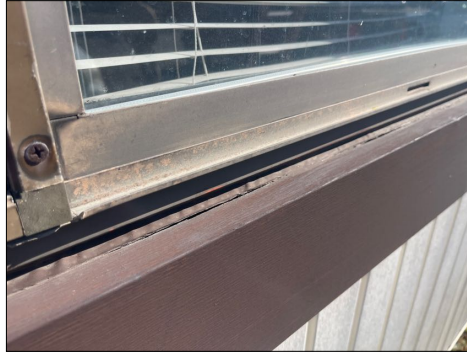
- 5.1. Sealant maintenance was needed at window(s) to prevent moisture intrusion. Location:multiple locations

Sealant needs repair

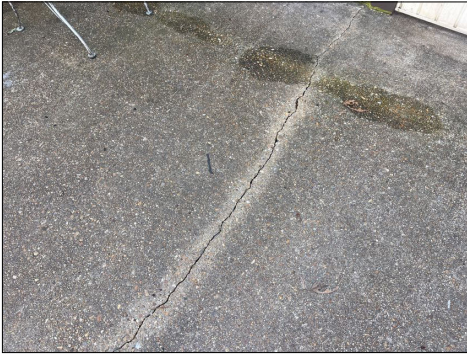
6.1. Cracked concrete should be repaired as needed. Location: rear

All cracks should be sealed

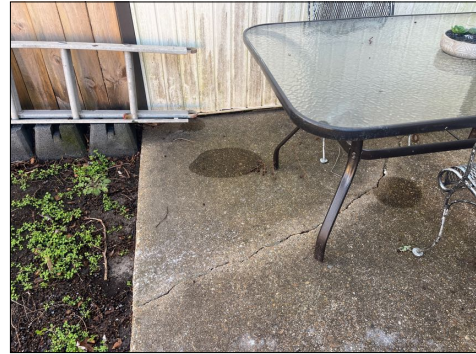
6.2. There was settling or cracking at the patio which has created trip hazards. You should repair as needed.

Settling

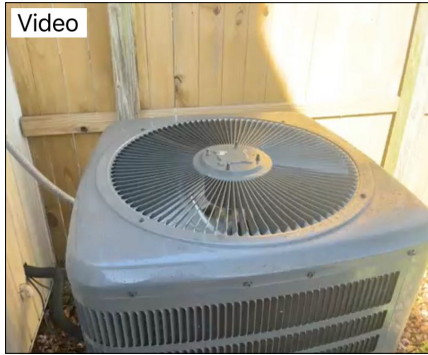
4.2. Due to the cold temperature the heat pump was turned to cool to test that the reversing valve was functioning. We cannot determine how well the unit cools.

Reverse valve tested

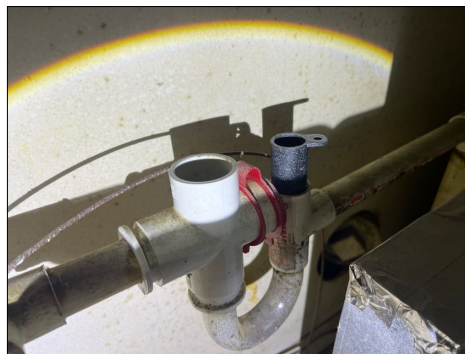
6.1. We recommend having a cap installed at the condensate line clean out to prevent conditioned air loss.

Cap needed at cleanout

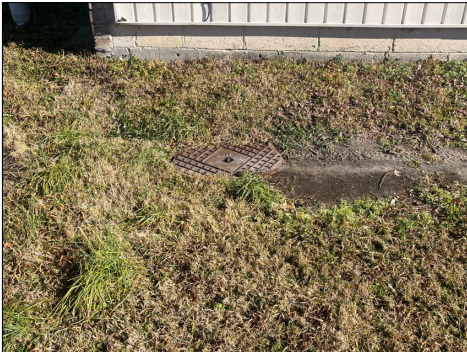
Shutoff underground at meter box

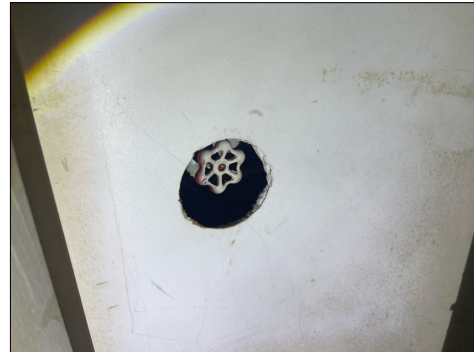
Water was publicly supplied the main shutoff was not labeled but there were valves observed. Recommend inquiring with the sellers. Location: utility closet

Shutoff in utility closet

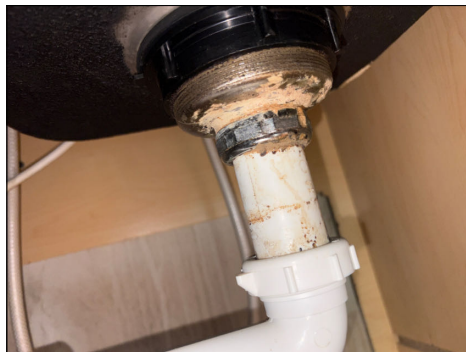
4.1. There were drain pipes that showed signs of past leakage. No leaking was observed at time of inspection, however it is recommended that the areas be monitored or evaluated by a qualified plumber. Location: kitchen sink

Signs of past leak

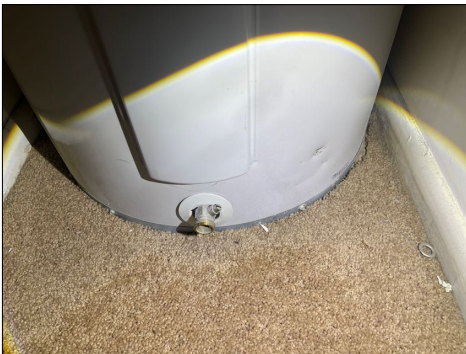
6.1. A drain pan and drain line is recommended to prevent damage if appliance leaks.

No drain pan installed

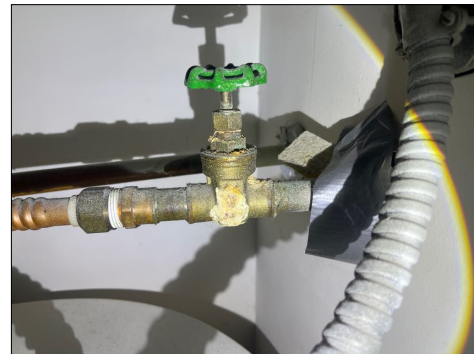
6.2. Mineral encrustation on fittings or valves should be cleaned to ensure that no leaking is present and be repaired if needed.

Mineral buildup

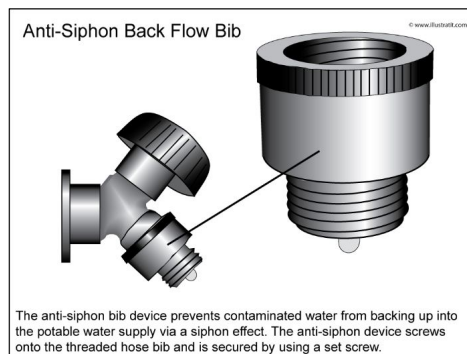
7.1. A hose spigot that was leaking while turned off should be repaired. Location:front

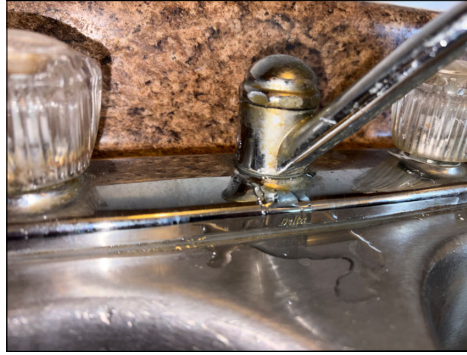
8.1. Leaking faucet controls should be repaired as needed. Location:kitchen sink

Leaking controls

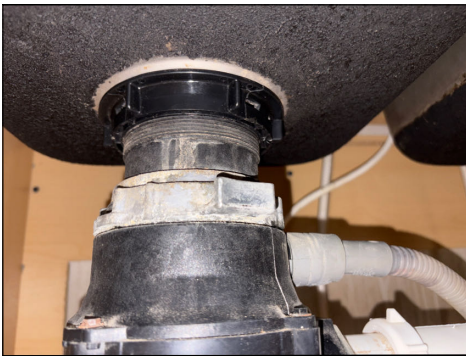
9.2. Leaking sinks should be repaired as needed. Location: kitchen sink, master bath sink

Leaking sink

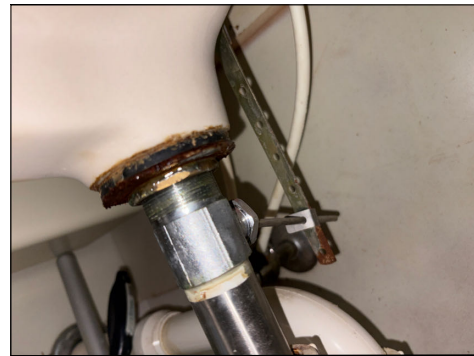
Leaking sink

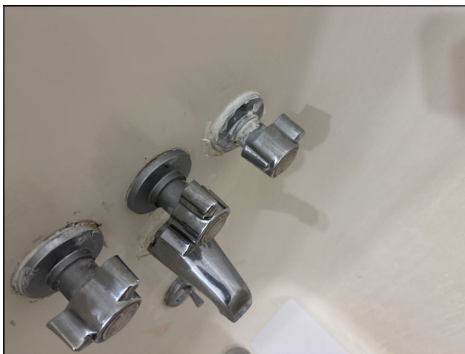
10.1. Excessive sealant was observed in the bathtub area. We are unable to determine if there was or is a moisture intrusion issue. Recommend inquiring with sellers or monitoring the area or further evaluation by a qualified plumber as needed. Location: Upstairs hall bath

Excessive sealant

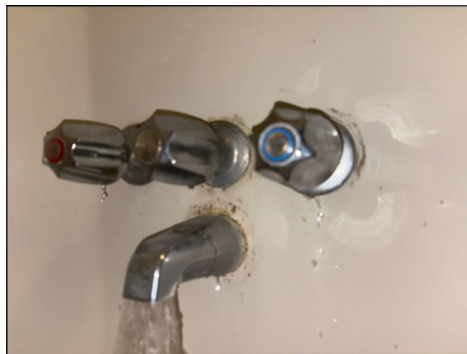
10.3. Leaking bathtub faucet controls should be repaired as needed. Location: master bathroom

Leaking control(s)

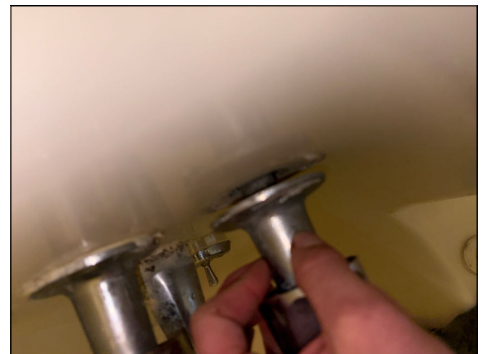
10.2. Open tub controls can allow moisture intrusion into the wall and should be secured or sealed to prevent moisture intrusion. Location: Master bathroom

Open controls

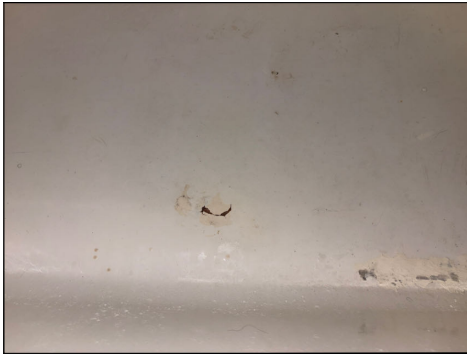
10.4. There was damage to a bathroom tub that should be repaired as needed. Location: Master Bathroom and hall bathroom

Bathtub damage

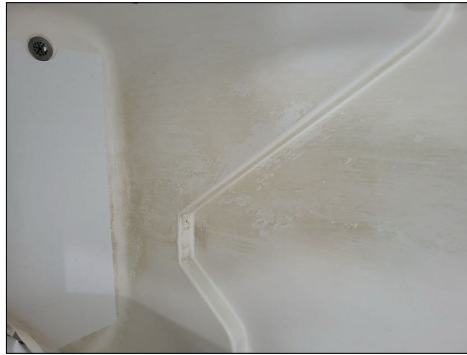
Damaged

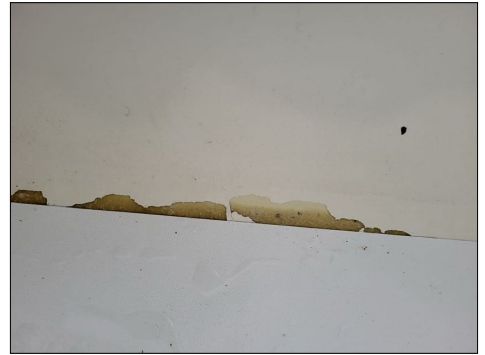
Damaged

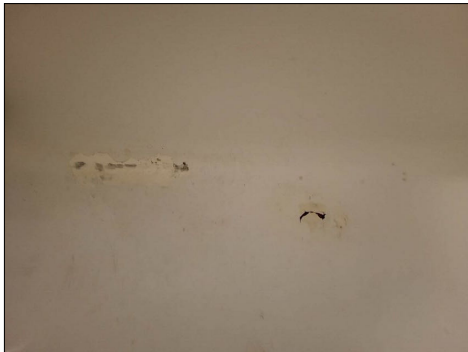
Damaged

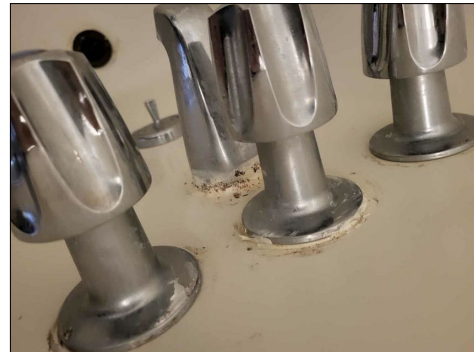
Damaged

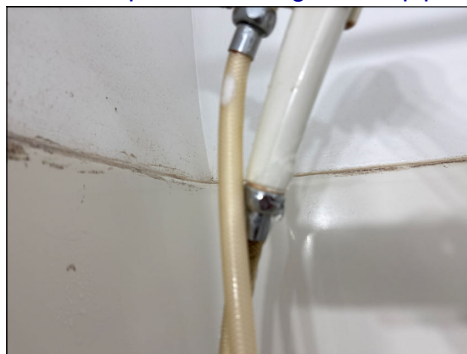
11.1. Leaking shower heads should be tightened or sealed to prevent moisture damage. Location: Upstairs hall bath

Leaking shower head

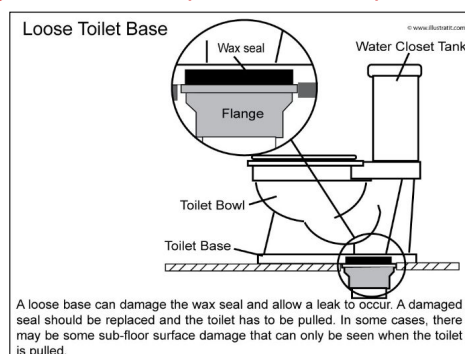
12.1. Loose toilet(s) should be secured to prevent damage and moisture issues. Location: upstairs hall bath

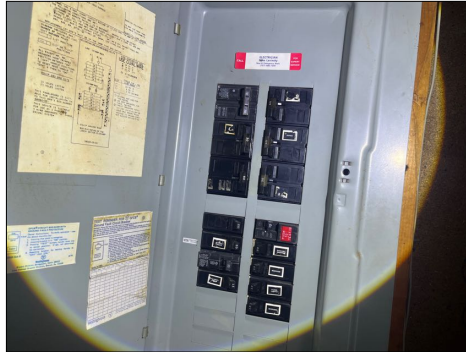
Main disconnect - shed

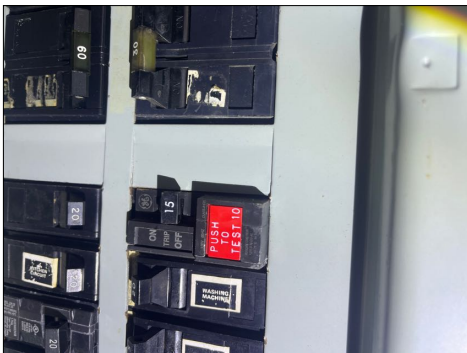
3.4. Breaker(s) were off in the main electrical service panel indicating there may be an issue. You should consult with the seller regarding this condition, and have repaired if needed. Location: **GIC**

Breaker off

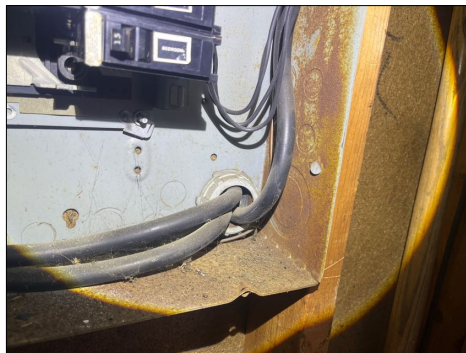
Rust in panel

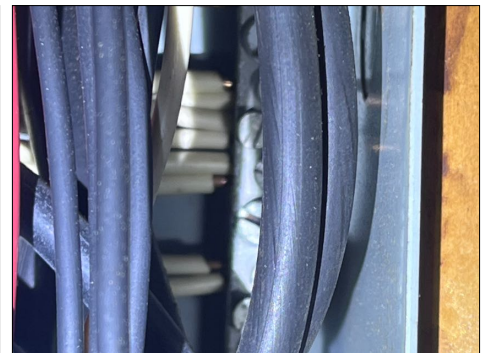
Neutrals should be terminated individually

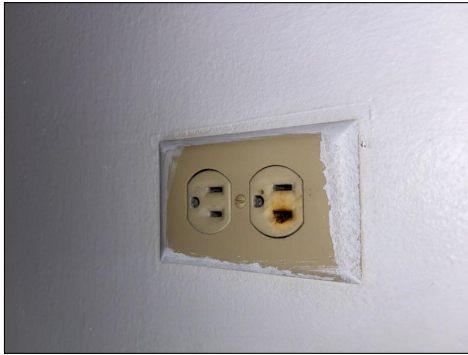
7.3. Scorched receptacles should be replaced. Location: upstairs front right bedroom multiple locations

Scorched receptacle

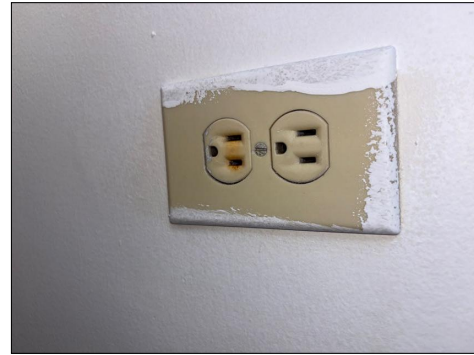
Scorched receptacle

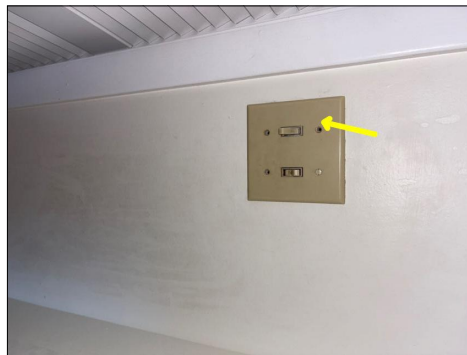
8.1. There was a switch that did not function as intended and should be replaced. Location: upstairs left bedroom  
upstairs right bedroom

Inoperable switch

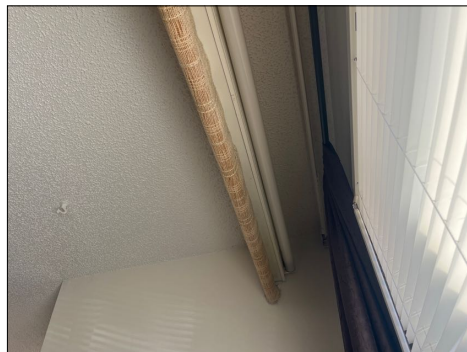
Improper installation

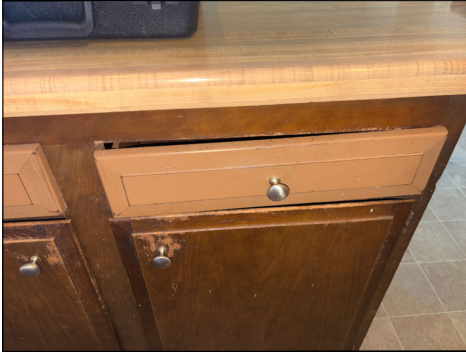
2.3. Drawer glides that did not function as intended should be repaired where needed. Location:kitchen island

Broken drawer glides

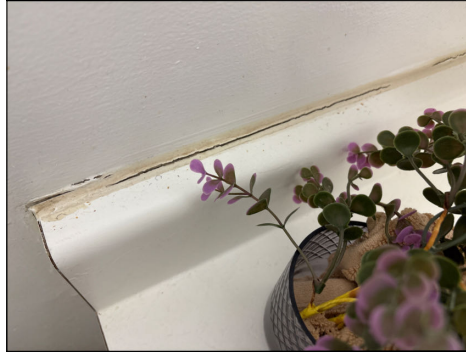
2.2. Sealant at the bottom of a back splash was damaged or missing and should be corrected. Location:upstairs hall bath, master bathroom

Recommend sealing

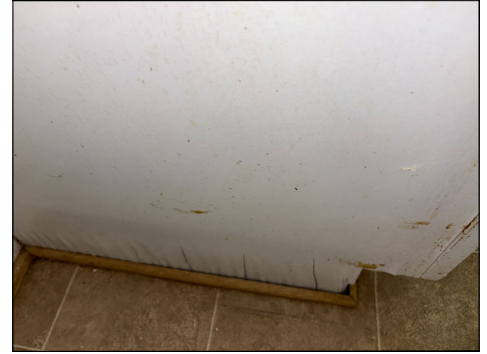
Damaged

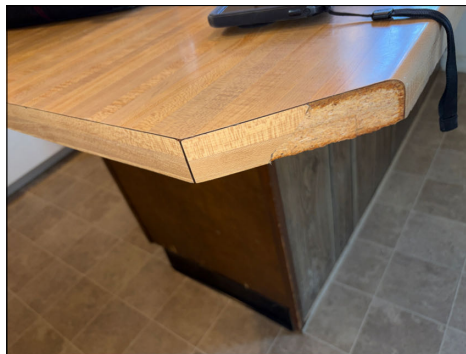
Damaged

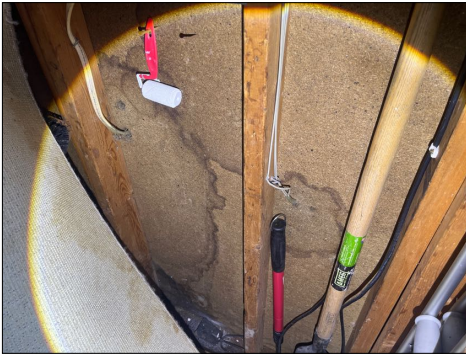
3.2. FYI: Moisture stains on the ceiling(s) were dry when tested with a moisture meter. We recommend asking the seller if action regarding any previous issues has taken place, and if issue is resolved. The interior condition of the ceiling is unknown. Location:left living area closet

Moisture stains - dry

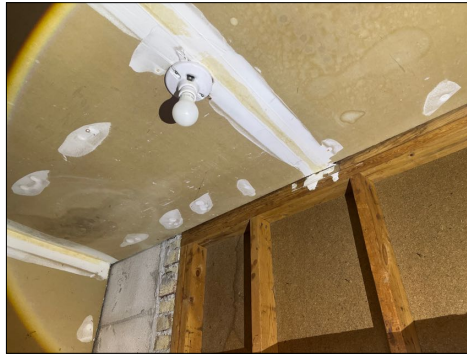
Moisture stains - dry

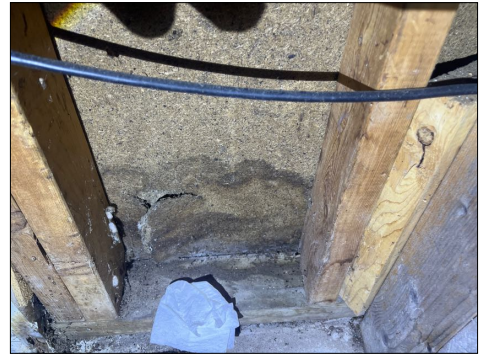
Moisture stains - dry

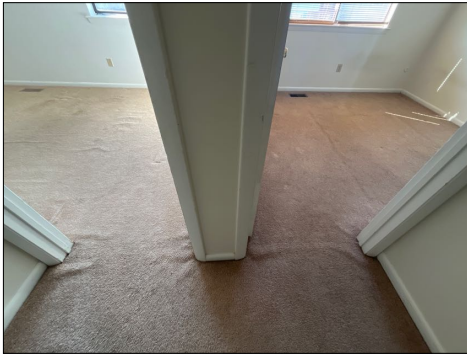
Uneven carpeting

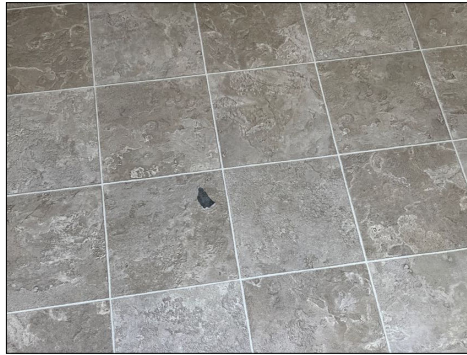
5.3. Damaged floors should be repaired or replaced as needed. Location: multiple locations

Damaged flooring

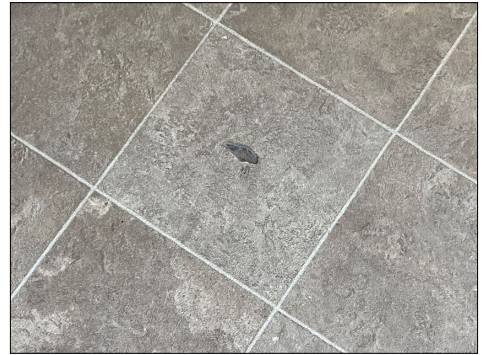
Damaged flooring

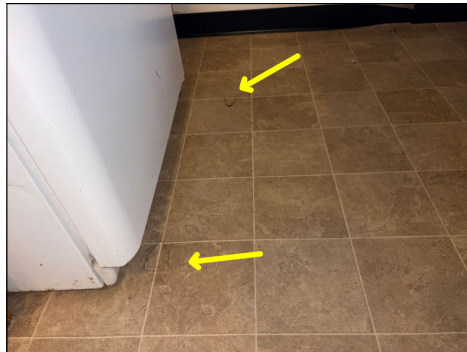
Damaged flooring

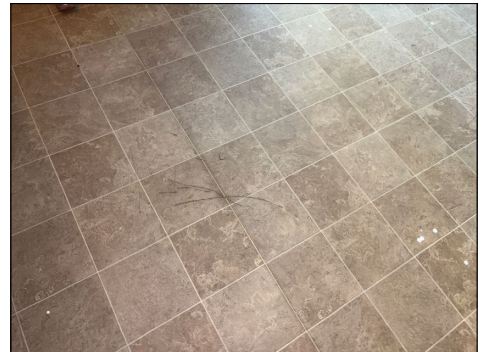
Damaged flooring

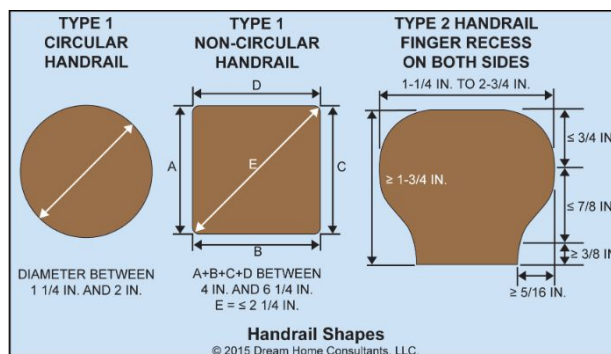
7.6. Loose railing(s) at the stairs should be secured to provide safe conditions. Location: bottom and top of staircase

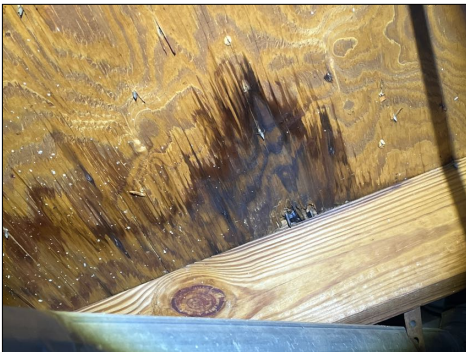
3.1. FYI: Visible moisture stains appeared to be from previous issues. There did not appear to be any active issues present, but could not be confirmed. Only a water test could determine if there was an active leak.

Moisture staining - evaluated dry

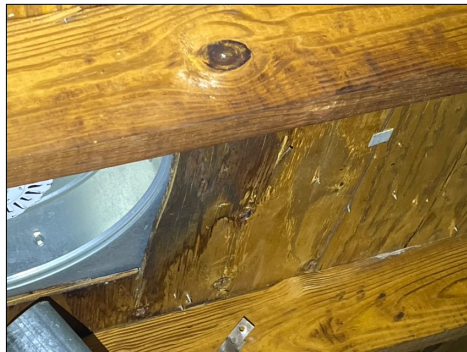
Moisture staining - evaluated dry

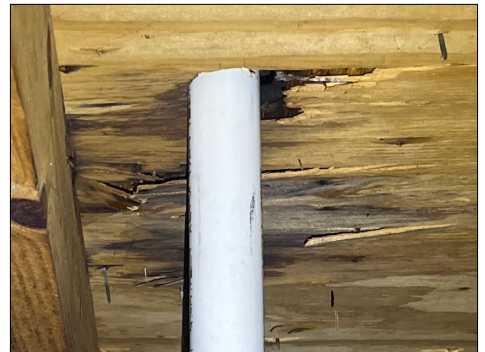
Moisture staining - evaluated dry

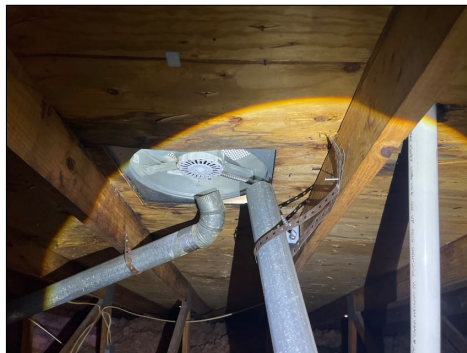
Venting at ventilator

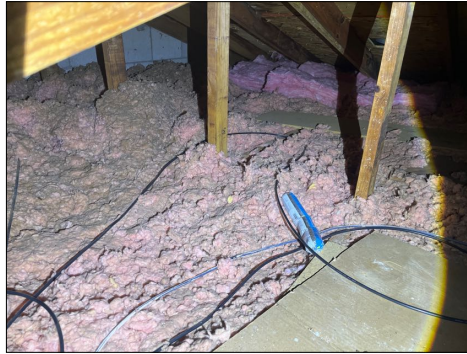
4.1. FYI: The insulation levels may have been acceptable at the time of original construction, but do not adhere to today's standards.

4.2. Improve: The insulation had settled or been compressed and most likely does not perform to the proper R-value.

Approximately 6 - 8 inches

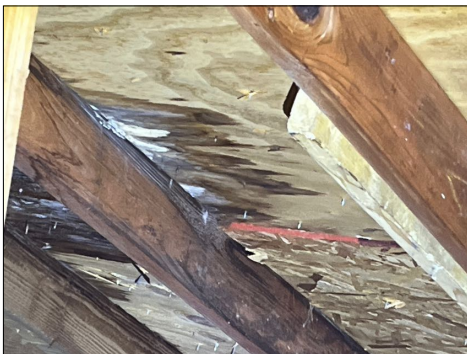
6.2. There were indications of moisture intrusion evidenced by stained roof deck, but the location was not accessible to test. All necessary repairs should be made if not previously corrected. Location: rear left, front right, rear right

Inaccessible stains

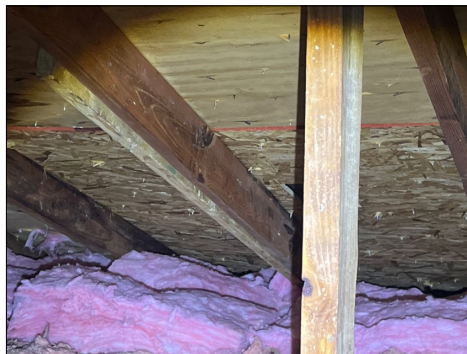
Previous repairs observed

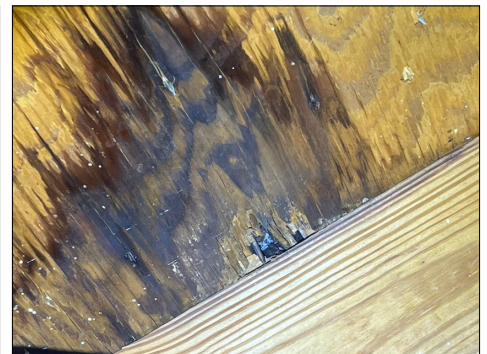
6.3. Damaged roof sheathing should be repaired as needed. Location: near power ventilator, front left plumbing vent, right of ventilator, front right

Sheathing damage

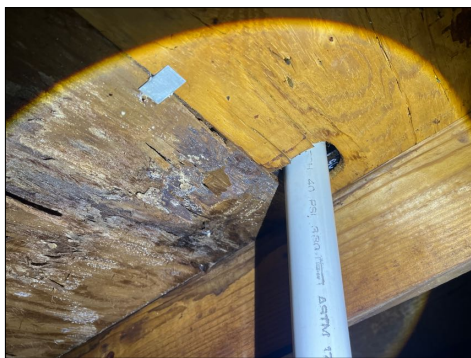
Sheathing damage

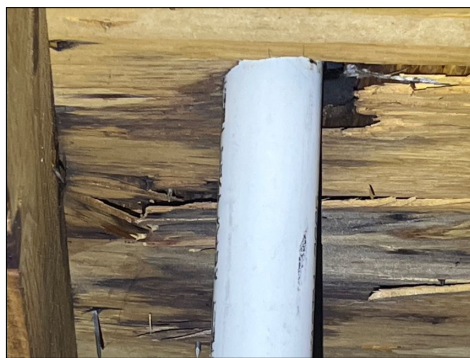
Sheathing damage

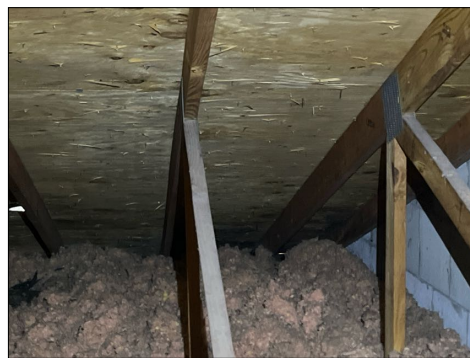
Inaccessible stains

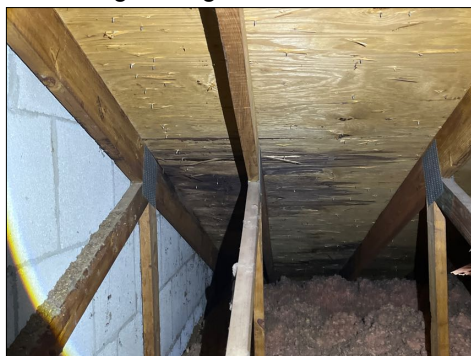
Inaccessible stains

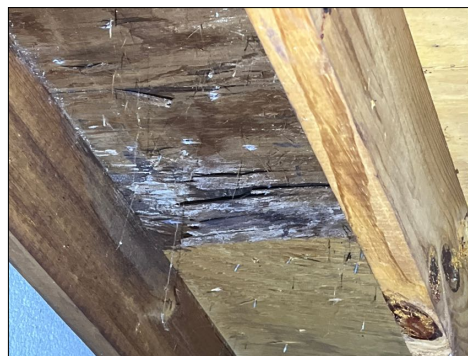
Sheathing damage

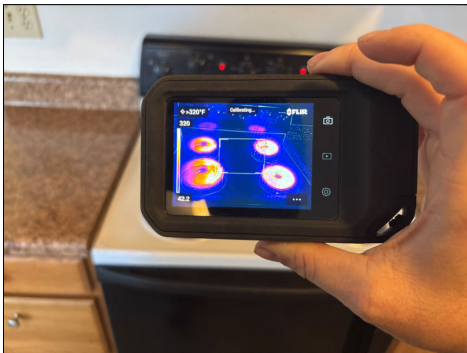
2.1. The heating elements/burners and oven operated when tested, but does not confirm the efficiency of the system. Not all settings were tested.

Functional

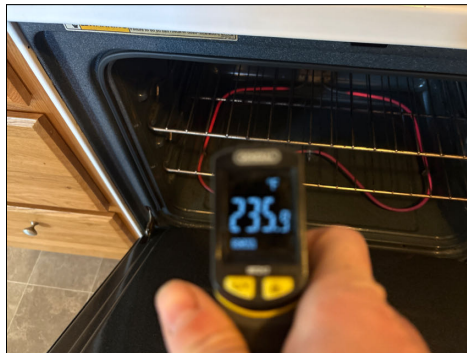
Functional

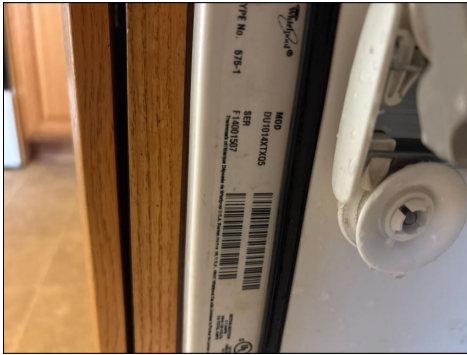
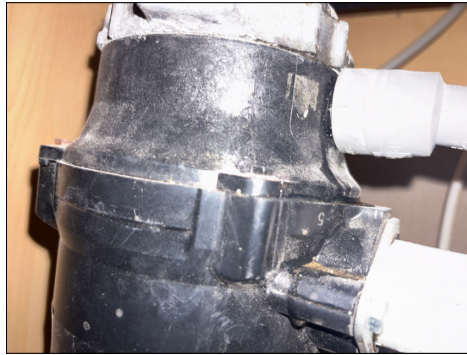
3.3. The dishwasher was leaking after being turned on, and should be repaired by a qualified technician.

Leaking

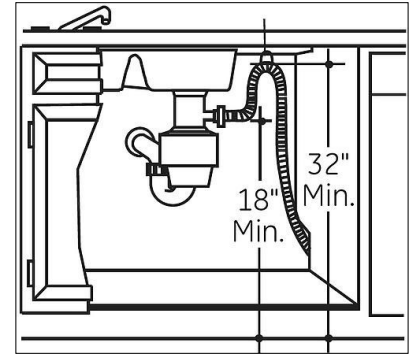
Dishwasher Highloop Example

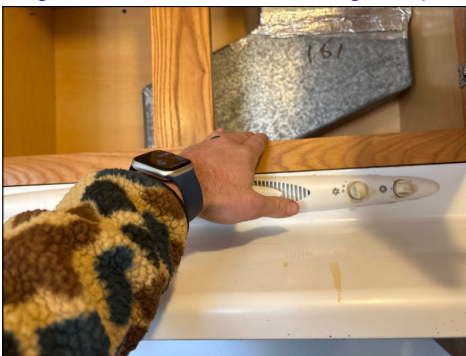
5.1. The range hood exhaust fan and lights operated with no deficiencies observed.

Functional

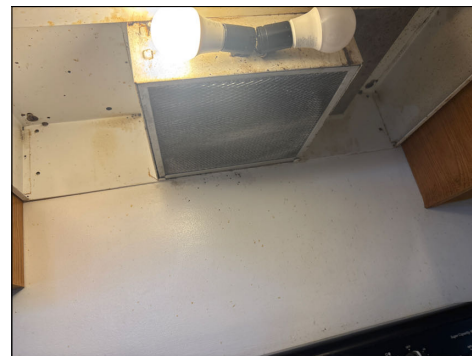
Functional

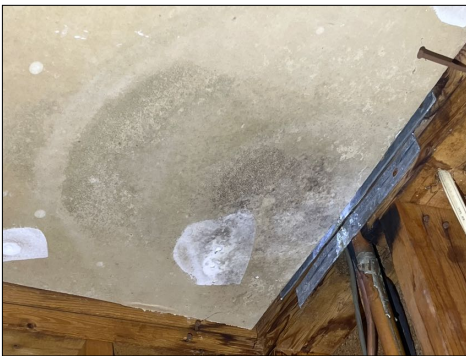
12.1. Visible **microbial growth**, type and extent unknown, had no elevated moisture levels. This may indicate a previous moisture issue has been remediated or is not presenting itself at this time. You should discuss with sellers regarding any prior moisture issues in this area. You should have remediated as needed. Location:shed

Microbial growth observed dry

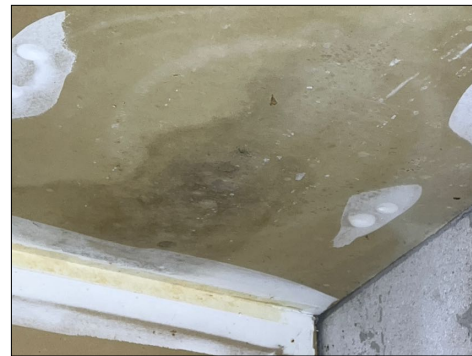
Microbial growth observed dry
