Working Paper

70

A TECHNICAL ASSESSMENT OF THE NORTH AMERICAN-STYLE 2X4 RESIDENTIAL CONSTRUCTION SYSTEM IN JAPAN

October 1999

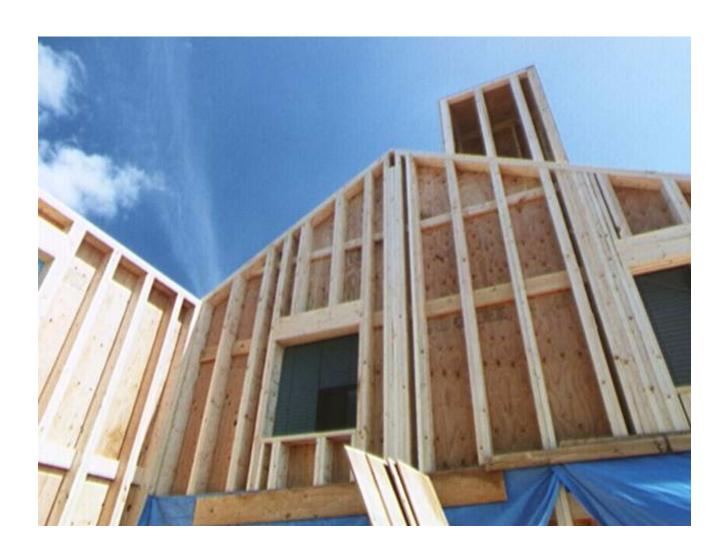
The excessive use of framing lumber was routinely observed. It is estimated to increase framing material costs by 30-35 %.

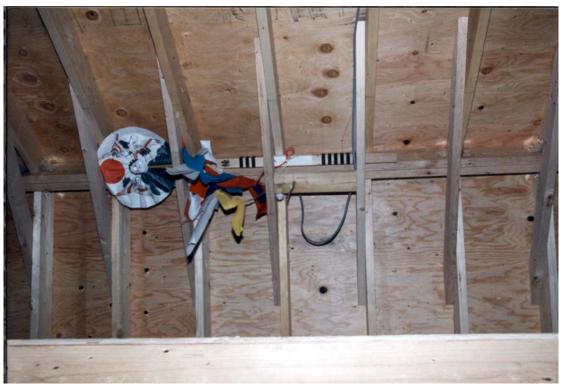
Photo 2. In a tradition derived from traditional post and beam construction, ceremonial items are often placed in the roof of 2x4 houses to bring the owner good luck and fortune.

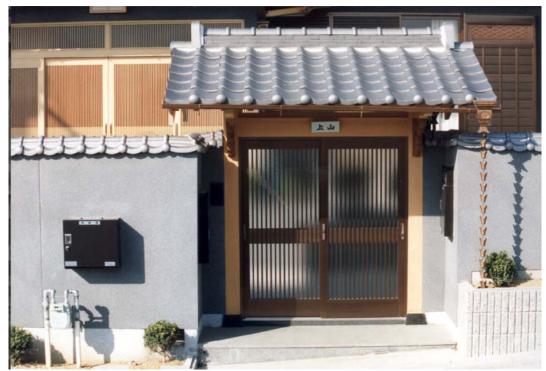
Photo 3. Entrance of a traditional post and beam house.

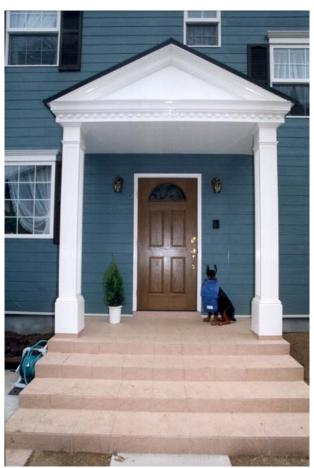
Photo 4. Entrance of a North American-style 2x4 home where the architect has gone to great lengths to produce an Americana motif.

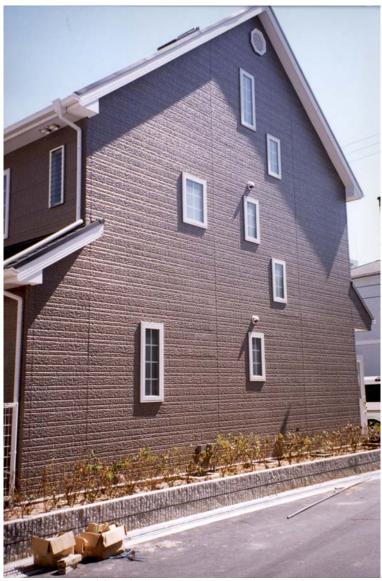
Photo 5. Lack of familiarity with North American architectural designs and building materials can adversely impact the aesthetics of a home.

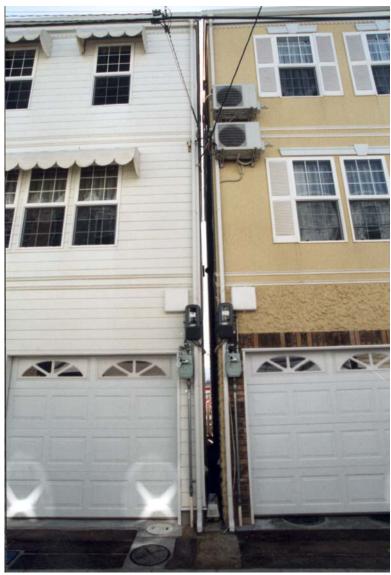
Photo 6. Poor design means that the garage doors at right must be raised before the septic tank covers can be accessed.

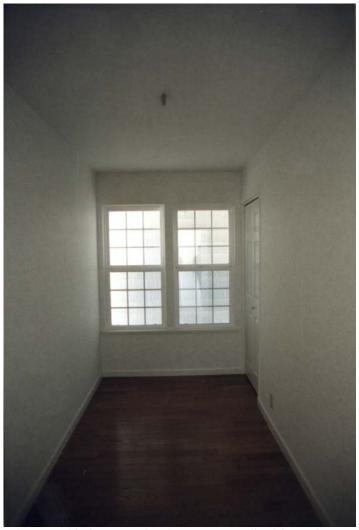
Photo 7. This fragmented and compartmentalized floor plan results in wasted hall space that is too narrow for a usable room and too wide for a corridor.

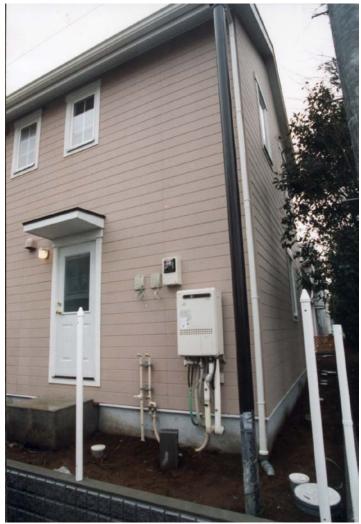
Photo 8. The conspicuous placement of service equipment is unsightly. Also, the height of the door above the landing poses a safety hazard.

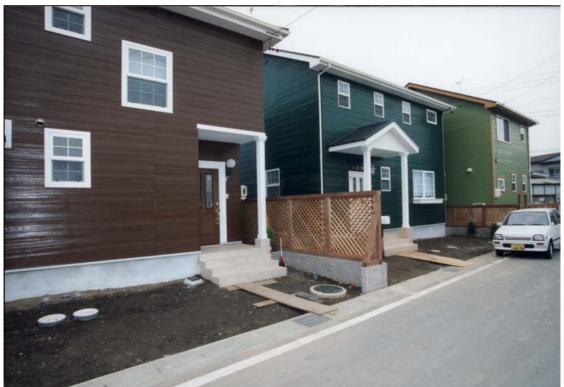
Photo 9. Lack of familiarity with North American architectural designs and single family housing developments can adversely impact the aesthetics of housing projects in Japan.

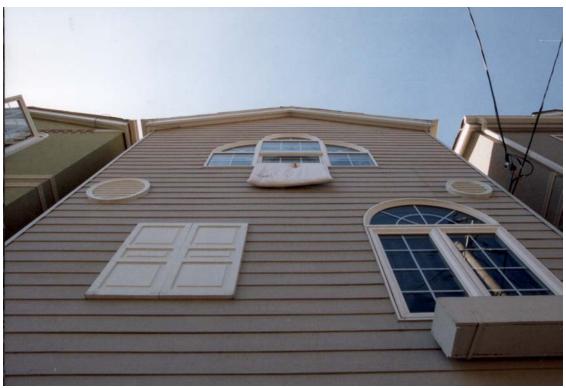
Photo 10. Lack of familiarity with North American building materials can adversely impact the aesthetics of 2x4 homes.

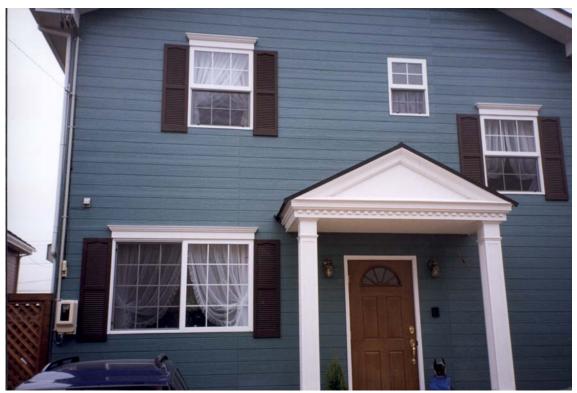
Photo 11. Lack of familiarity with specifying imported building materials resulted in a mismatch between the length of windows and shutters.

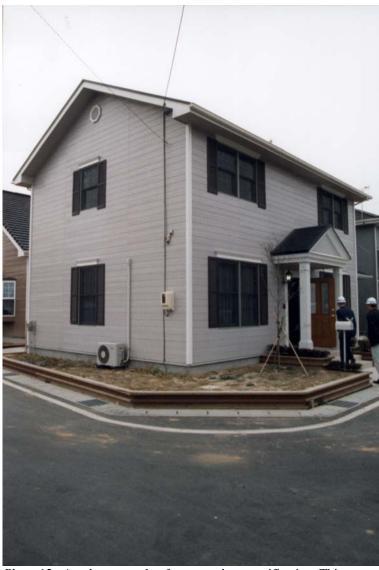
Photo 12. Another example of poor product specification. This picture also highlights the small size of building lots in urban Japan.

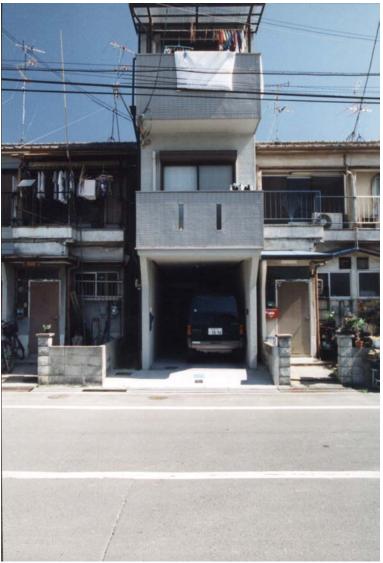
An important area of concern noted by the technical assessment team was the lack of understanding of the North American 2x4 construction management process. Building lot sizes are typically quite small in urban Japan (Photos 12 and 13). As a result, most material storage and preparation occurs on the work platform, contributing to congestion and adversely affecting worker productivity (Photos 14-16). In addition, cultural norms in Japan require that builders and contractors erect intricate and expensive scaffolding and tarp systems to minimize the visual and noise impacts of the construction process on nearby neighbors (Photo 17). These scaffolding systems impede workers' movement around the construction site, restrict their access to the work platform during the construction process, and complicate the handling and movement of building materials on site.

Photo 13. Narrow building lots in Japan increase the importance of employing efficient construction management practices in residential construction.

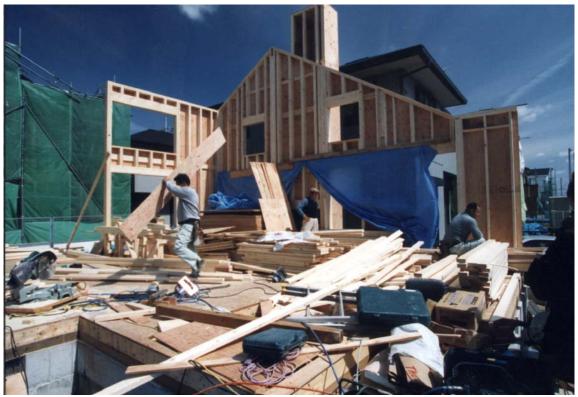
Photo 14. Small lot sizes lead to material storage on work platforms, contribute to crowded and unsafe working conditions, and result in excessive material handling.

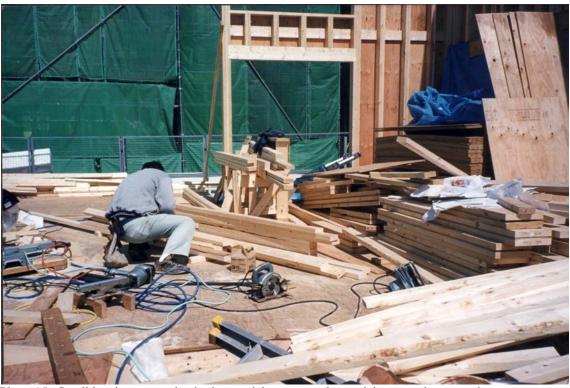
Photo 15. Small lot sizes mean that both material storage and material preparation operations occur on the work platform.

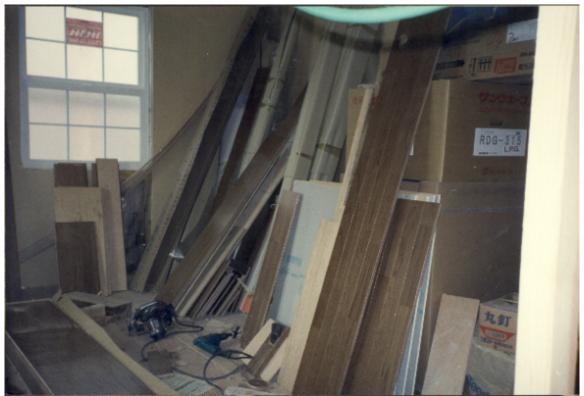
Photo 16. Storage of building materials on the construction site results in excessive material handling, contributes to reduced worker productivity, and can potentially lead to increased damage of finished products (e.g., windows).

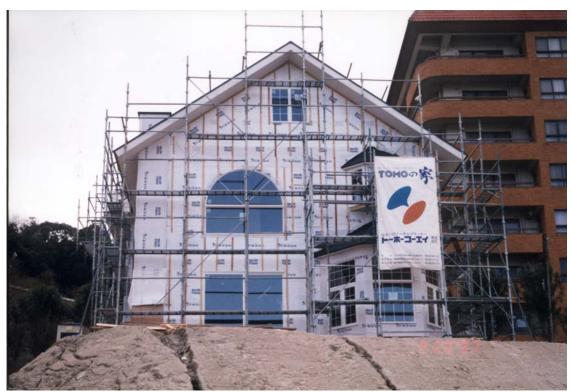
Photo 17. The extensive use of intricate and expensive scaffolding systems in Japan can hinder the movement of both carpenters and building materials on the job site.

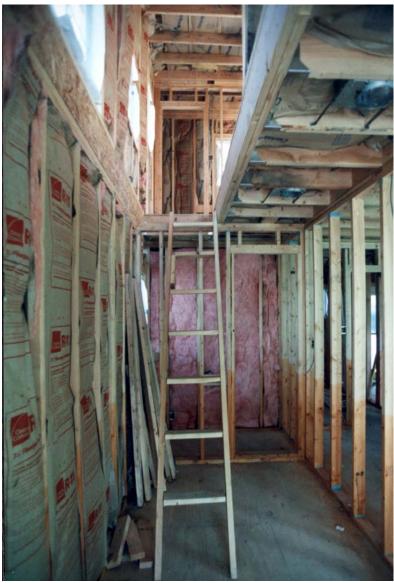
Photo 18. Insulation on this exterior wall has been incorrectly installed. Note the use of an unsafe makeshift ladder well into the construction process.

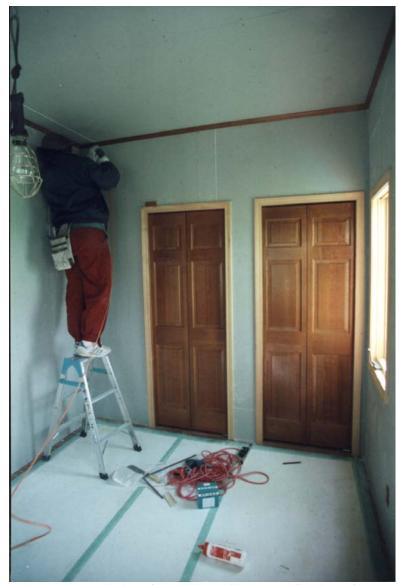
Photo 19. Installation of mouldings, millwork and flooring often occurs before wall surfaces have been finished.

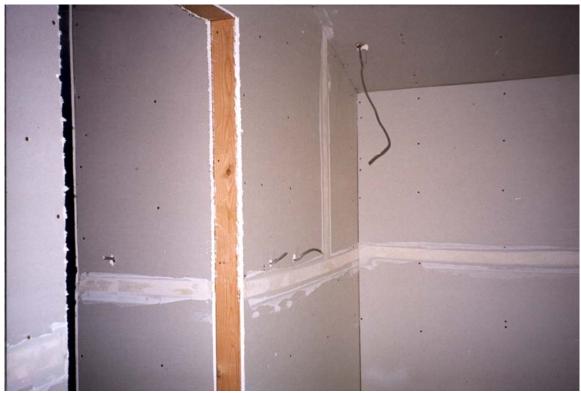
Photo 20. Wall board is often installed over electrical outlets and electricians waste time locating outlets and cutting outlet openings in the wallboard.

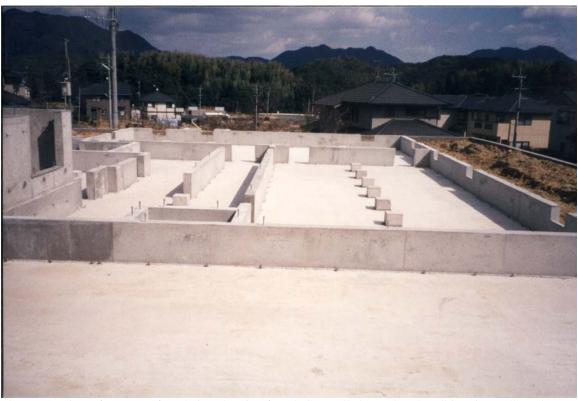
Photo 21. View of Japanese foundation showing foundation walls located under all interior walls and pier blocks at the middle of longer spans.

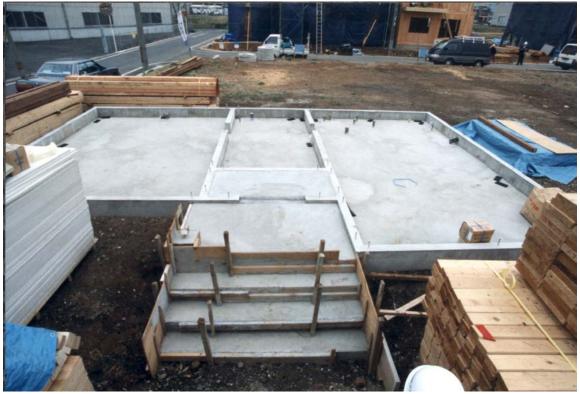
Photo 22. In many cases foundation walls do not provide adequate ventilation for the crawl space.

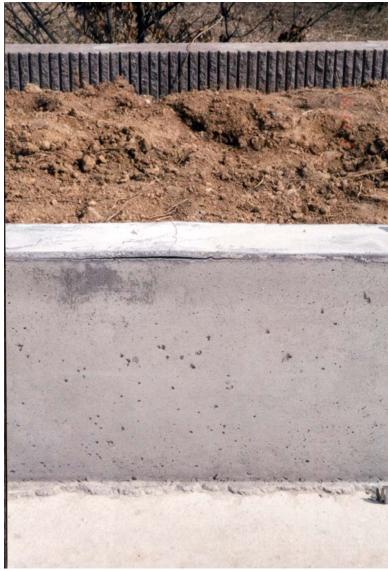
Photo 24. Poor adhesion by the thin mortar layer used to level foundation walls often results in separation.

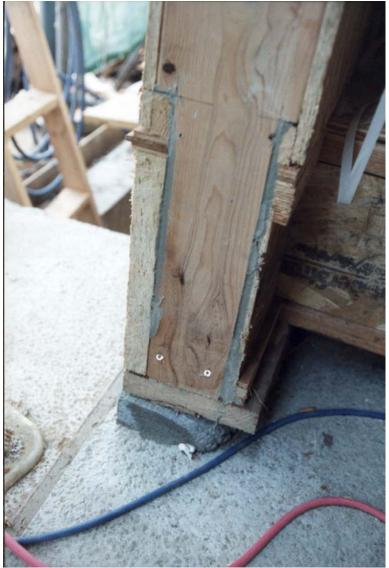
Photo 25. A structurally unsound effort to level an uneven foundation.

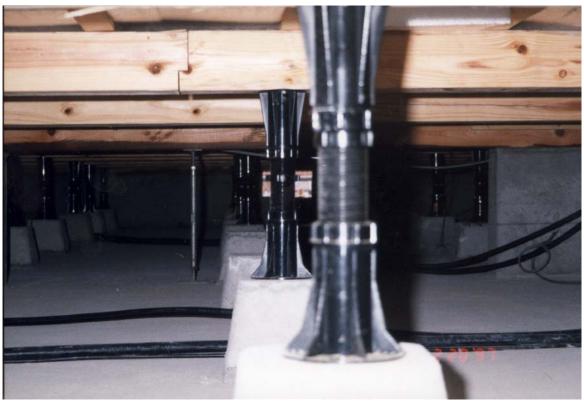
Photo 26. Expensive and potentially unsound support columns are not connected to the pier blocks or floor joists and can kick out during an earthquake. Note the end notch where adjacent joists are butted is not located above a support column.

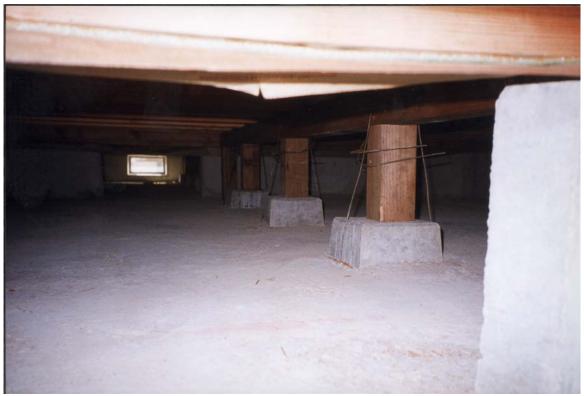
Photo 27. Support columns have not been secured to the foundation or floor joists and a structurally unsound system of wires has been used to prevent the columns from kicking out during a seismic event.

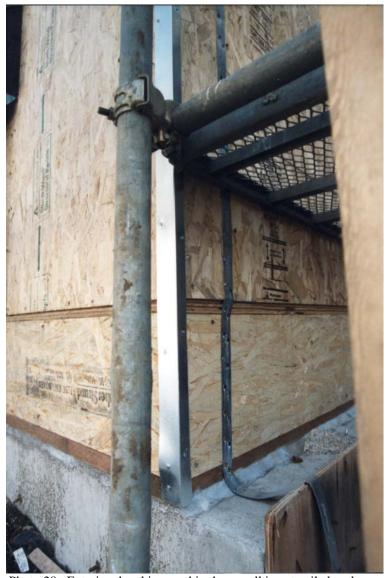
Photo 28. Exterior sheathing on this shear wall is not nailed to the sill plate and thus does not tie the house to the foundation.

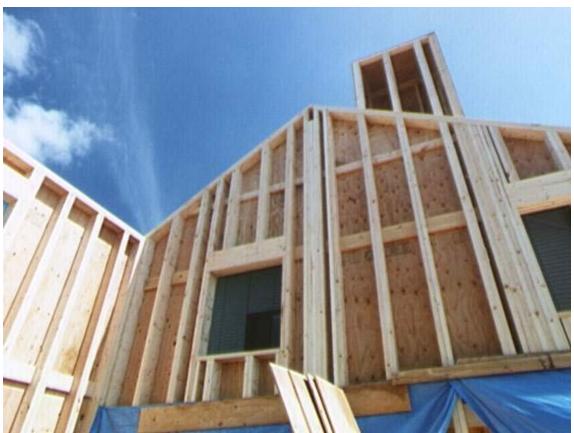
Photo 29. The excessive use of framing lumber was routinely observed and is estimated to increase framing material costs by 30-35 percent.

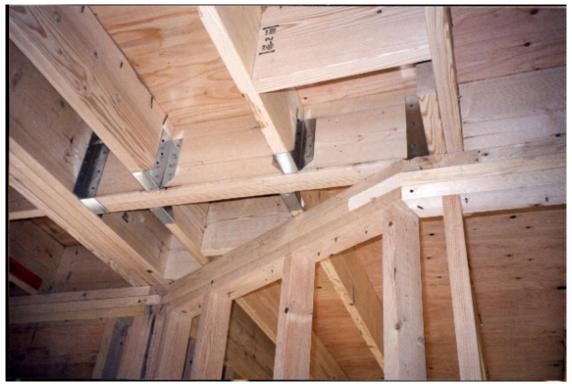
Photo 30. An example where triple top plates have been used.

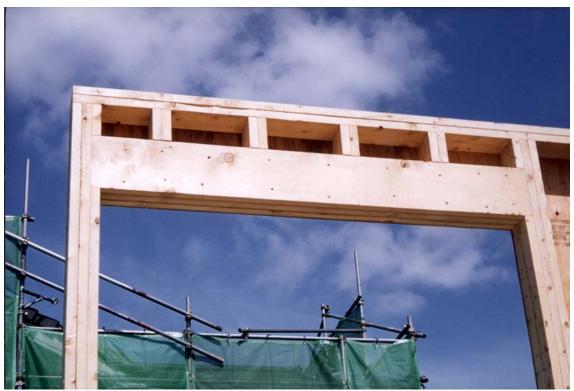
Photo 31. All window and door headers were tripled in this project, resulting in excess material and labor costs.

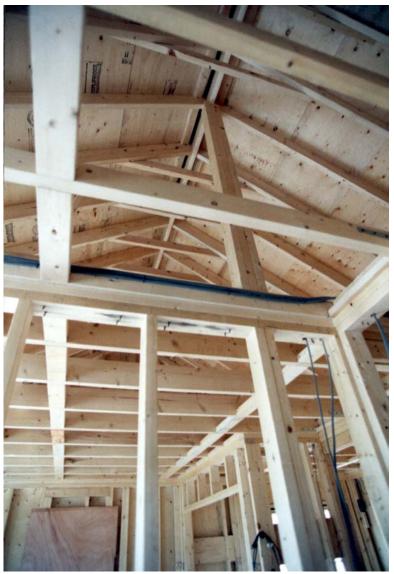
Photo 32. Specification of high grade lumber can add significantly to framing material costs without significantly improving structural performance.

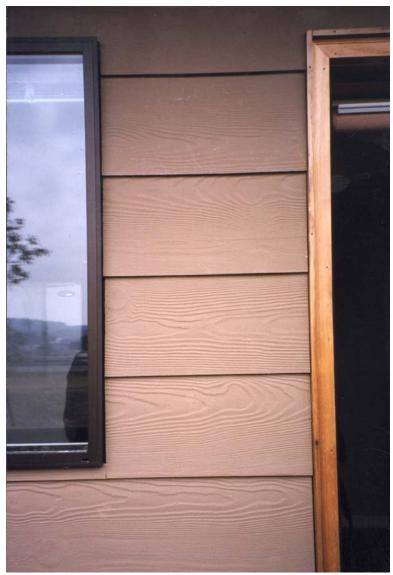
Photo 33. Failure to install flashing or apply caulk around exterior doors and windows allows moisture to penetrate exterior walls.

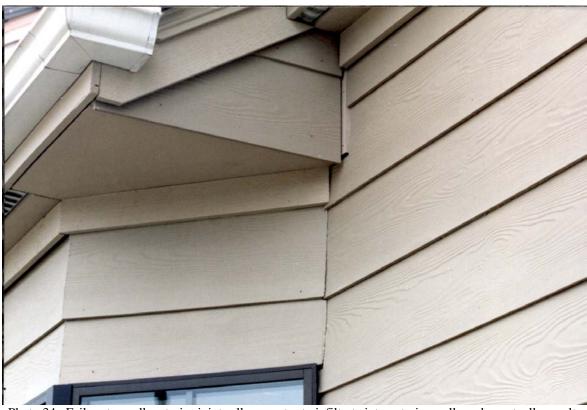
Photo 34. Failure to caulk exterior joints allows water to infiltrate into exterior walls and eventually results in their deterioration.

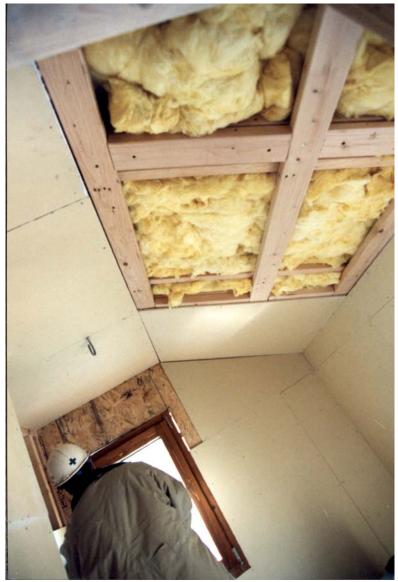
Photo 35. Incorrect installation of insulation reduces the loft of the batts and results in reduced thermal performance.

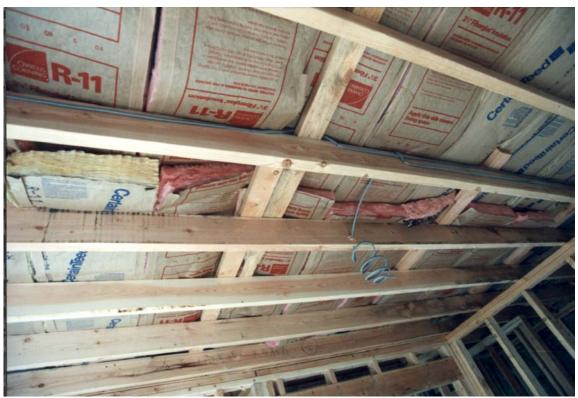
Photo 36. Insulation was often under specified and improperly installed, adversely impacting the thermal performance of the home.

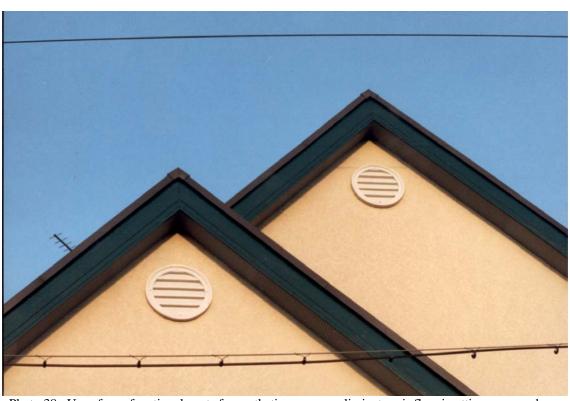
Photo 38. Use of non-functional vents for aesthetic purposes eliminates air flow in attic spaces and under roofs and contributes to moisture buildup.

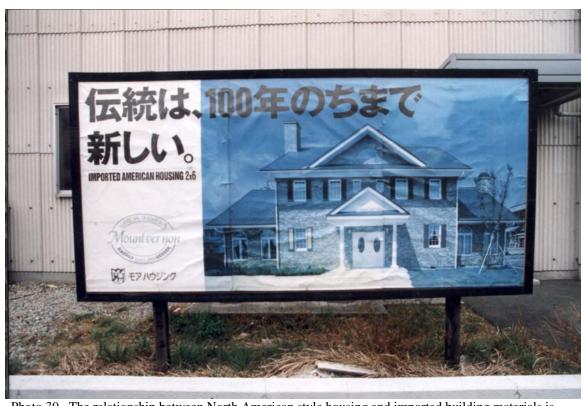
Photo 39. The relationship between North American style housing and imported building materials is often emphasized at housing developments in Japan. As a result, it is critical that these products perform well in order to maintain their competitiveness.
