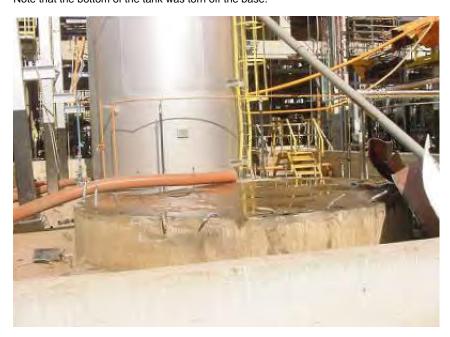
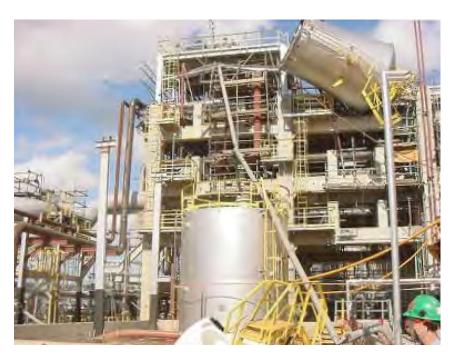
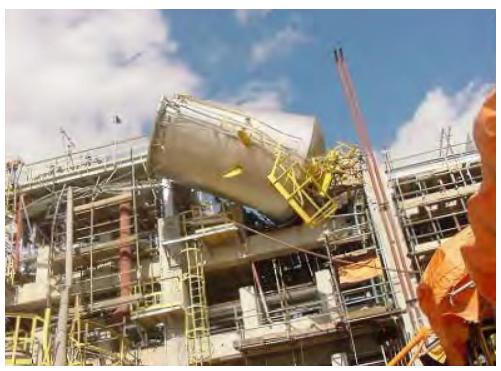
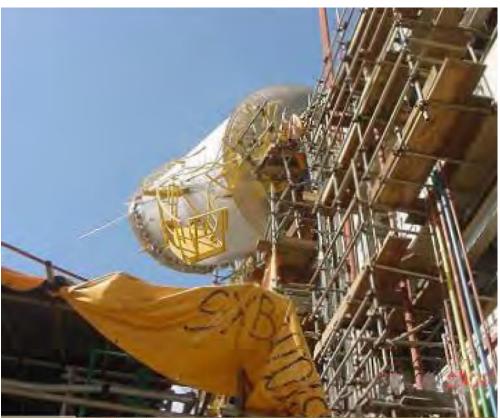
This accident occurred while a pneumatic test was being carried out on a pipe that was connected to the tank. No blanking plate or figure eight was installed to isolate the tank from the circuit. Only the inlet valve to the tank was closed.

The valve was leaking, causing the tank to become pressurized and fly off like a rocket. Note that the bottom of the tank was torn off the base.
